Stillwater Vertical Lift Bridge Rehabilitation

Todd Owens, P.E.
HNTB Corporation

TENTH BIENNIAL SYMPOSIUM

Abstract

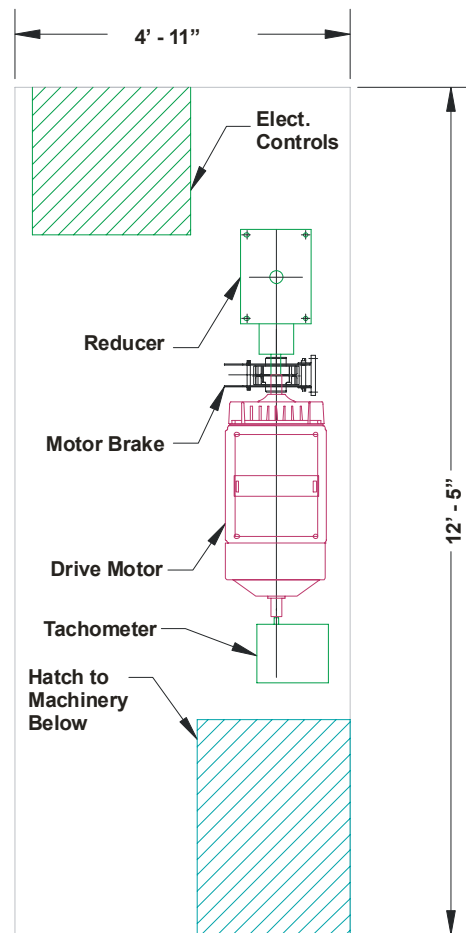
Figure 7: New Tender's House Layout

The eddy current drive was problematic and unreliable. It will be replaced with a 40 HP DC drive system. This power increase for the drive motor was the result of slightly more conservative design criteria than was in place from the original design. The chain drive was difficult to access and maintain due its location between the guard rail and the house. It will be replaced with a series of right angle reducers. A right angle reducer from the tender's house will transfer torque from the horizontally mounted drive motor vertically to another right angle reducer below. The layout of the machinery in the tender's house can be seen in Figure 7.

An alternative was selected that allowed the original tender's house to remain in its original state from outside appearances. Inside the house would contain the tender, drive motor, motor brake and right angle reducer. An additional house would be built right next to the original tender's house. The new house (electrical house) would contain the electrical panels necessary to operate the new drive system and meet electrical code for cabinet clearances. This alternative was determined by the project stakeholders to have the least impact on the historical aspects of the bridge while providing the rehabilitation required to ensure the bridge would operate well into the future.
