**HEAVY MOVABLE STRUCTURES, INC.
SIXTEENTH BIENNIAL SYMPOSIUM**

**Three Mile Creek – Pivot Bearing
Investigation, Design, and Replacement**

Tyler J. Miller, P.E.

Modjeski and Masters, Inc.

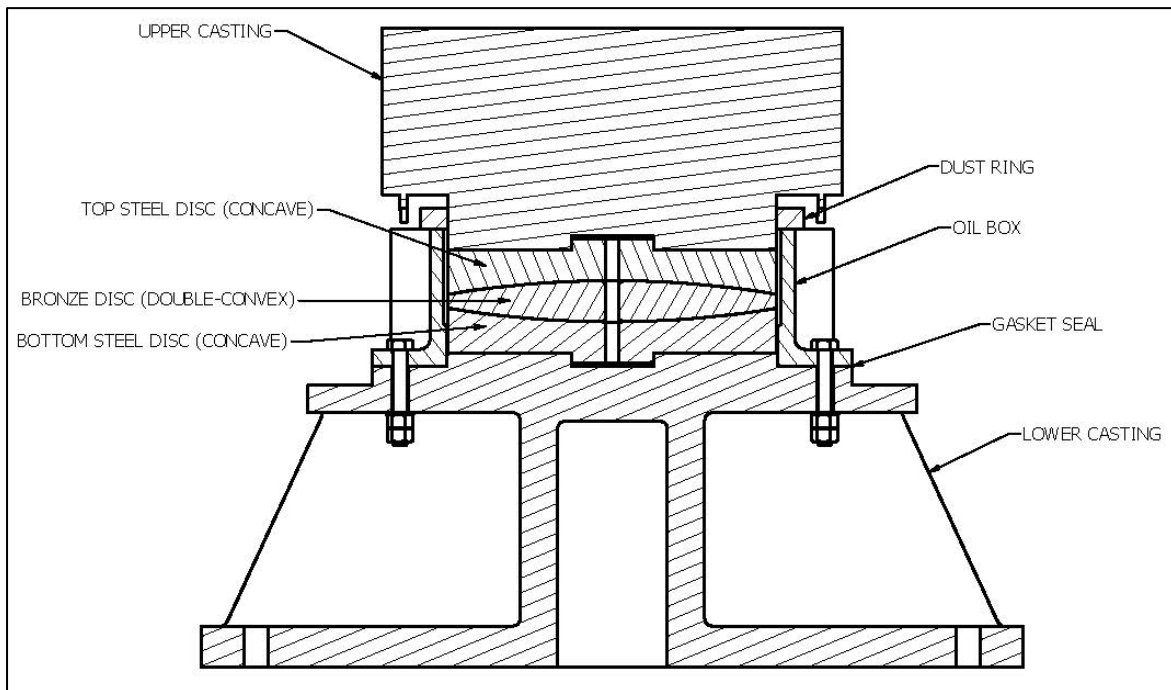
Figure 2. Common three disc pivot bearing assembly

Although the three disc pivot bearing assembly is presently operational at many swing bridges, the design can become problematic due to its inherent unstable nature. Pier settlement or span imbalance will often intensify the issue. Any position adjustments are made by middle and upper discs relative to the fixed lower disc, creating a new center of rotation as shown in Figure 3. The double-convex middle disc and the downward concave upper disc are very sensitive to equilibrium changes and can become displaced. Once displacement occurs, there is no self-correcting tendency to return to an original position. The discs can protrude beyond the lower disc to the point where they apply force on the oil box. This unintended contact force on the oil box may loosen or break mounting bolts and damage the gasket seals, preventing the retention of bearing lubrication and accelerating wear. Displaced discs may also cause the swing span to lean more heavily to one side causing wedge operational issues or excessive wear in the balance wheel components. The pivot bearing discs are inaccessible due to the oil box enclosure. Therefore, diagnosis of a problem can be difficult and the shifted discs issue may be disguised as excessive span imbalance. The only potential solution to “reset” the existing bearing assembly is to jack the entire swing span and manually reposition the discs.
