**HEAVY MOVABLE STRUCTURES, INC.  
SEVENTEENTH BIENNIAL SYMPOSIUM**

**Retrofit of a Rolling Leaf Bascule Bridge –  
Laurel, Delaware**

By Gregory Black, P.E., Neil Shemo, P.E. and Dan Griffith,  
P.E.

Design by AECOM in support of the Delaware Department  
of Transportation

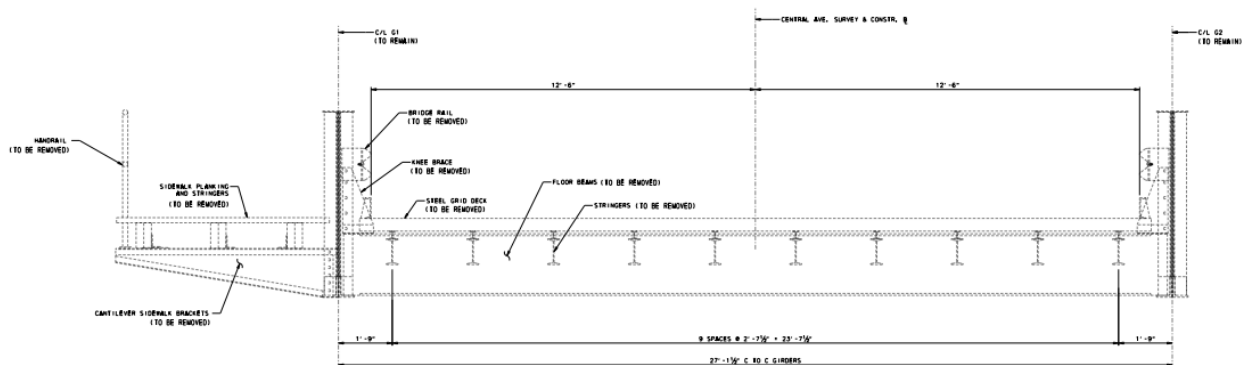
Figure 3: Existing Typical Section – Span 1

The stringers and floor beams in Span 1 have been replaced in a previous rehabilitation and are in good condition. The stringers and floor beams in Span 2 had not been replaced, most likely due to concerns over stabilizing the track girders during construction, while the floor beams were removed. Instead, the floor beams in Span 2 had cover plates welded to the bottom flanges. There were also cover plates located at the top flanges, but during inspection, these were determined to be ineffective as they are not actually connected to the top flanges of the floor beams. Interestingly, the floor beam at the north abutment is actually bearing on the beam seat for its full length. The stringers and floor beams in Span 1 and the

stringers in Span 2 are in good condition. The floor beams in Span 2 have section loss to the webs near their connections to the girders and the bottom flanges at the bracing connections. Similarly, the bottom flange bracing in Span 1 is in decent condition, while the bracing in Span 2 is in poor condition, including areas of severe deterioration and loose connections.

The bascule girders in Span 1 received several repairs during a previous rehabilitation, which included replacement of rivets with high strength bolts, complete replacement of the bottom flange angles and the complete replacement of the last few feet of the girders adjacent to the south abutment. Despite the previous rehabilitation, the Span 1 girders still exhibit minor section loss to the web above the bottom flange angles. Additionally, there is significant section loss to the web where the floor beam connections bolt on. During the original construction, holes were fabricated in the webs of the west through girders in order to allow for the passage of splice plates between the sidewalk brackets and floor beam top flanges (See Figure 5). These holes exhibit significant section loss, with knife edging.

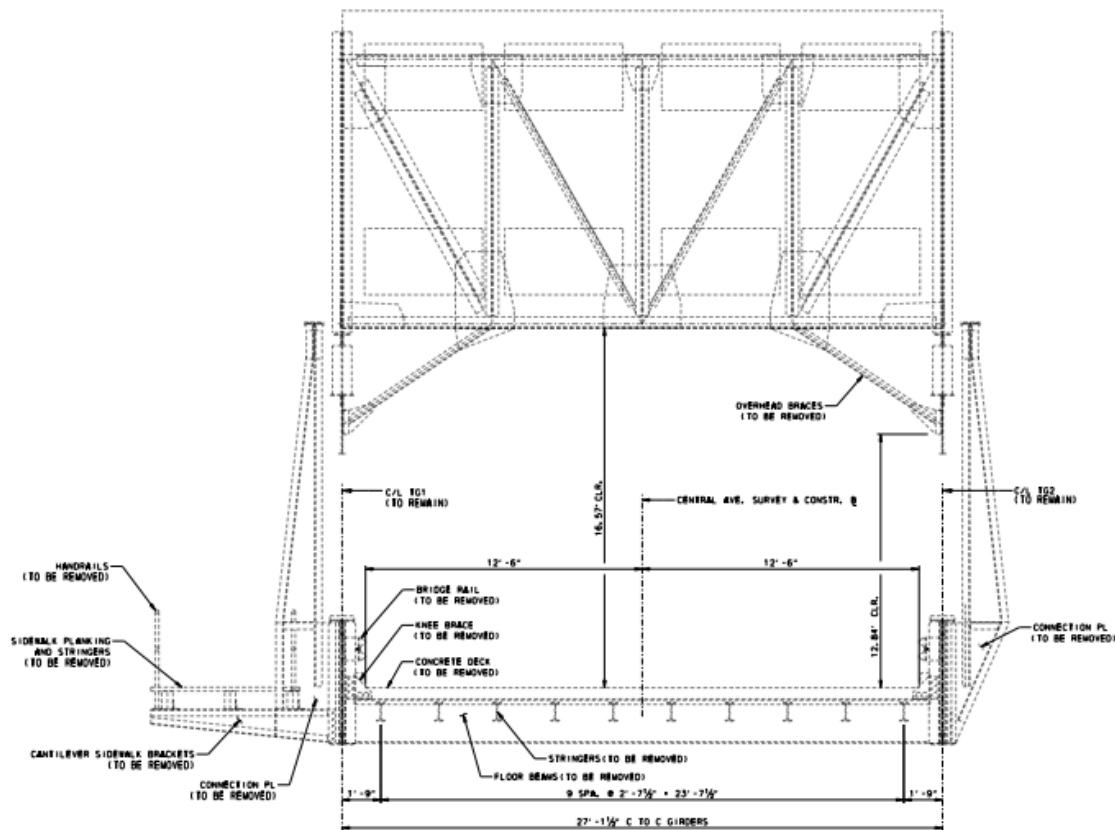
Figure 4: Existing Typical Section – Span 2

The track girders in Span 2 are original construction, with no previous repairs, with the exception of jacking stiffeners which were added when bearings at the abutment were replaced (See Figure 6). The webs of the track girders adjacent to the bearings exhibit areas of holed through section loss. The bottom flanges of both girders exhibit areas of 100% section loss at all floor beam connection locations and above the substructure.

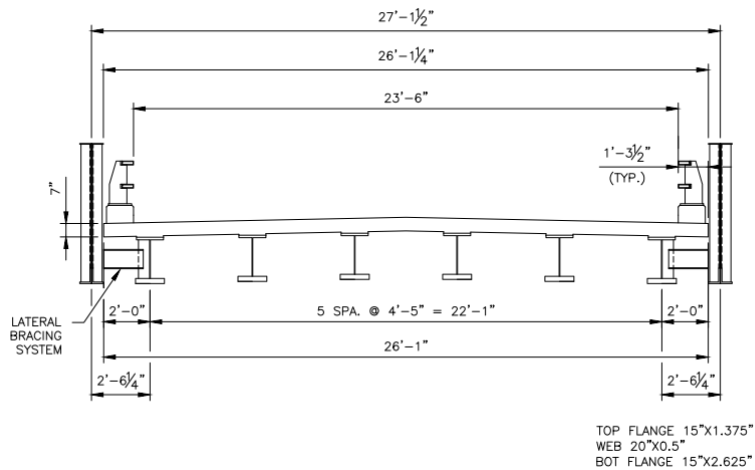
Figure 8: Steel Girder Option (Not Selected For Final Design)

The design team investigated steel beams first. The result was short heavy sections, with thick bottom flanges. These weren't efficient sections, and the depth of the girders would make diaphragm installation challenging. As one alternative, the design team investigated NEXT beams, due to their shallow profile. However, further investigation determined that after including final beam camber, NEXT beams would be deeper than the steel girders or other prestressed girder options. After further investigation it was determined that a 29 inch deep

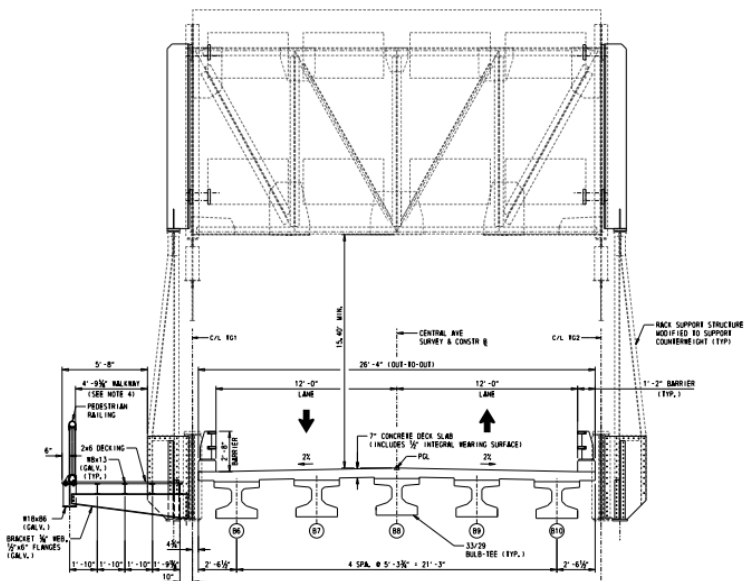
Figure 9: Prestressed Bulb-Tee Girder Option, Span 2

Bulb-Tee girder with a 7 in composite concrete deck was the more efficient prestressed girder option. Initial price investigation also determined that it would be more efficient than the steel girder alternative. Although the second span is significantly shorter than the first, the same beams were used for consistency and due to the fact they were the shortest standard Bulb-Tee's available. The new superstructure depth would be 36 inches, not including haunches, camber, or cross-slope. This resulted in a depth significantly

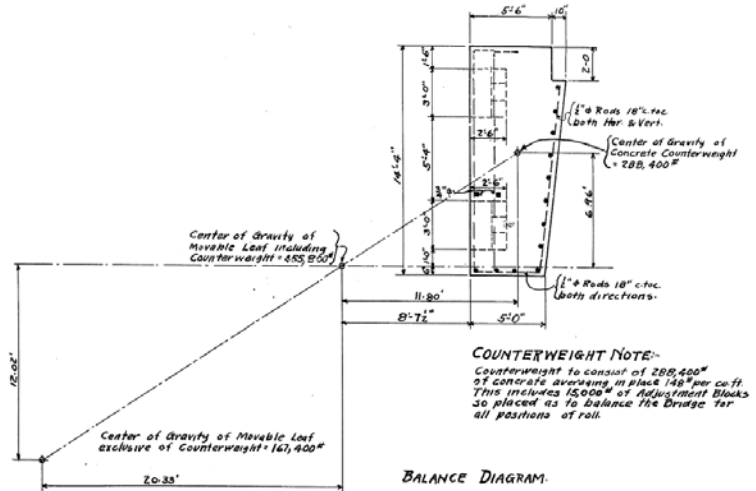
Figure 11: Balance Diagram for Existing Structure

The isolation of the new superstructure from the existing through girders leaves the existing structure in an unbalanced condition. Per the existing plans, the entire rolling leaf weighs 440,800lbs, including the counterweight (See Figure 11). This does not include 15,000lbs of balance blocks that were previously removed from the structure. The counterweight itself weighs 273,400lbs and is centered 11.80ft from centerline of pier for an eccentric load of 3,226.12ft\*kips. This eccentric counterweight load would either need to be supported, or removed. Permanent removal would modify the look of the existing structure, which is against the goals of the project and would require the construction of a false counterweight. Additionally, the segmental girders would need to be stabilized during demolition and reconstruction.

After additional investigation, it was determined that the existing rack frame could support the counterweight with minor modifications. These included directly connecting them to the counterweight (See Figure 9), adding a tension tie and building new bearings at the base of the rack support columns. A second redundant system to resist the counterweight eccentricity is provided by new anchor bolts at the existing south abutment, which are designed to resist the full uplift force from the counterweight. A third redundant system is the new bridge superstructure itself. Although the lateral braces allow for differential movement, any large movement of the girders would be stopped by the connection to the new prestressed girder superstructure, which outweighs the old floor beam and stringer system.
