**HEAVY MOVABLE STRUCTURES, INC.  
SEVENTEENTH BIENNIAL SYMPOSIUM**

**Obtaining Acceptable Load Sharing & Gear  
Action without a Differential**

Geoffrey L. Forest

Modjeski and Masters, Inc.

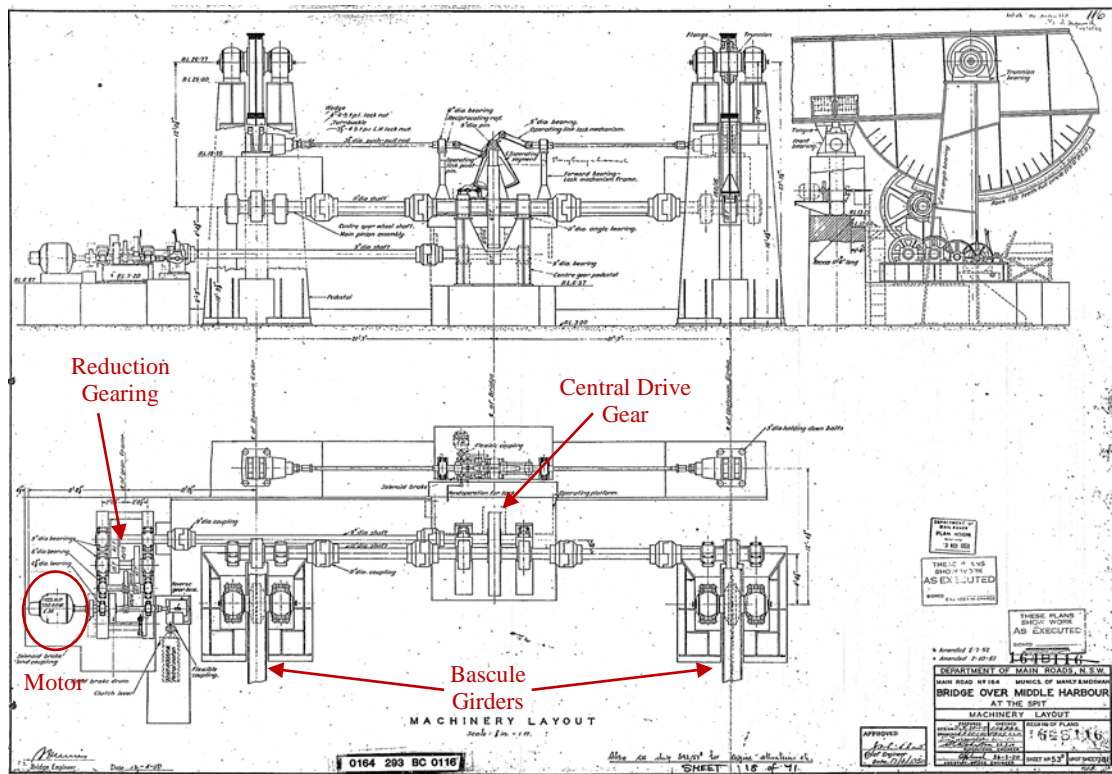
Figure 1 – Original configuration of span drive machinery

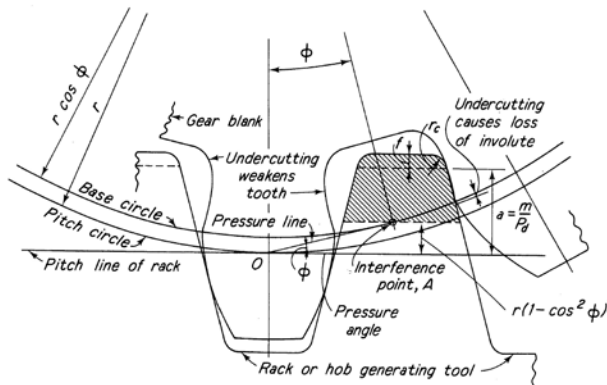
Figure 2 – Description of undercutting from fabrication

The wear pattern observed was reminiscent to undercutting, which can occur during the fabrication process of a gear. A gear with a small number of teeth, as a result of fabrication, can result with an “undercut” area in the dedendum near the root (see Figure 2). Undercutting is undesirable because “...from a load-carrying standpoint, the undercut pinion is low in strength and wears easily at the point at which the undercut ends” [Dudley, Handbook of Practical Gear Design, 1994, Section 3.5] and measures are generally taken by the gear designer/fabricator to avoid undercutting in the fabrication process.

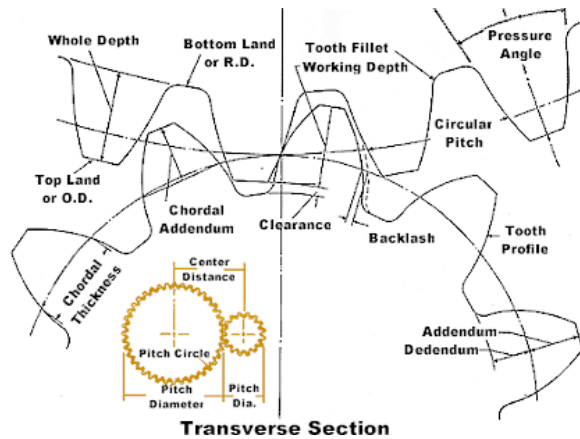
Figure 3 – Properly engaged gears with pitch circles just touching

Another possibility of the cause of the wear is an over-engagement of two mating gears. When properly aligned, the pitch circles of gears should “touch” but not overlap (see Figure 3). Any overlap in the pitch circles is an over-engagement of the gear set. When gears are over-engaged significantly, the tip (addendum) of the larger gear can interfere with the lower portion (dedendum) of

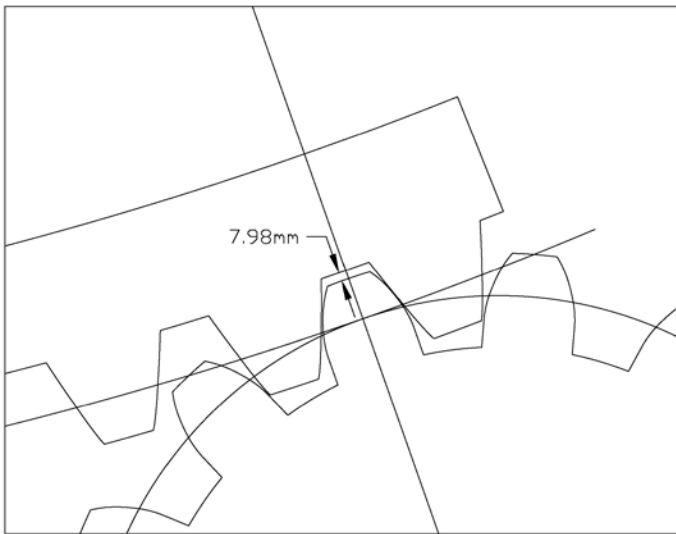
Figure 6 shows over-engagement of the east rack pinion by 0.200" (5 mm) and includes the average wear of the rack and pinion. For comparison, Figure 7 shows a gear set with proper engagement and no wear.

Figure 7 – Scale drawing of rack/pinion mesh with correct engagement
