**HEAVY MOVABLE STRUCTURES, INC.  
SEVENTEENTH BIENNIAL SYMPOSIUM**

**Mitigation of Cracks in  
Sheave Trunnions for the  
Burlington Bristol Bridge**

Robert D. Gessel; ASNT Level III  
Wiss, Janney, Elstner Associates, Inc.

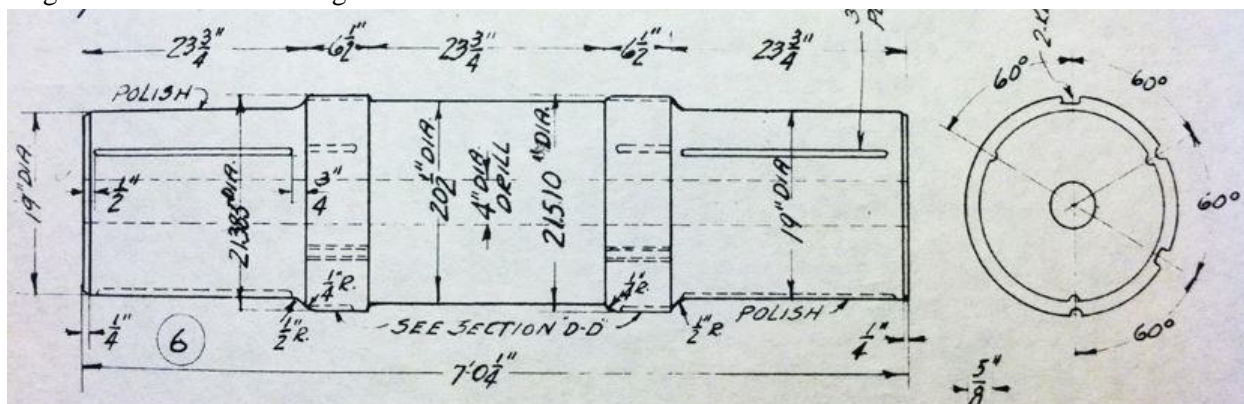
The drawing in Figure 2 shows the design of the forged steel trunnions used in the Burlington-Bristol Bridge. The journal ends are reduced from the nominal 21-1/2 inch sheave seat diameter to 19 inches, and fitted to the plain half-bearings mounted at tops of the counterweight towers. The journal bearing surface

transitions with a 1/2 inch radius fillet to the thrust face. A center-bored hole extends through the full length of the 7 ft-1/4 in. long trunnions.

FIGURE 2: An excerpt from drawings shows the overall design, and geometric features of the trunnions.
