**HEAVY MOVABLE STRUCTURES, INC.
SEVENTEENTH BIENNIAL SYMPOSIUM**

**CONSTRUCTION ENGINEERING FOR
THE ADAMS STREET BASCULE BRIDGE
AND VIADUCT REHABILITATION IN
CHICAGO**

Milhouse Engineering & Construction, Inc.

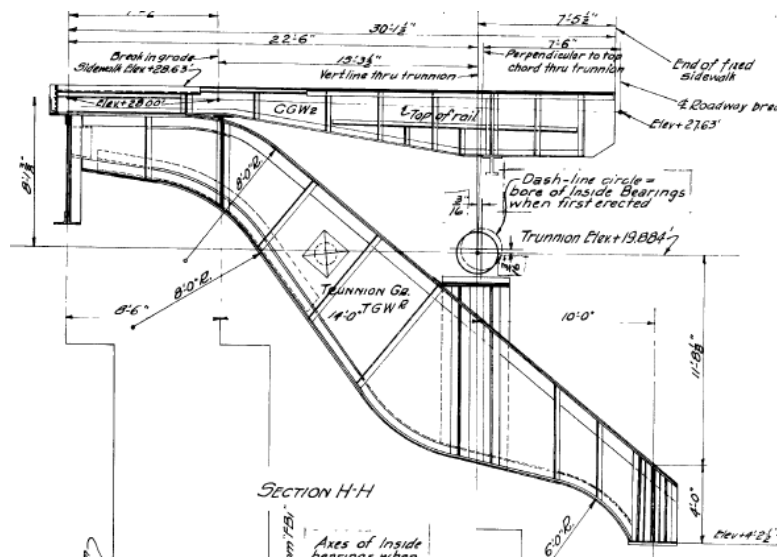
Figure 2: S-Girder

The bascule leaf trunnions are supported by a pair of longitudinal girders that span from the river wall to the backwall and an S-girder. This arrangement allows the trunnion loads to be supported by the caissons located at the river wall and backwall of the bridge pit and eliminates the need for extensive piling and concrete substructure supports. The trunnion supported on the longitudinal girder sits on a braced pedestal mounted to the longitudinal girder. The longitudinal girder, S girder and live load bearing are supported at the river wall by a large steel built up grillage support embedded in the concrete. The longitudinal girders consist of two deep built up members tied together with heavy cover plates. See Figures 2 and 3 for the S-Girder and Longitudinal Girder details respectively.
