**HEAVY MOVABLE STRUCTURES, INC.  
SEVENTEENTH BIENNIAL SYMPOSIUM**

**Emergency Strauss Bascule Link Pin  
Repair - Seabrook Bascule Bridge**

Tyler J. Miller

Modjeski and Masters, Inc.

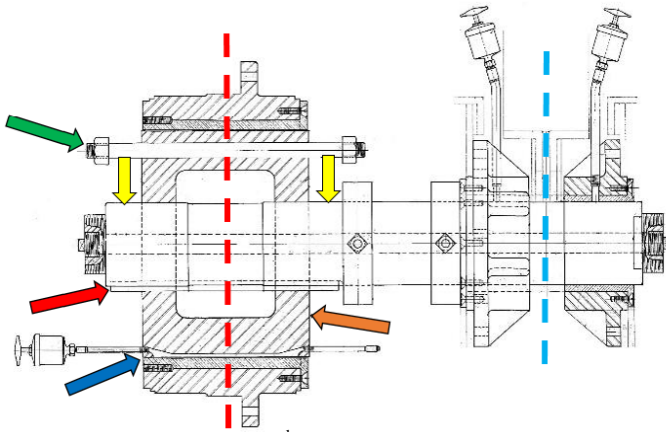
The counterweight link forces in the original 2<sup>nd</sup> Link Pin assembly are resisted by a steel pin, steel sleeve, bronze bushing, and steel bearing housing (see Figure 2). The bascule truss gusset plates support the pin. Six retainer turned bolts secure the sleeve to the truss gusset plates to prevent rotation. The sleeve to bronze bushing interface provide the bearing surface for all relative movement between the

Figure 2 - Seabrook 2<sup>nd</sup> Link assembly cross section comprised of the counterweight link (red dashed line), main sleeve (orange arrow), bronze bushing (blue arrow) supported by the main pin and the span gusset plates (not shown at the yellow arrows), and the operating strut connection (blue dashed line). Note the grease grooves in the sleeves (blue arrow), the retainer bolts to resist main sleeve rotation (green arrow), and the pin key to restrict pin rotation (red arrow).

The operating strut connection presented a second design challenge. Friction from the operating strut bearings causes rotational forces in the pin that must be resisted. Originally the pin was keyed to the span gusset plates for this purpose (refer to Figure 2); however, the new gusset sleeves were not thick enough for a keyway. Another method with similar anti-rotation capacity was required for the pin. The answer was found by adding flats at the interface between the end of the pin and the inboard gusset sleeve (see Figure 3). Ears were also added to the gusset sleeves, extending to two of the new shear insert plugs, to anchor the gusset sleeves from rotation.
