**HEAVY MOVABLE STRUCTURES, INC.
SEVENTEENTH BIENNIAL SYMPOSIUM**

**Counterweight Trunnion Bearing Rehabilitation
for a Strauss Heel Trunnion Bascule Bridge**

John Williams, PE
Stafford Bandlow Engineering

CSX Bridge QDC 1.71 is a double track Strauss heel trunnion bascule bridge in Buffalo, NY constructed circa 1912. The length of the bascule span from the heel trunnion to the live load supports at the toe end of the span is 124 feet. The total weight of the counterweight is estimated to be 800 tons, producing a reaction at the counterweight trunnion bearings of approximately 1,400 tons total or 700 tons per bearing. The structure spans over the Buffalo River and is operated infrequently for marine traffic. Typically the span is operated mostly in the winter months to permit ice breaking operations on the Buffalo River in an effort to prevent ice jams and resultant flooding in the South Buffalo communities along the river. Openings are also required for periodic dredging operations on the river. The waterway is considered a federal navigation channel and is controlled by both the Coast Guard and the Army Corps of Engineers. Presently CSX operates a single track over the structu

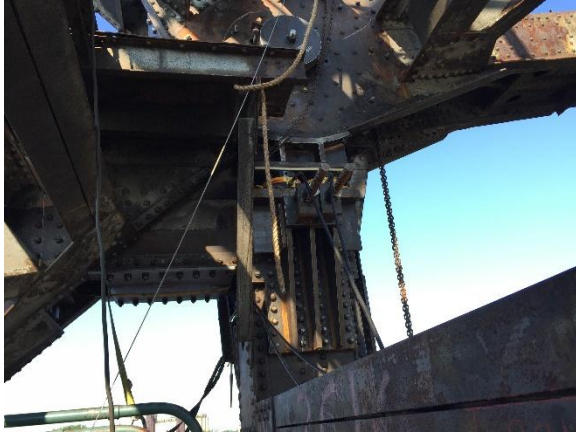
Photo 20: Vertical jacking system installed.

Once the marine outage was initiated, the vertical and horizontal jacking hardware was affixed to the existing counterweight tower structure. Hydraulic cylinders were installed and the vertical and horizontal hydraulic systems were pressurized simultaneously to create a combined jacking force equally opposing the trunnion bearing reaction in both magnitude and direction. All jacking operations were performed between train movements across the structure. See Photos 20 and 21.

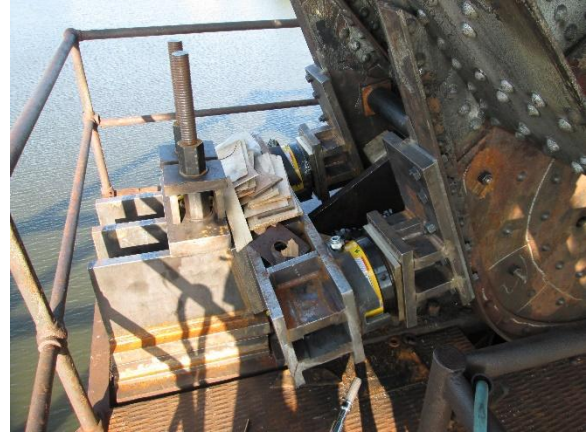
Photo 21: Horizontal jacking system installed.

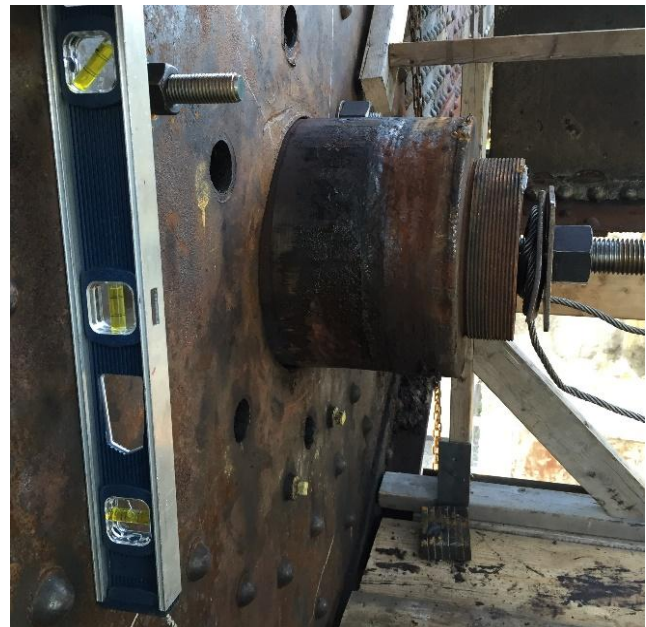
Photo 22: Close-up view of the existing counterweight trunnion pin where it interfaces with the counterweight truss during removal.

With the trunnion assembly unloaded, the existing studs, pin, sleeve and bushing were removed. The existing bearing housing was cleaned and measured using a portable coordinate measuring machine (CMM). The engineered plastic “quarter-sleeve” blocking system was installed and the temporary pin was inserted and secured in position. All tasks were completed within the available work window. See Photos 22 through 28.

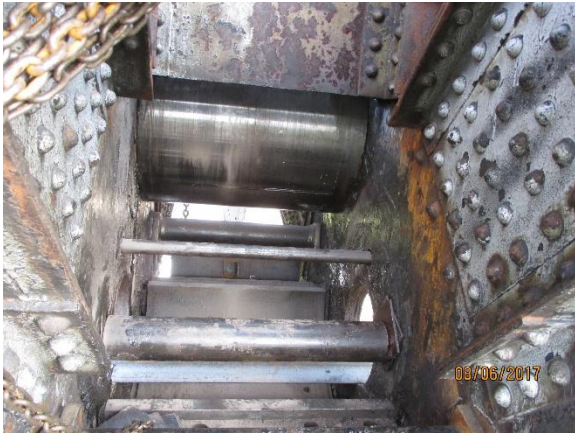
Photo 23: View inside the counterweight truss as the existing sleeve was lifted out of position. Temporary bracing installed as the sleeve moves along the removal path.

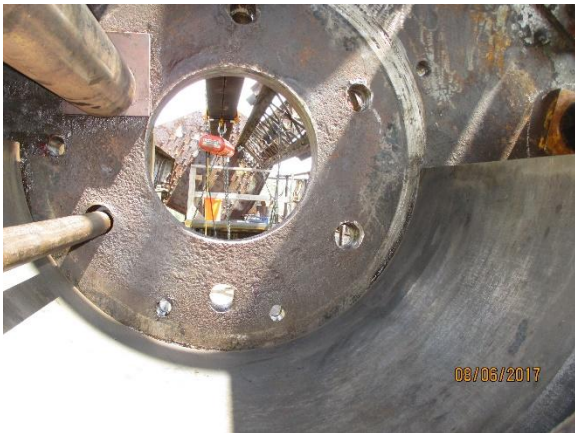
Photo 25: View inside the counterweight truss with the bushing removed and the existing bearing housing cleaned for inspection and measurement.

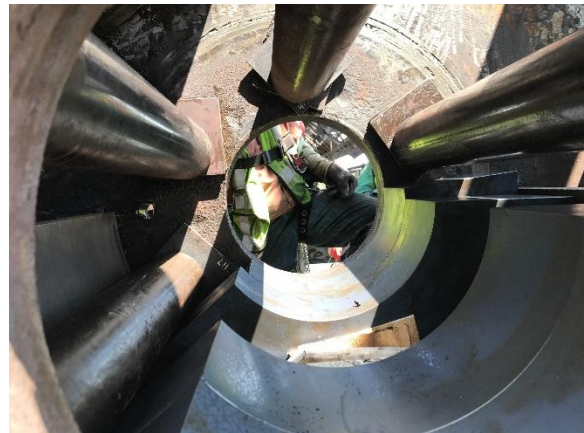
Photo 26: View inside the counterweight truss with the engineered plastic "quarter-sleeve" blocking system installed prior to installing the temporary pin.

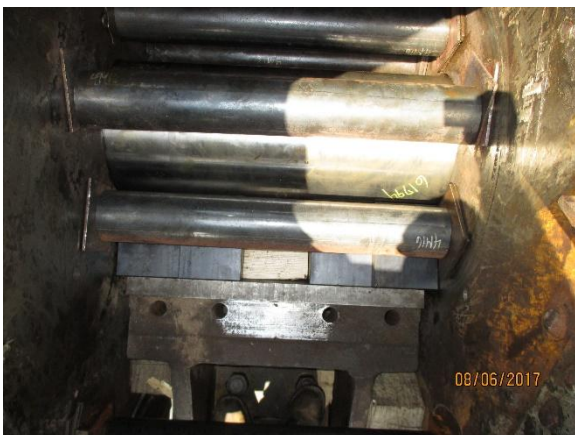
Photo 27: View inside the counterweight truss with the engineered plastic "quarter-sleeve" blocking system installed and the temporary pin in place.

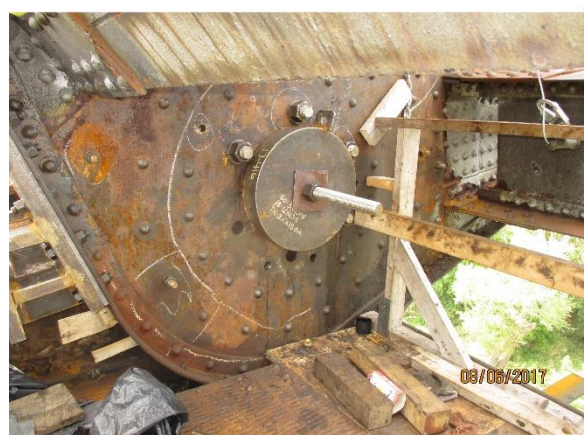
Photo 28: Temporary pin secured, work window 1 complete.

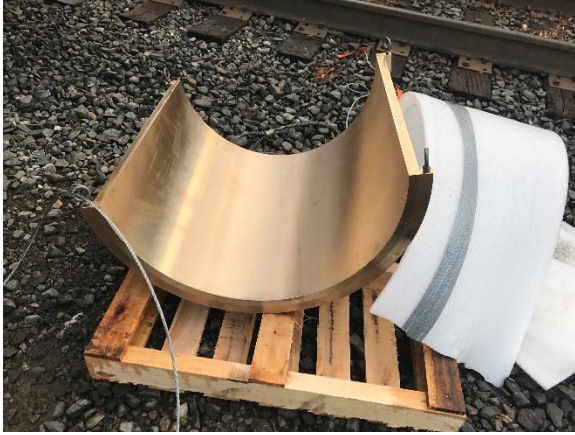
Photo 29: The new bushing finish machined and ready for installation.

In the interim period between work windows 1 and 2, finish machine work was completed for the new bushing outside diameter and the new sleeve with the exception that finish stock was provided for the inside diameter. See Photos 29 and 30.

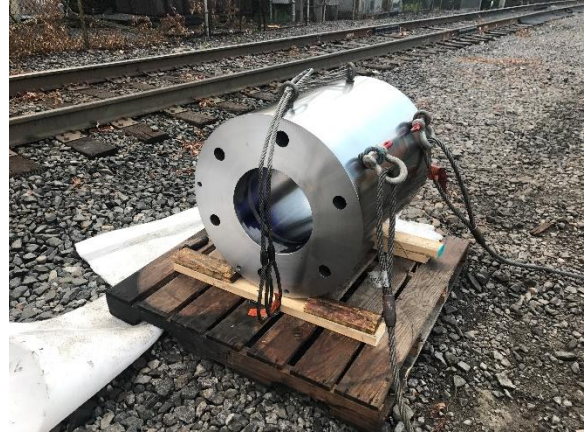
Photo 30: The new sleeve finish machined except for the inside diameter and ready for installation.

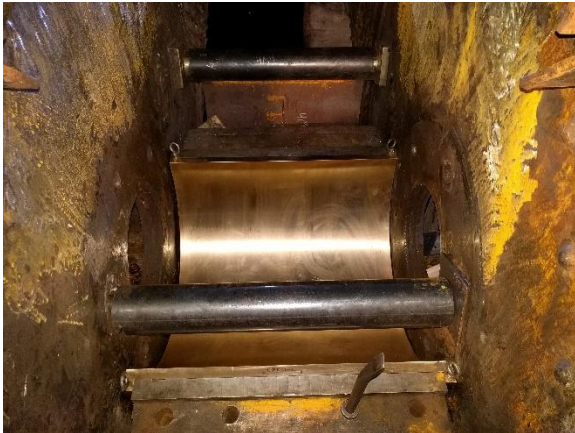
Photo 31: The new bushing after installation in the existing bearing housing.

The temporary pin and blocking were removed, the new bushing was installed and seated in the bearing housing, and the new sleeve was installed and aligned in the bushing with gaps all around to allow for slight relative movement of the counterweight truss relative to the bearing housing. Shims were installed to fill the gaps between the end of the sleeve and the gussets of the counterweight truss. Temporary studs were installed and tensioned to secure the sleeve in position. All tasks were completed within the available work window. See Photos 31 through 33.

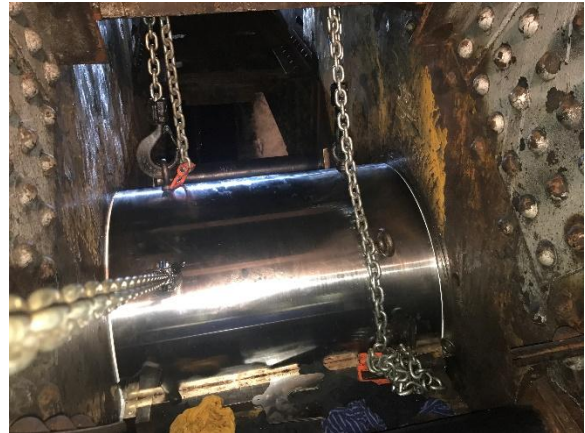
Photo 32: The new sleeve hung in place inside the counterweight truss, aligned to the bushing.

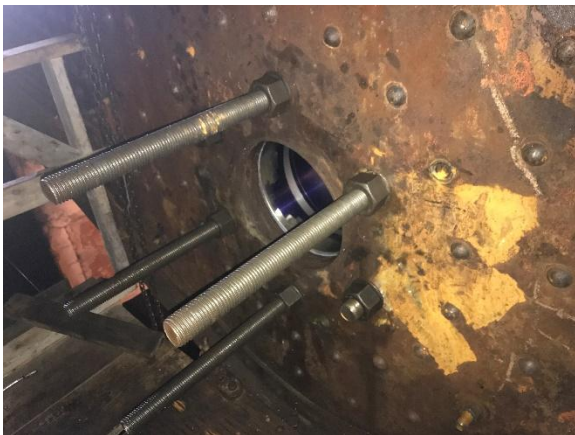
Photo 33: Temporary studs installed and tensioned to secure the new sleeve.

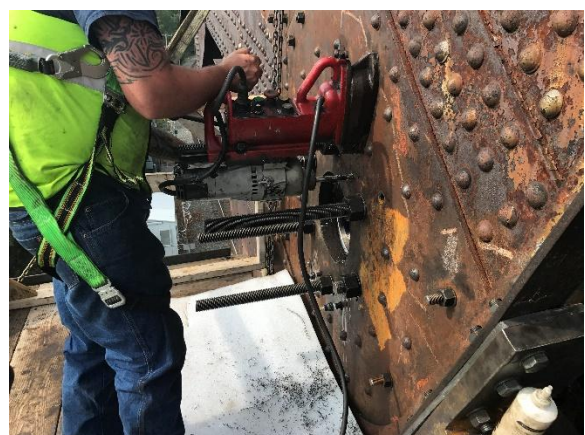
Photo 34: Drilling holes for alignment dowels.

In the interim period between work windows 2 and 3, small dowels were installed to lock the sleeve in position relative to the truss and the bore in the sleeve and truss was line bored to clean up. After line boring was complete, the finished inside diameter was documented and transmitted to the shop for finish machining of the permanent pin. The temporary pin was also installed for additional redundancy for the interim period after the line boring was complete and prior to work window 3. During this period, Hohl Industrial conducted numerous “practice runs” of the pin installation sequence to ensure the procedure could be completed in less than the anticipated 5-minute window in which the pin would be warming/expanding. See Photos 34 through 36.

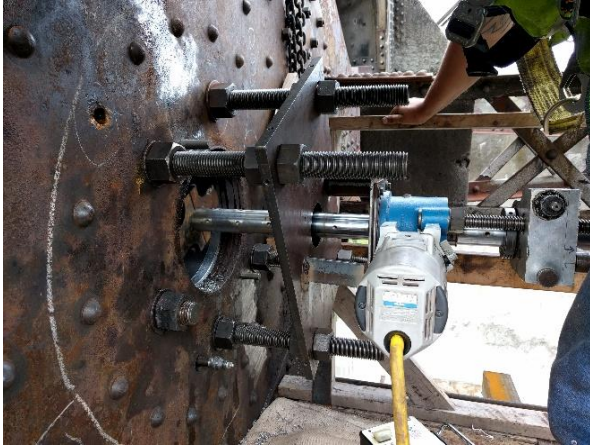
Photo 35: Line boring equipment installed and boring underway.

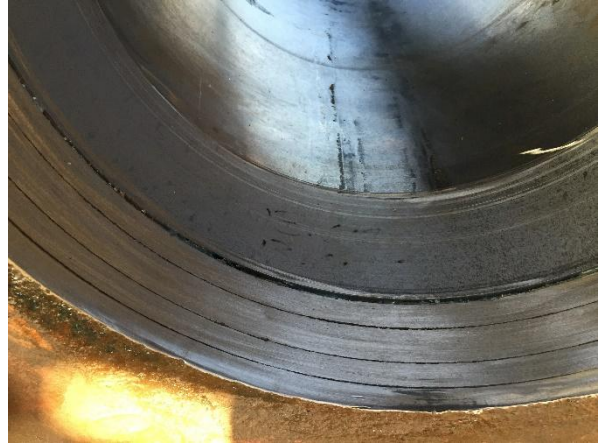
Photo 36: Close up view of truss and sleeve after line boring.

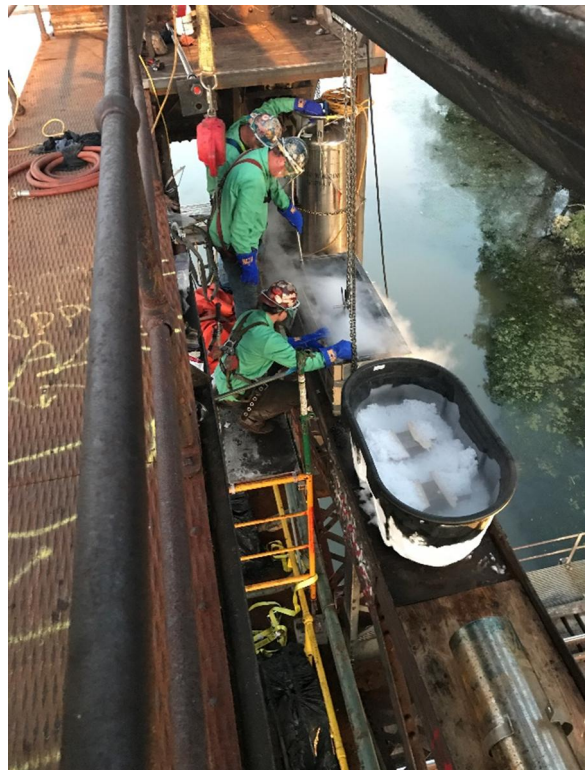
Photo 37: The permanent pin has been removed from the dry ice and transitioned to the liquid nitrogen for further cooling.

The temporary pin was removed, the new pin was cooled, initially by dry ice and then in liquid nitrogen for installation into the bore. The elapsed time from removing the pin from the liquid nitrogen bath to installation through the sleeve was less than 3 minutes. Once the pin was installed and the temperatures normalized, pin nuts were secured. The temporary studs were removed one at a time and the permanent studs were installed and tensioned. All tasks were completed within the available 24-hour work window. See Photos 37 through 39.

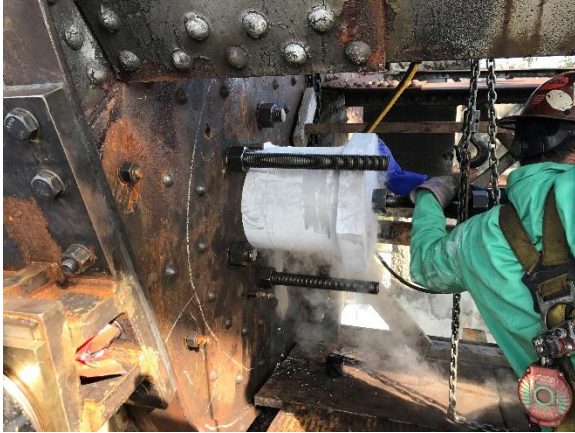
Photo 38: Permanent pin partially installed from inboard side of truss.

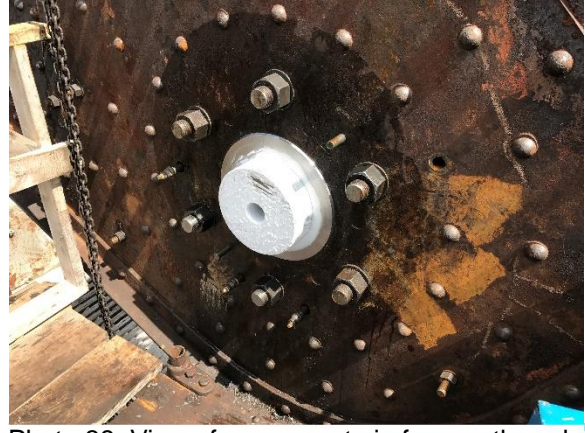
Photo 39: View of permanent pin from outboard side after it was fully inserted, prior to installation of the pin nut.

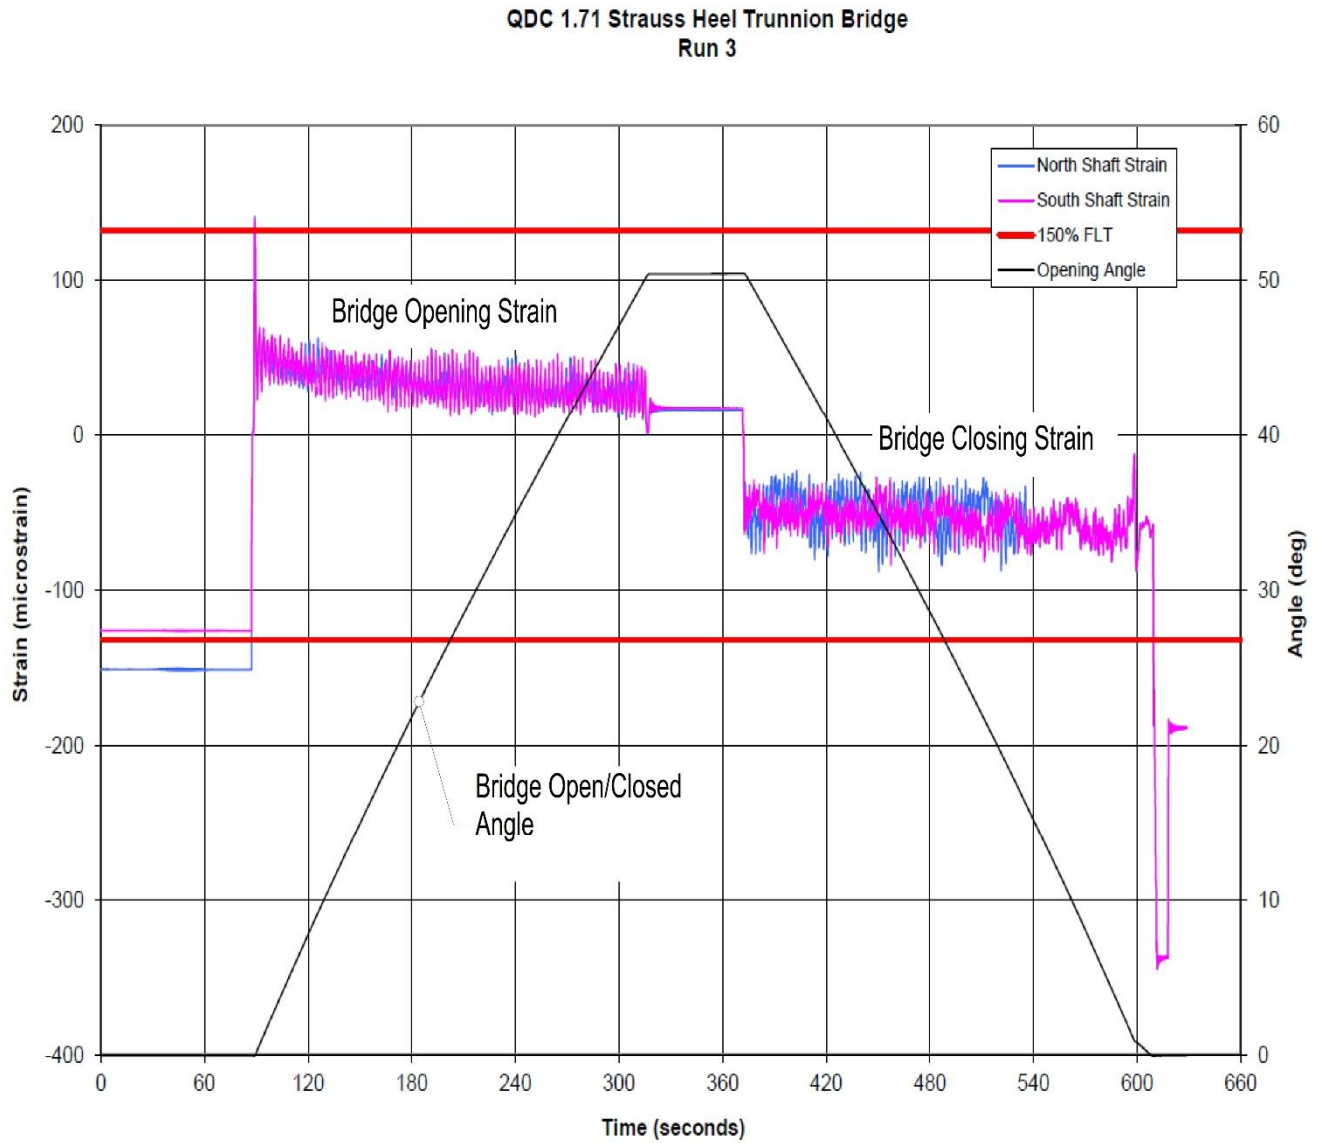
All of the jacking components were removed and preparations were made for operating the span. A successful test opening was performed on September 13, 2017. Operating loads in the span drive machinery were monitored real time using dynamic strain gage measurements. A strip chart of the raw strain gage data and graphical results from the balance analysis is shown in Figures 40 and 41.

Span balance and system friction was derived from the strain gage data. The results showed that average friction decreased by 14% for the movable span compared to the testing results from 2014. The only known change to the bridge since the 2014 test is the counterweight trunnion bearing rehabilitation which indicates that the new bearing has less friction than the existing bearing it replaced. In addition to the reduction in friction there were no noises or vibration emanating from the counterweight trunnion assembly as there had been in the past.

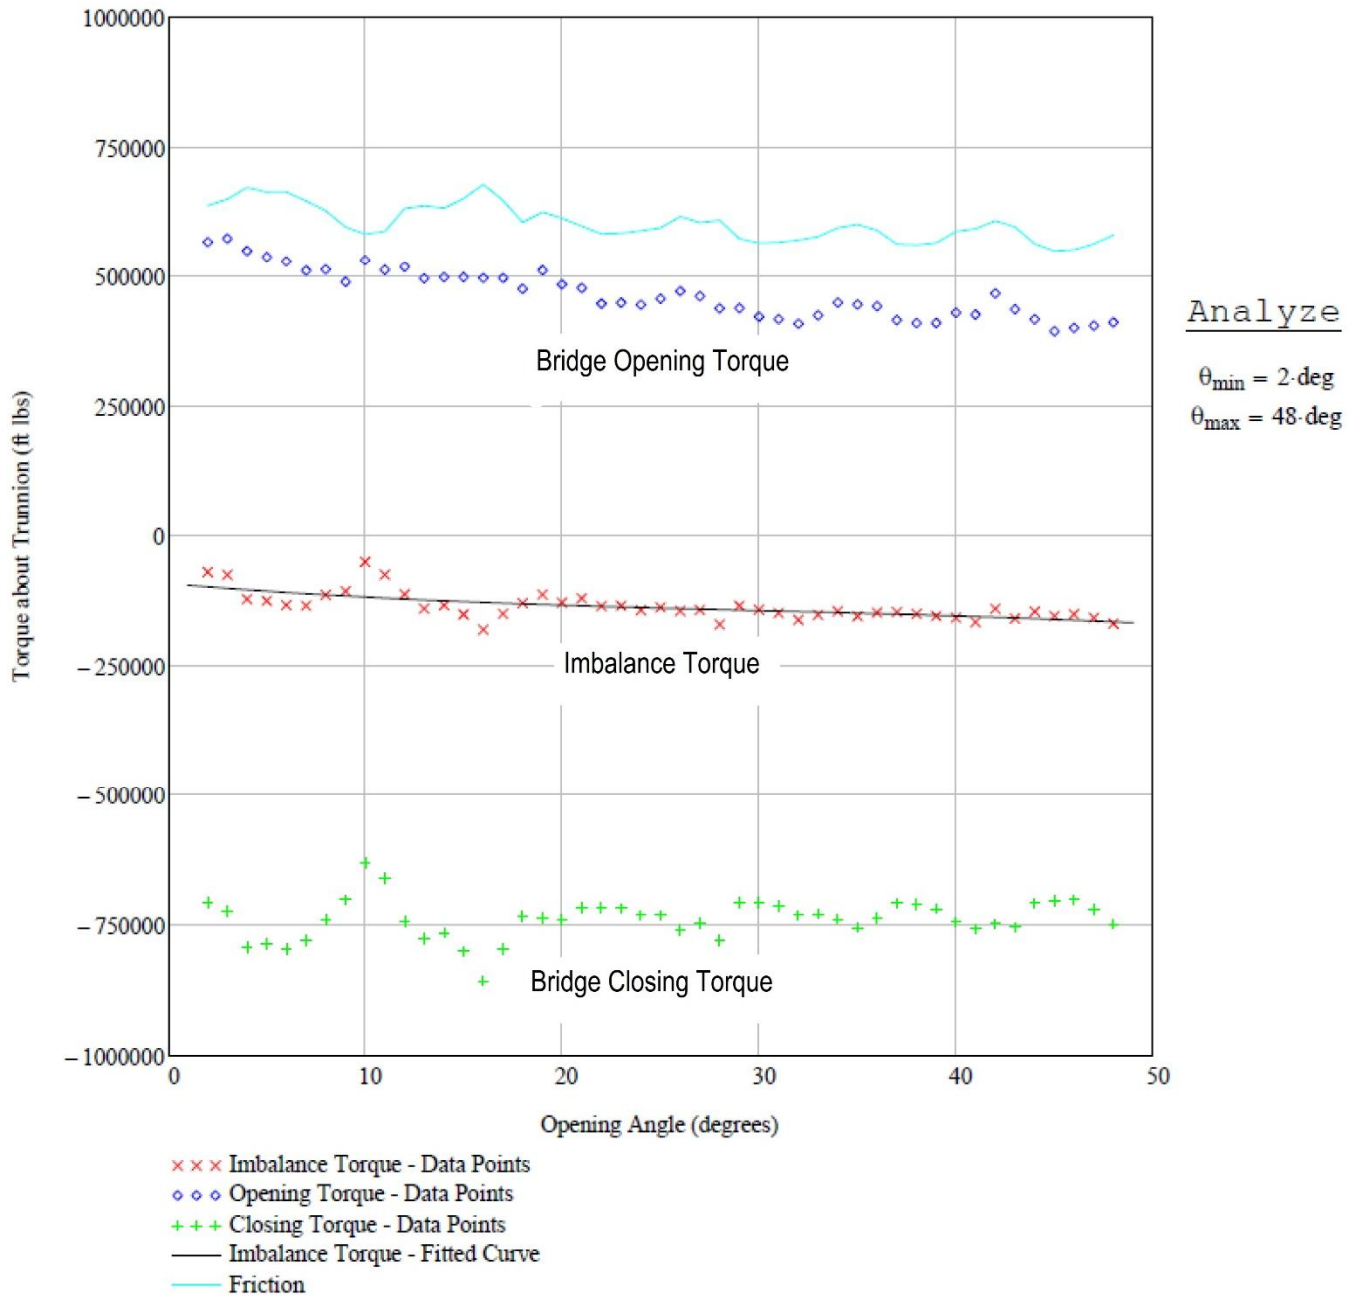
Figure 41: Graphical results from the balance analysis of the strain gage data.
