**HEAVY MOVABLE STRUCTURES, INC.
SEVENTEENTH BIENNIAL SYMPOSIUM**

92nd Street Bascule Bridge Repairs

Brian J. Santosuosso, S.E.

Wiss, Janney, Elstner Associates, Inc.

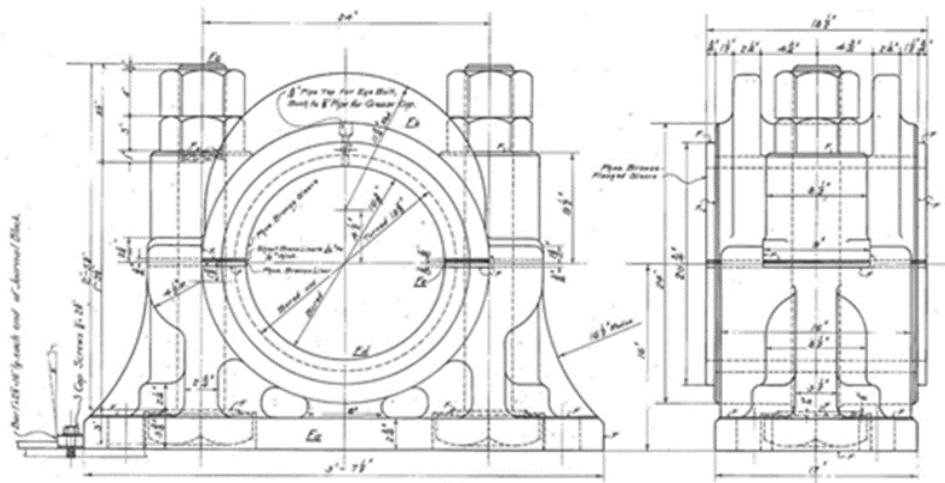
FIGURE 12. As-designed pinion shaft bearing Journal Block F, also known as the B1 bearing. Detail taken from the original bridge design drawings.

Two conditions of concern were observed. When struck with a 3 lb. hammer, some of the four turned bolts were able to be rotated. Therefore, the bolts were clearly not tight. In addition, it was possible to insert a putty knife horizontally into the bearing sleeve between the shaft and the phosphorous bronze bushing to a depth of about 2 inches. This is shown in Figure 13, and is indicative of advanced wear.

After completion of the investigation related to Journal Block F the loose base bolts connecting the north rack pinion shaft journal block to the machinery frame were tightened by CDOT and leaf operation was restored driving the leaf with a single pinion.

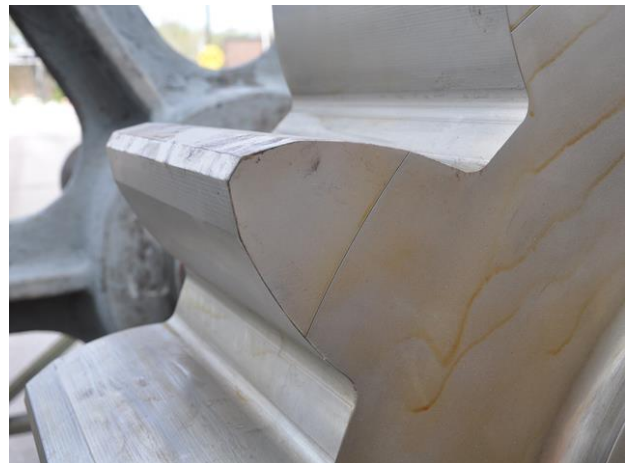
The work proceeded first at the south rack and pinion while the leaf was operated using the north rack and pinion. Once the south rack and pinion was reinstalled and operational, the rehabilitation work was performed for the north rack and pinion. A photograph showing the unique tooth profile and tooth tip relief required at the new south pinion is given in Figure 17. Work was completed in late 2012 and bridge was returned to normal operational service, driven by both racks and pinions. A precision survey was not performed to document the as-built condition of the rehabilitated rack and pinion alignment. In addition, no bascule span balance adjustments were made in an effort to minimize pinion tooth loads during leaf operations.

FIGURE 17. Special pinion tooth profile used for the new south pinion.

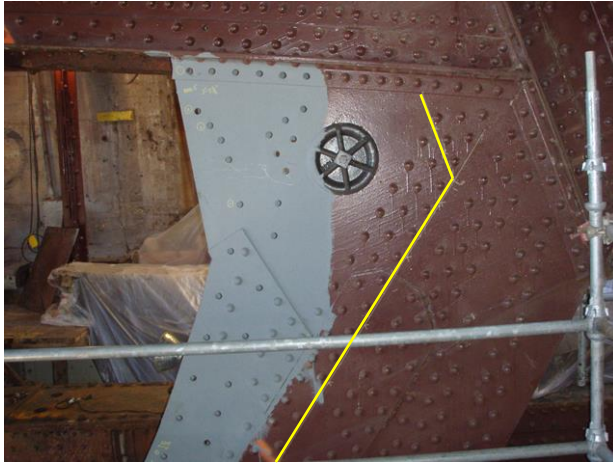
FIGURE 21. Yellow paint stick layout marks shown on the existing structure during development of final shop drawings for the new rack side plates.

Shop drawings were created for the new side plates and engineers used the shop drawing information to lay the geometries of the new side plates out on the structure. Minor adjustments required by existing field obstructions and actual fastener layout on the existing trusses were made to the drawings, and the shop drawings were released for fabrication. Figure 21 shows an example of the layout marks on the inboard side of the south truss at the top of the rack.

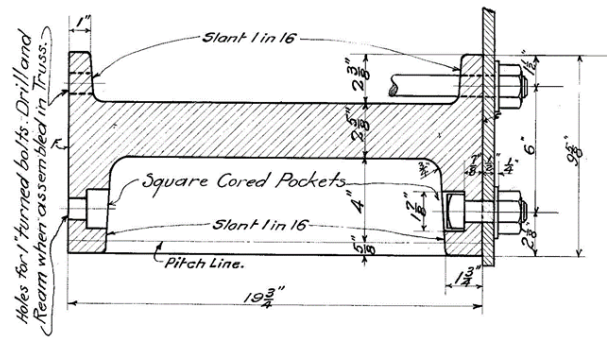
FIGURE 24. Typical section through rack segment taken from the original design drawings showing fastener arrangement.

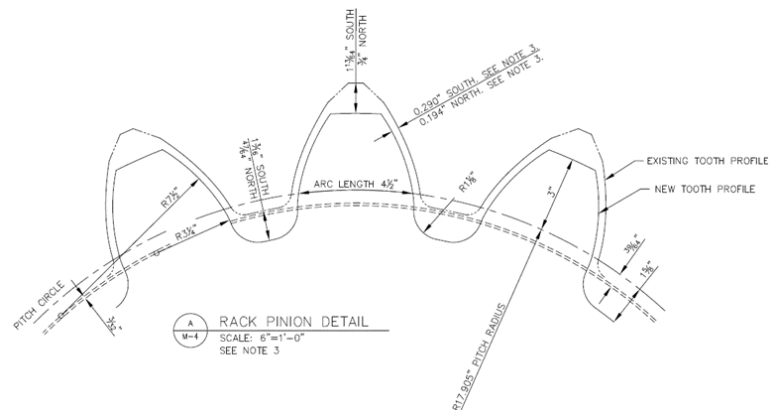
FIGURE 25. Design drawing excerpt showing new pinion tooth profile inside extents of existing pinion forgings.

The pinion gear teeth were designed to closely resemble those of the original 1913 design specifications, with minor adjustments as needed to provide an acceptable mesh. An advantage of this design choice was that the existing pinions (fabricated under the previous construction project) were machined down to the new tooth profile. It was therefore not necessary to source new forgings and cut completely new gears for this project, saving the cost of the forgings and project schedule time required to acquire them. Figure 25 is an excerpt from the design drawings showing the new pinion tooth geometry inside the extents of the existing pinion forgings.

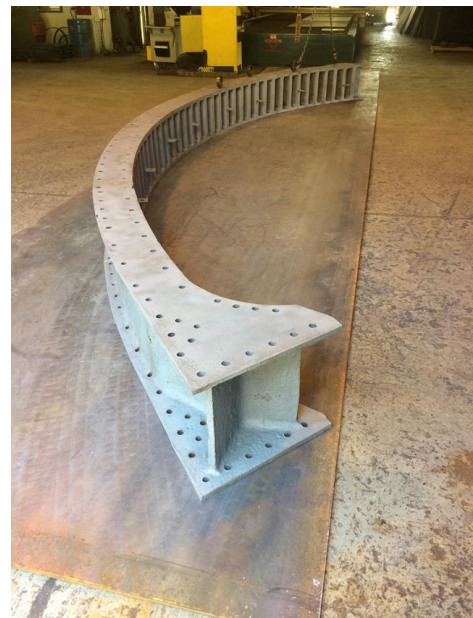
FIGURE 27. Typical rack assembly laid out on the floor plate during the templating process.

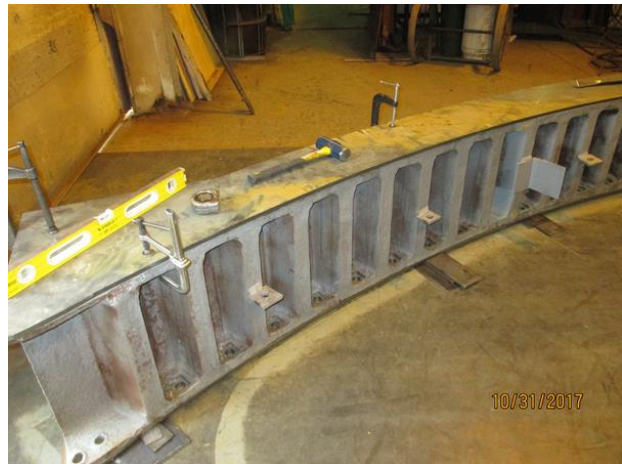
FIGURE 28. Template clamped to the rack during the templating process.

match drilled through the 1/2 inch thick template. Temporary bolts were installed through several of the holes and the tack welds fixing the opposite side of each rack segment to the floor plate were removed. The entire rack was then flipped over, shimmed true and flat, and the process was repeated for the second template and then for the second rack. Figure 27 shows one full rack (five segments) laid out on the floor plate during the templating process. A representative photograph showing a template in position for match drilling is given as Figure 28.

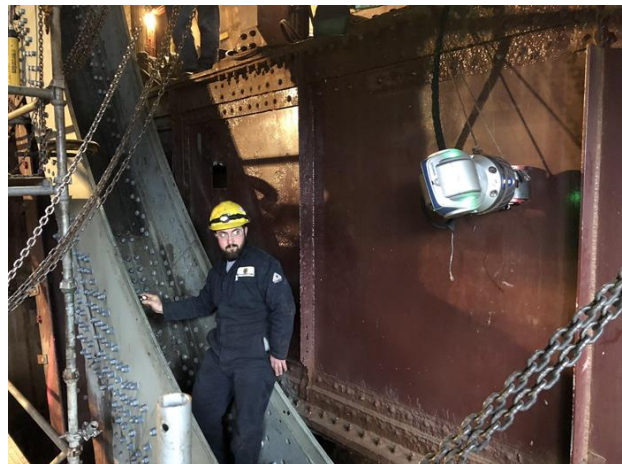
FIGURE 29. IPM Personnel utilizing laser tracker to verify template alignment.

The rack segments and templates were then shipped back to the bridge and prepared for installation. The inboard and outboard template for the south rack were temporarily hung near the desired position within the existing rack gusset plates. The inboard template was indexed along the existing rack gusset plates to the desired position and then a precision laser measuring instrument was used to adjust the inner radius of the template until data along the curve closely matched the design inner radius for the completed rack assembly. Measurement operations in progress are shown in Figure 29.

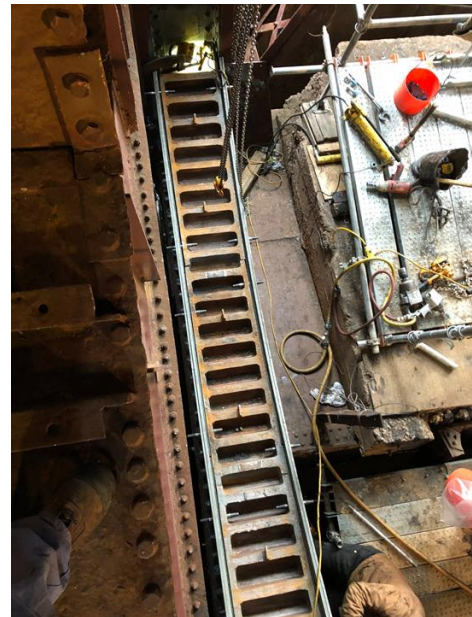
FIGURE 30. Rack segments installed with alignment pins, ready for final drilling and reaming.

The templates were removed and the five segments were pinned in position. Temporary bolts and clamps were used to compact the gusset and side plates against the rack segments and the outer radius through bolts were installed by sliding them through the assembly. Nuts for the through bolts were made snug tight on both ends. The north rack segments are shown pinned in position in Figure 30.

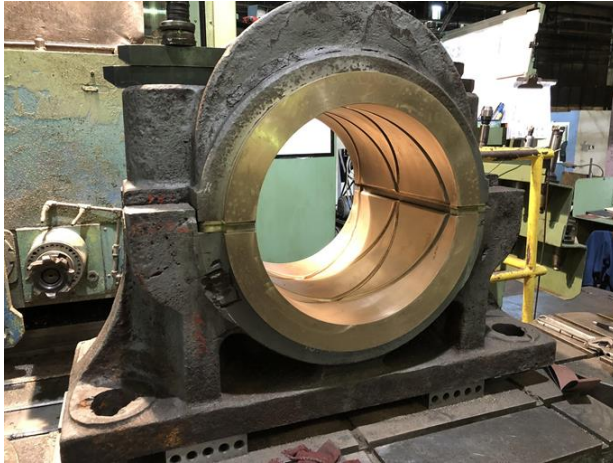
FIGURE 31. The B1 bearing assemblies were refurbished in the shop.

The rehabilitation of the B1 bearing assemblies (Journal Block F) required design of new bushings within the journal block, and design of new keeper chocks installed at either end of the bearing base. Bronze bushings fabricated from Alloy C93700 were specified. The bearing block housings and caps were shipped to a machine shop where the new bushings were fabricated and installed. The inner diameter of the bronze bushings were finish-machined to an LC6 fit with the existing pinion shaft after the pinion shaft was cleaned with emery cloth to remove foreign materials and any raised score marks.

The journal block was completely restored including providing new liners, new turned cap bolts, machining the inside bore to provide an LC1 fit with the new bushing and machining the bottom to provide a flat faying surface. The side faces of the base were also machined flat to bear upon the side chocks.

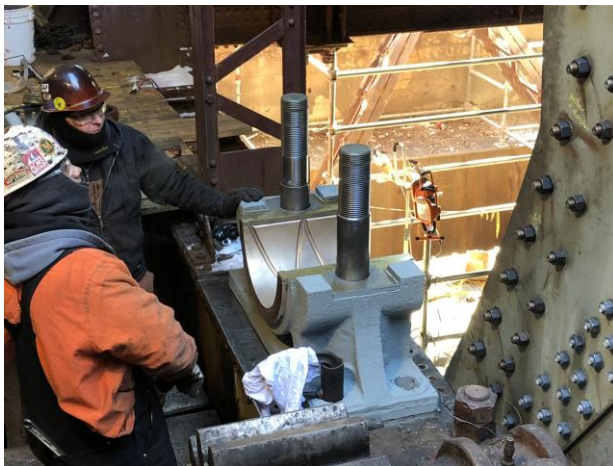
FIGURE 33. The refurbished B1 bearing housing reinstalled on the machinery girder.

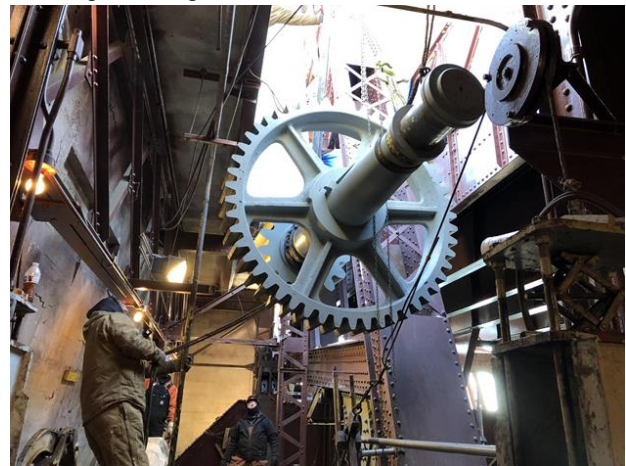
FIGURE 34. The pinion shaft assembly, which had been refurbished in the shop, was re-installed.

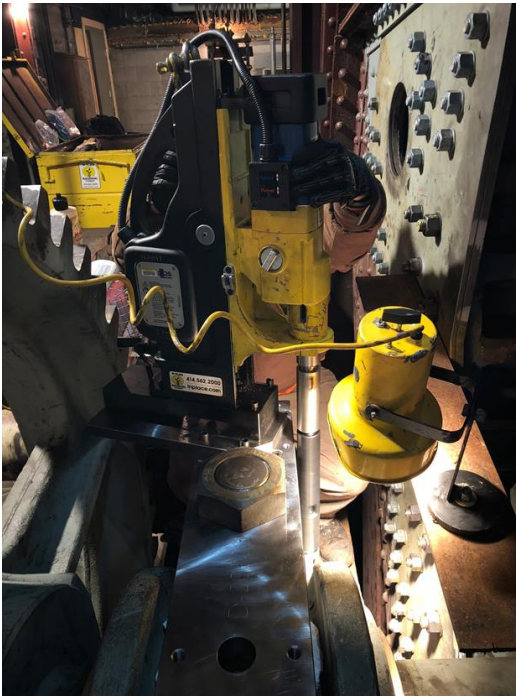
FIGURE 35. Field machining setup for reaming B1 bearing base stud holes.

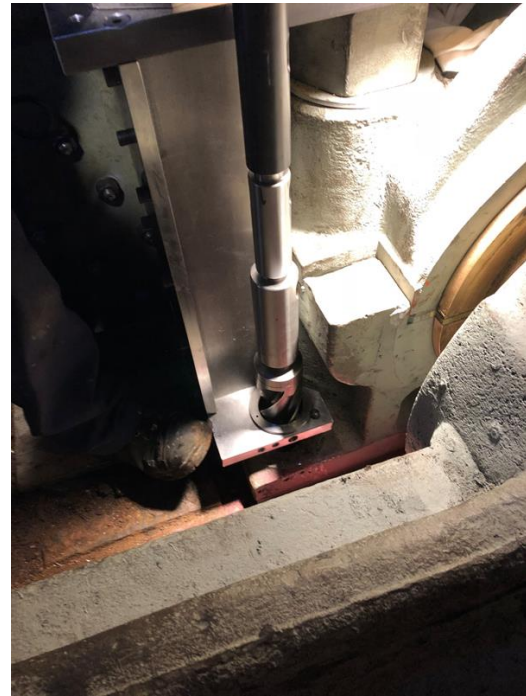
FIGURE 36. Detail of fixture for reaming B1 bearing base stud holes.

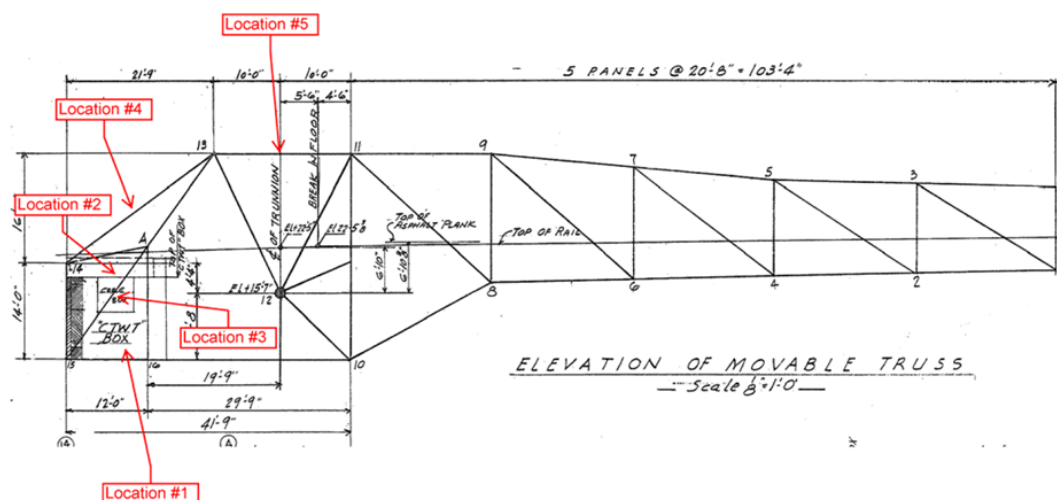
The leaf center of gravity was low resulting in a situation where there was a fairly typical imbalance moment when seated but a relatively high imbalance moment with the span open. The imbalance with the bridge open was greater than the imbalance with the bridge closed by a factor of 2.6. There is no benefit to having the imbalance increase to this extent and as such it was recommended to make ballast adjustments. The objective of ballast changes to the leaf was to bring the leaf center of gravity up, without much change to the toe reaction when seated. To accomplish this it was necessary to remove weight were practical from below the trunnions and add weight where possible above the trunnions. There were five different locations considered for adding or removing ballast as identified in Figure 38.

FIGURE 38. Possible ballast locations.

The engineering team determined the optimal position to add ballast weight to the span was within the truss upper chord members above the trunnion (Location #5 in the sketch). This ballast position causes the most effective change in vertical center of gravity position with the bridge seated because it is the highest point of the span. It also causes the least change in toe reaction with the bridge seated since it is located directly over the trunnion axis, and serves to counteract the problem of increasing imbalance as the bridge opens because the top chord member rotates from above to behind the trunnion as the bridge operates.

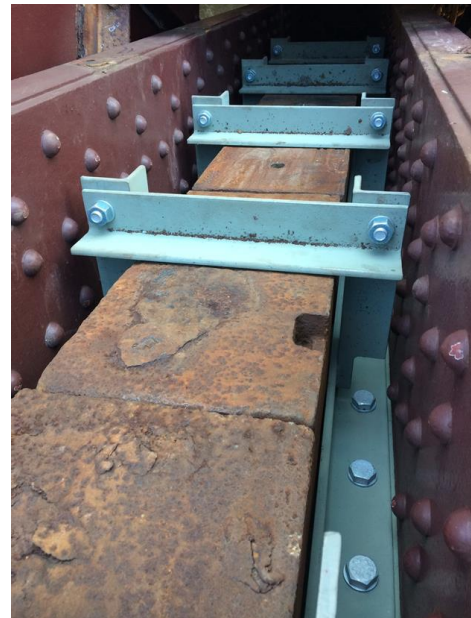
FIGURE 39. Ballast arrangement shown within South Truss Member 13-11.

- Bottom batten plates and lacing bars were removed and replaced with a 1 inch thick plate, full width and length of the member.
- A “keeper” system of steel angles was bolted to the interior surface of the new bottom plate that allows easy addition and removal of 1 foot cube steel counterweight blocks. These blocks are the typical weight adjustment medium used by CDOT forces, and were on hand for use. A total of eleven blocks could be installed in each truss member. This system is shown in Figure 39.

- Top batten plates and lacing bars were removed and replaced with segments of 1 inch thick plate, full width of the member. Each plate segment was just over 2 feet long. The plate segments, when butted tight together, ran the full length of the member.

- The 1 inch thick top plate segments were drilled to receive 4 inch thick and 2 foot wide steel ballast plates. These 4 inch thick top plates were drilled and tapped to receive an eye bolt for easy handling.

- All of the new materials were mechanically fastened to the existing truss member using high strength bolts.

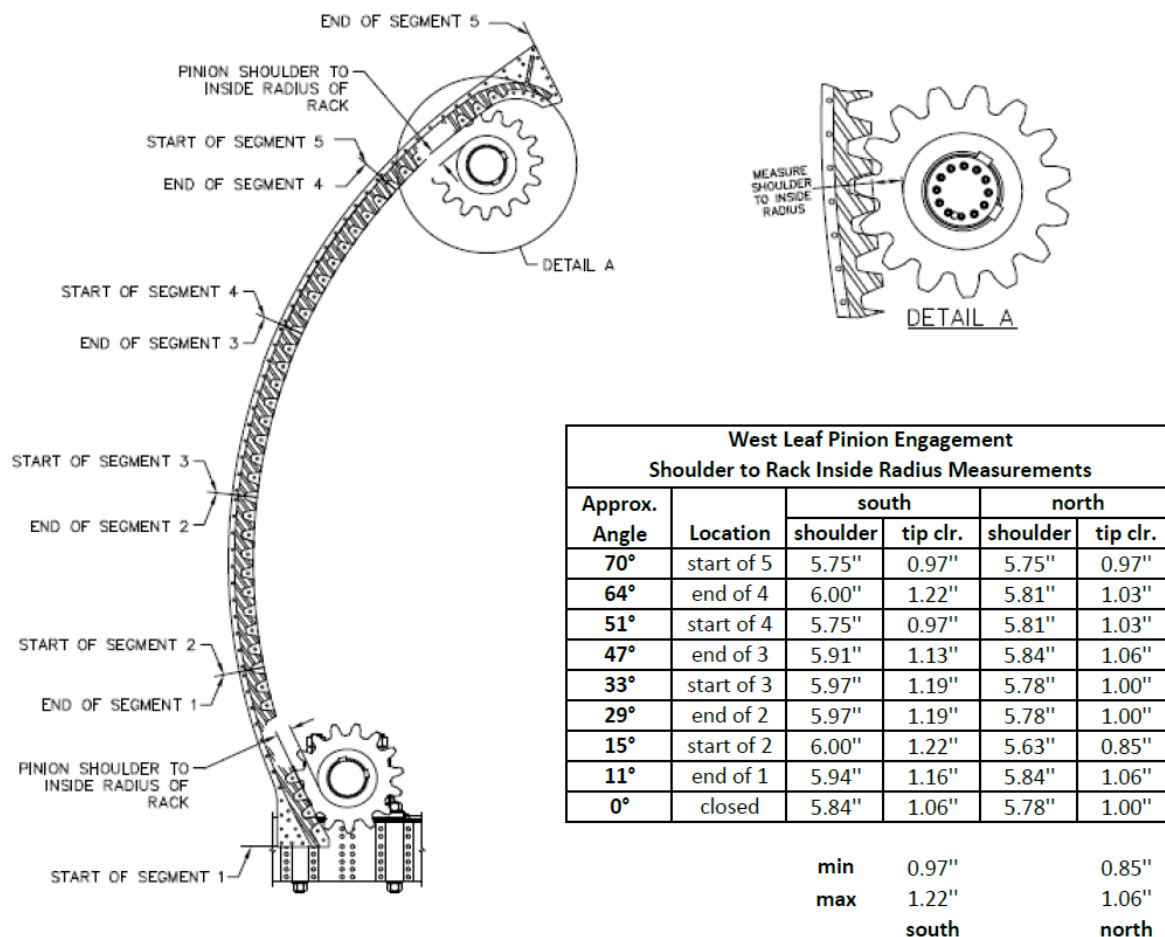
- The maximum radial misalignment of the racks noted was 0.22 inches, a significant improvement versus the previous condition. See tabulated measurements below.

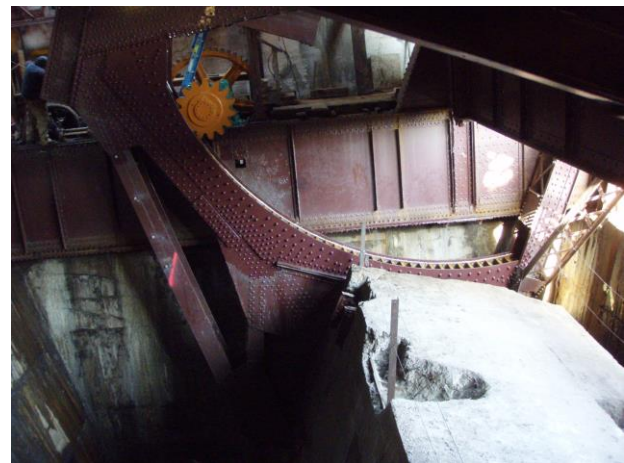
The results of this work were successful in raising the angle to the center of gravity from -67 degrees to approximately 0 degrees so that the maximum span heavy condition was at the seated position and there was negligible imbalance in the raised position. The seated toe reaction was maintained at about 2,000 lbs. A photograph of the completed north truss is provided as Figure 41.

FIGURE 41. View of completed north truss.
