**HEAVY MOVABLE STRUCTURES, INC.  
SEVENTEENTH BIENNIAL SYMPOSIUM**

**Machinery Repairs to Maintain Operability  
of an 1890's Swing Span**

Robert J. Tosolt, P.E.  
Stafford Bandlow Engineering, Inc.

Bridge DM-84.35 carries a single railroad track over the Nanticoke River in Seaford, Delaware. The movable span of the bridge is a 172-foot-long through girder center bearing swing span. The bridge provides a 48-foot-wide navigable channel when opened.

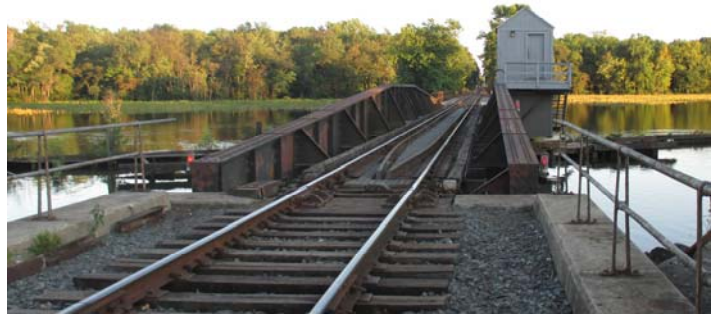
**Figure 2: View of swing span from south approach. The span is aligned and supported for rail traffic.**

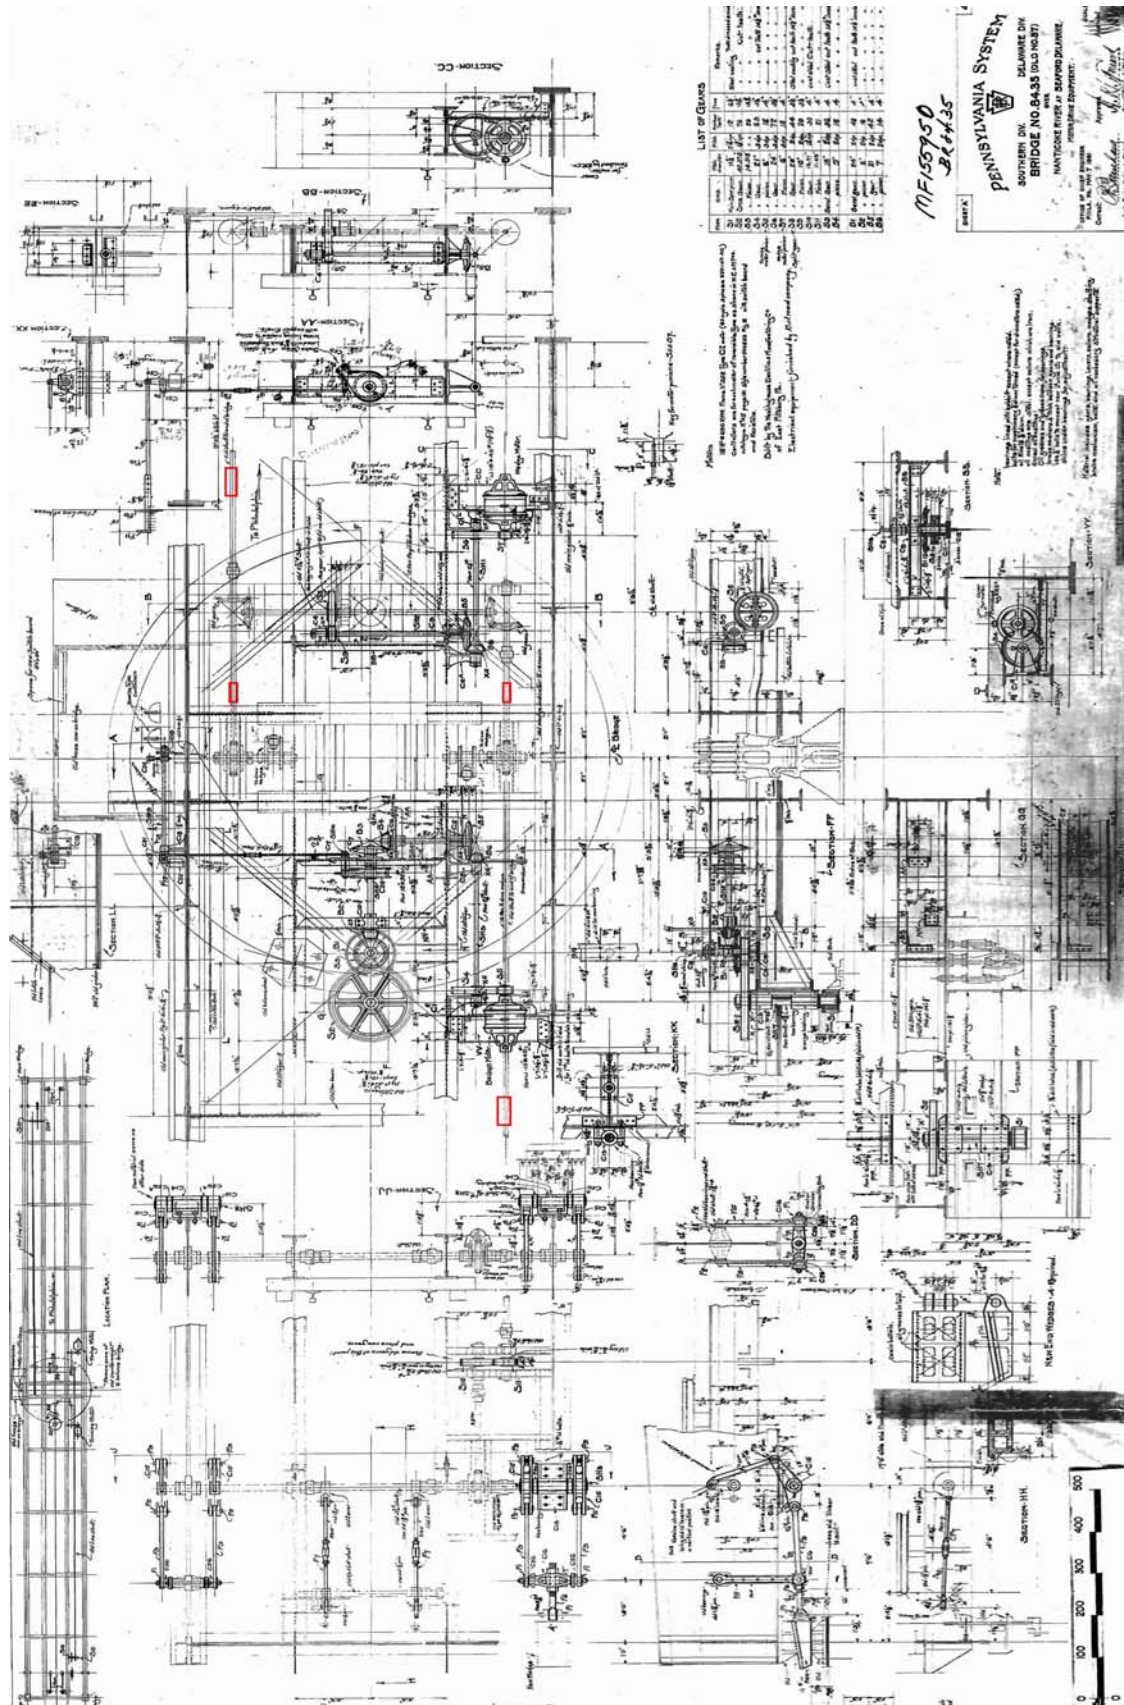
Figure 4 – Machinery Layout at Mid Span. Red boxes indicate strain gage locations.

To quantify the loading of the wedge drive machinery, and to further investigate system loading to provide a basis for the cause of the key failure, the investigation expanded to quantify the operating loads. SBE instrumented the wedge drive machinery with strain gages to document the operating loads throughout wedge operation. Gage installation location is identified in Figure 4. A series of wedge operations was performed to document that the wedge loading was repeatable.

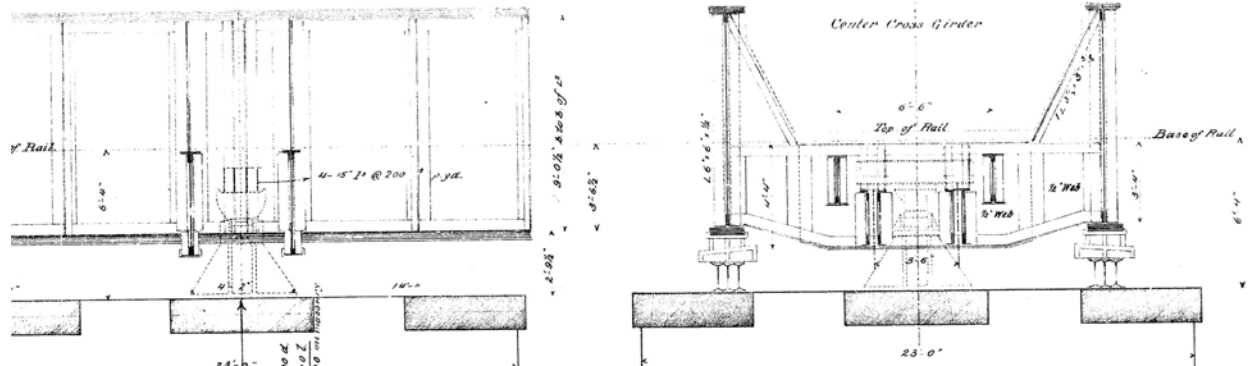
**Figure 10– Elevation View of Center Support Assembly.**  
*Excerpt from 1890x Design Plans.*

As found, 2 of 4 bolts had failed. As a result, half of the weight of the structure had redistributed to areas not intended to carry this load. Re-evaluating the end wedge failure and observed bridge behavior in light of this finding, it can be surmised that the redistribution of loading resultant from the bolt failure contributed to: overloading of the end wedges, extreme loading at the balance wheels, and a shift in the position of the center bearing contributing to bridge orbit during operation. Without correction, it can be expected that deterioration would progress until the swing span would have dropped off the center bearing. Whether this occur under rail traffic or during operation, the result would have been unacceptable.

- Cribbing was installed under the center cross girder to provide additional support to the span in the closed position.
- Bridge openings were curtailed. The problem was identified at the end of the navigation season and the bridge is normally closed for the winter, so this did not present a significant obstacle to the marine community.
- The integrity of the balance wheel axles were assessed through ultrasonic inspection prior to any additional openings to ensure that overload had not compromised the integrity of the wheel axles.
- A shop detail was prepared to replace the failed carrying studs.
