**HEAVY MOVABLE STRUCTURES, INC.
NINETEENTH BIENNIAL SYMPOSIUM**

106th Street Bascule Bridge Repairs

Brian J. Santosuosso, S.E.

Wiss, Janney, Elstner Associates, Inc.

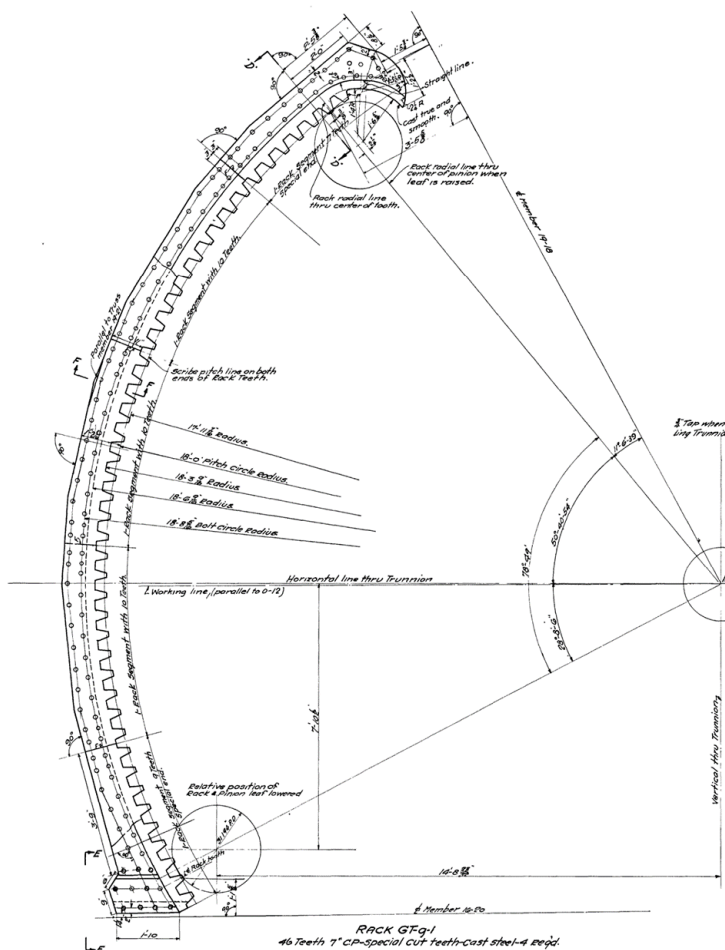
FIGURE 3. Rack orientation.

The four racks, consisting of five segments each, were evaluated over a series of three site visits. See Figure 3. Rack teeth (RT) were designated as RT1 through RT46 from the bottom of the rack to the top. Excessive pack rust and debris were typically located on the teeth toward the bottom of each rack. RT3

through RT39 are typically engaged during normal bridge operations and were inspected up close for any defects. RT40 through RT46 are located above the typical rack teeth that are engaged during normal bridge operations. These teeth were not inspected up-close, but were visually reviewed from the machinery frame.

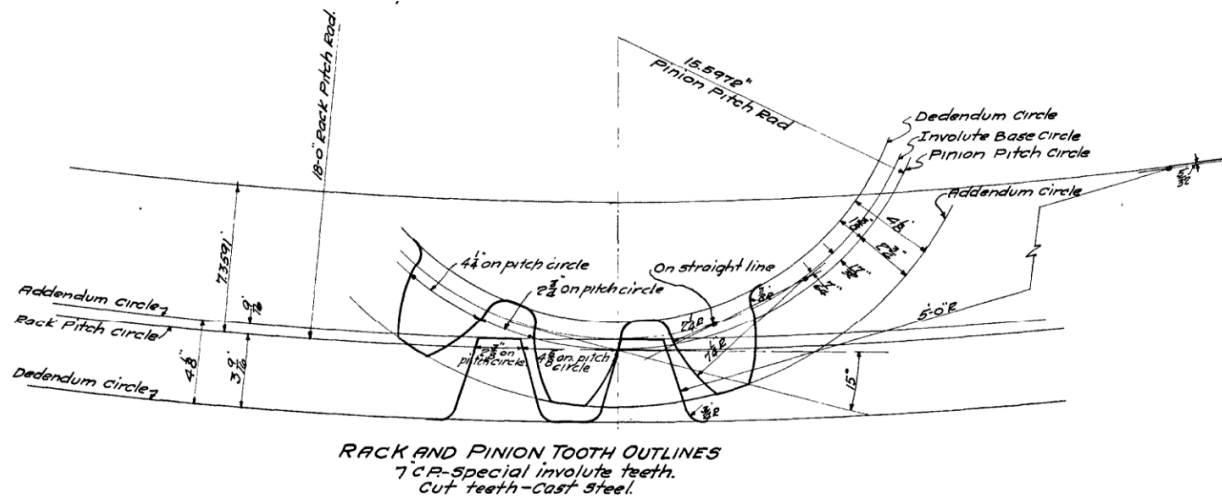
FIGURE 9. Design rack and pinion geometry.

The collected measurements at the north rack and pinion location indicate that the root to tip clearance in the vicinity of RT4 was 3-1/4 inches resulting in an engagement depth of 11/16 inches compared to a design engagement depth of 3-5/16 inches or 21% of the originally specified engagement. This combined with the rolling action of the gears and gear tooth wear were sufficient for the rack and pinion to disengage. Design rack and pinion geometry is shown in Figure 9.

1. Modify the geometry of the rack pinion teeth at the northwest quadrant to provide teeth with a longer addendum and greater engagement. While this solution provided for greater engagement, the gear tooth geometry required to provide satisfactory engagement was detrimental to the performance of the gears and would have likely result in accelerated gear tooth wear.

2. Increase the diameter of the northwest rack pinion by designing a new pinion with one additional tooth. This would increase the pinion diameter by 2.2 inches and increase the pinion engagement by 1.1 inches. Additional design modifications may have been required to optimize engagement but the primary increase in engagement was due to the increase in the number of teeth. This option would result in gear tooth geometry similar to the existing gear tooth geometry and therefore the gear teeth were not expected to experience accelerated wear. However, operational testing and possible electrical/mechanical adjustments would need to be investigated and implemented in order to ensure proper load sharing between the two motors that drive the leaf.

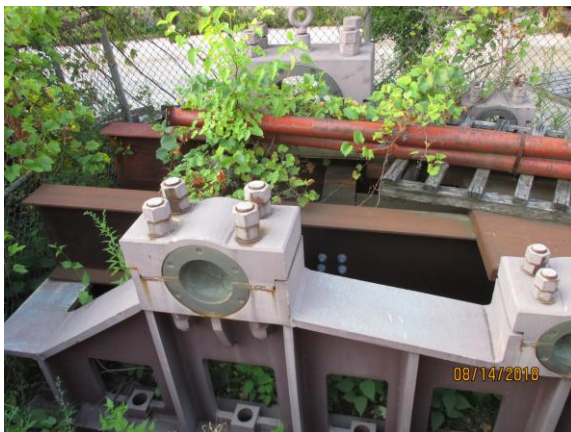
FIGURE 20. Frame at storage location.

Many years ago, CDOT procured a replacement machinery frame for the northwest quadrant and this frame was never installed. The frame was essentially the same as the existing frame but was of welded steel construction instead of the original cast steel construction. The frame was sitting in a CDOT yard and was initially inspected in August of 2018. At the time of the initial inspection, the frame appeared to be in serviceable condition despite having been stored outside for many years. See Figure 20.

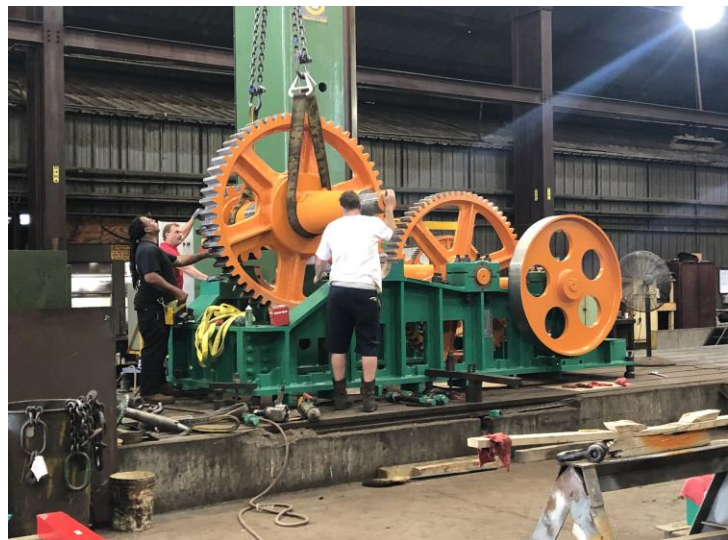
FIGURE 21. Machinery frame during shop assembly.

All work was complete by SMC in early June of 2019. Figure 21 shows the northwest machinery frame in the final stages of assembly in the shop.

- Rehabilitate machinery frame.
- Provide new rack pinion.
- Rehabilitate existing northwest rack pinion shaft and mount new pinion on shaft.
- Provide replacement shaft for failed southwest span drive machinery shaft and mount existing gears on new shaft.
- Provide new machinery brake wheel for northwest span drive machinery and mount on existing shaft.
- Hand polish all machinery shaft journals.
- Assemble northwest machinery frame and confirm proper alignment and test for free rotation by hand.
- Mount and align rewind span drive motor to the frame.
- Clean and paint all machinery.

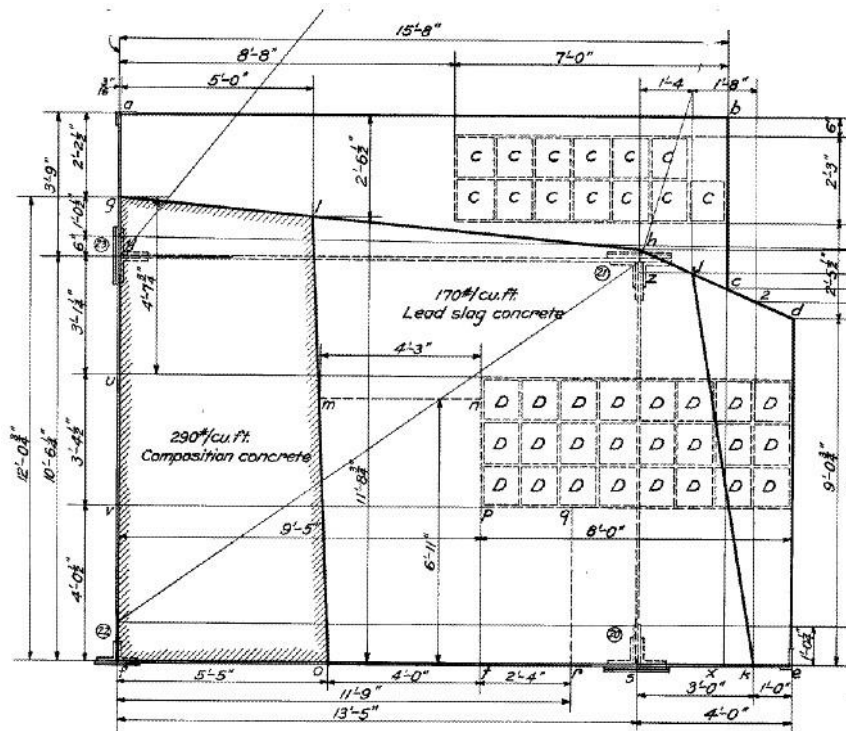
FIGURE 23. Counterweight section from original bridge design drawings.

The west leaf counterweight consists of a concrete counterweight with embedded plate girders and truss members that form the overall counterweight frame. According to the original design drawings, the rear portion of the counterweight was to be filled using a 290 lb./cu. ft. composition concrete mixture (steel punchings mixed with normal weight concrete) while the remainder of the volume was to be filled using 170 lb./cu. ft. lead slag concrete. Lower and upper pockets in which removable cast iron counterweight blocks could be stored were also included in the original design. A section view of the original design is shown in Figure 23.

and extent of the existing deterioration, it was recommended that selective demolition to remove loose and damaged areas of the concrete counterweight be completed and that an innovative approach to both encapsulating vulnerable concrete and raising the counterweight center of gravity be developed.

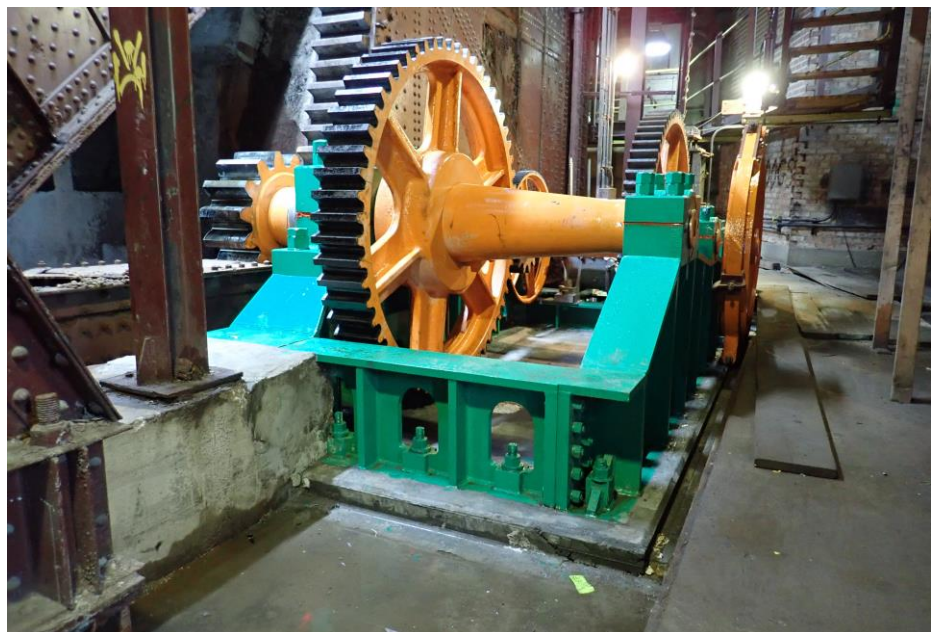
FIGURE 26. Finished grouted machinery frame support and floor.

Grouting took place in two lifts due to the depth of the pour. The material selected was intended to provide extended working time to allow installation of the grout over a large area prior to set-up. This high-precision mineral-aggregate grout also provided a non-shrink solution that achieved a minimum of 8,000 psi strength in 28 days. A product representative was consulted at the site to determine the proper grouting lift height and curing parameters to achieve the desired result. A representative photograph of the finished floor product is shown in Figure 26.

The new machinery room floor and frame support in the areas affected by the demolition were restored using an innovative approach to achieve the desired result. First, the portion of the machinery room floor interior to the new machinery frame was formed and poured. Materials consisted of normal weight concrete and the final floor finish was sloped to a drain that will allow future water to exit the area rather than building up and potentially causing anchor bolt and frame deterioration. Once this section of the floor was allowed to cure and experience initial shrinkage, the remainder of the floor area and machinery frame support was achieved by grouting.
