**HEAVY MOVABLE STRUCTURES, INC.  
NINETEENTH BIENNIAL SYMPOSIUM**

**CSX New River Bascule Bridge  
Emergency Coupling Replacement**

Robert Algazi P.E., Amaka Anderson P.E., David Nyarko P.E, Roger Khouri P.E.  
WSP USA, FL, NJ, and NY, USA

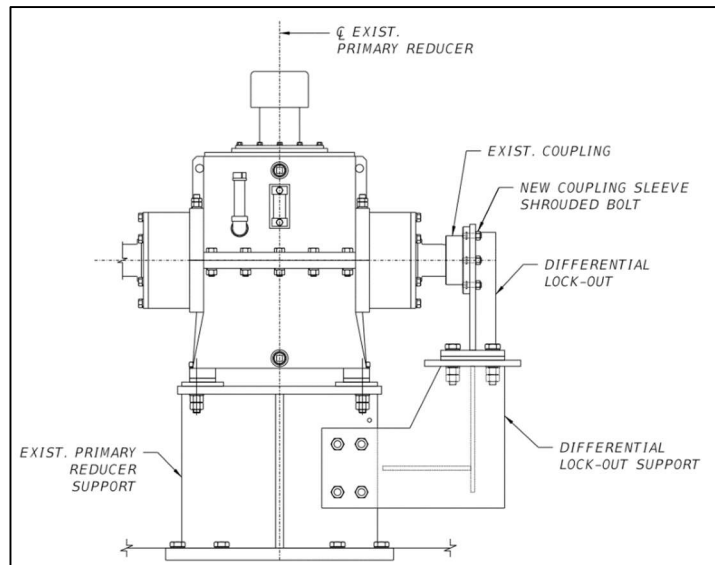
Figure 5: Primary Reducer Differential Lock-out Mechanism

In order to operate the bridge in a single pinion configuration, a differential lock out mechanism was required. The primary reducer had a differential which would mean that disconnected output shaft must be locked in place in order for the connected output shaft to function properly. A new lock-out mechanism was provided for this purpose. It was mounted to a temporary support mounted to the existing reducer support. After construction, the lock-out mechanism and temporary supports were returned to the department and can be used in the future if other repairs are necessary.

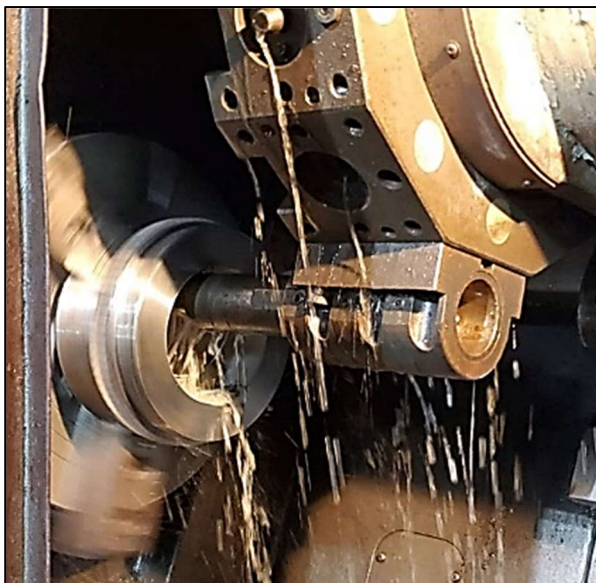
Photo 10: Shop Machining of The Sacrificial Coupling Bore

With the exact measurements of the shaft and keyseats known, the dimensions of the coupling keyway and bores could be finalized and machined. The shop had all couplings pre-bored as to speed up the turnaround for final machining. For the sacrificial coupling, final machining and boring was performed prior to the outage based on the original as-built shop drawings. This was done to reduce the outage period.

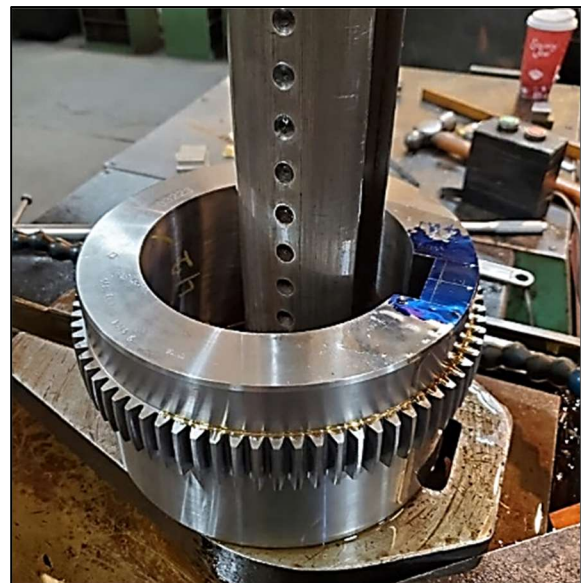
Photo 11: Shop Machining of The Sacrificial Coupling Keyway

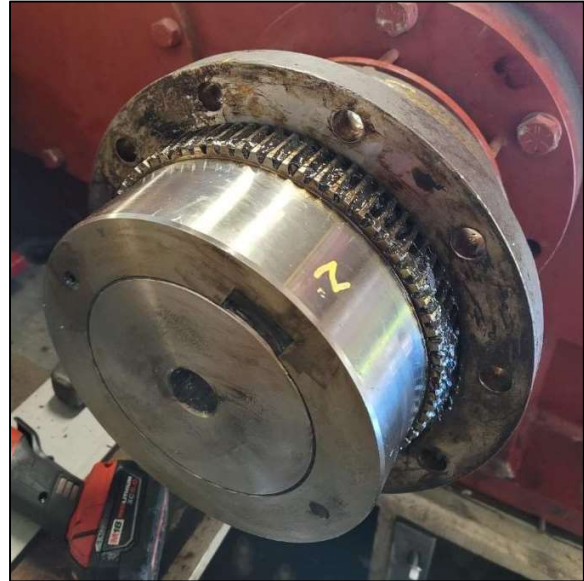
Photo 12: Final Coupling Installation

After all machining was done and the couplings were shipped to the job site, the new couplings were installed. Alignment of the machinery was checked and corrected when the machinery was reassembled. Functional testing was performed after each phase since the coupling that was just installed would now be the primary mode of operation.

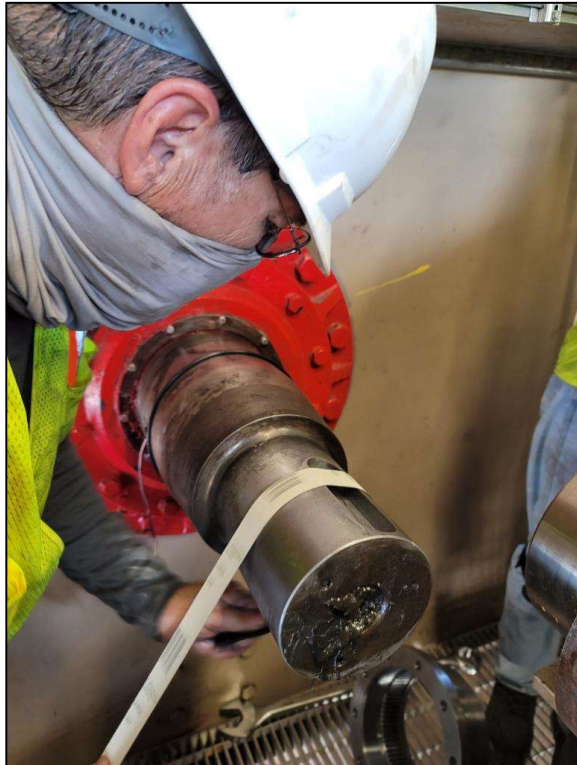
Photo 14: Millwright Polishing Shaft Surfaces

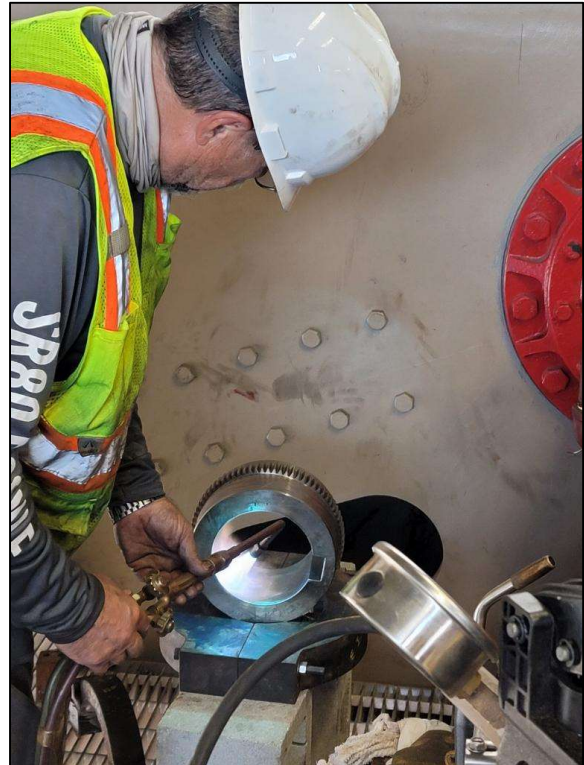
Photo 13: Millwright Heating Coupling Hub for Installation
