**HEAVY MOVABLE STRUCTURES, INC.
NINETEENTH BIENNIAL SYMPOSIUM**

**Movable Bridge Operational Testing
Strain Gage and Electrical Load Recordings
Case Studies and Lessons Learned**

Ryan Kanagy, Ralph Giernacky, Yang Zheng
Wiss, Janney, Elstner Associates, Inc.

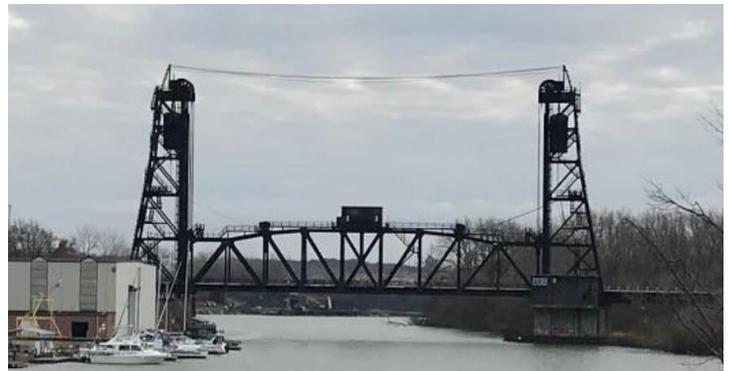
Poor control of this span drive vertical lift bridge caused excessive machinery torque oscillations during operation. Raising and lowering resulted in an uneven “see-saw” movement end-to-end of the lift span, with the two ends alternating between static and dynamic conditions. The span drive operating ropes and the other drive machinery components were subjected to impact loads due to the halting nature of the operation.

FIGURE 1. NS B-210.21 Span drive Vertical Lift Bridge in Lorain, Ohio.

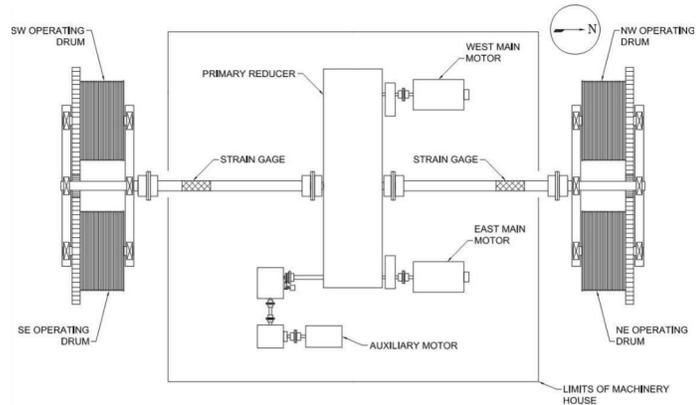
The investigation included a review of the mechanical systems and mechanical and electrical load recordings. Mechanical loads were recorded via strain gages at the output of the primary gear reducer (FIGURE 2) and electrical recordings at the drive to assist in the investigation. These tools are invaluable when troubleshooting operation issues as they provide the drive loads close to the power supply and close to the moving span.

FIGURE 2. Lorain Lift Bridge. Machinery Arrangement and Gage Location.

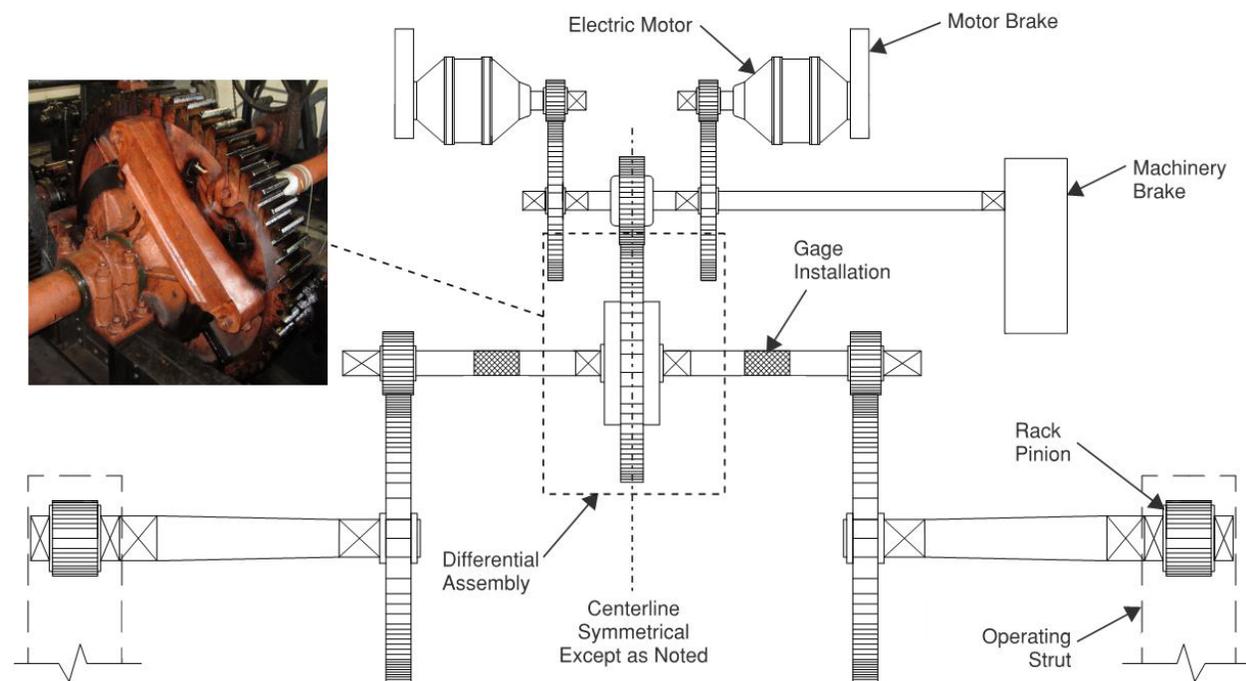
Strain gage loads were recorded to determine the imbalance as part of an inspection of the bridge. The gages were installed at the output of an open gear differential assembly, located centrally in with the drive assembly. See Figure 13.

FIGURE 13: LaSalle Causeway Bascule Bridge. Span Drive Machinery Schematic.

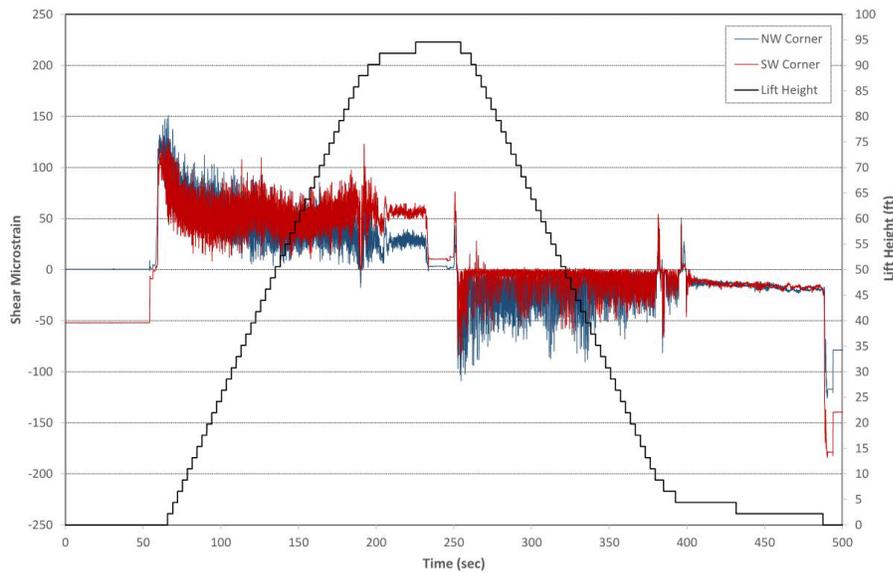
2021 maintenance efforts at this bridge included a review of imbalance and indexing (load sharing) for this tower drive vertical lift bridge. Testing demonstrated a difference in the corner-to-corner balance trend during lift span operations. The behavior of the west tower machinery is described in Figures 20 through 23. Figure 20 shows the strain gage strip chart from the west tower. Figure 21 shows the imbalance curve fit from the two corners combined. Figures 22 and 23 show the imbalance curve fit data for each of the two corners, analyzed separately.

FIGURE 20: Rt. 1&9T over Passaic River. West Tower Strain Gage Recording.

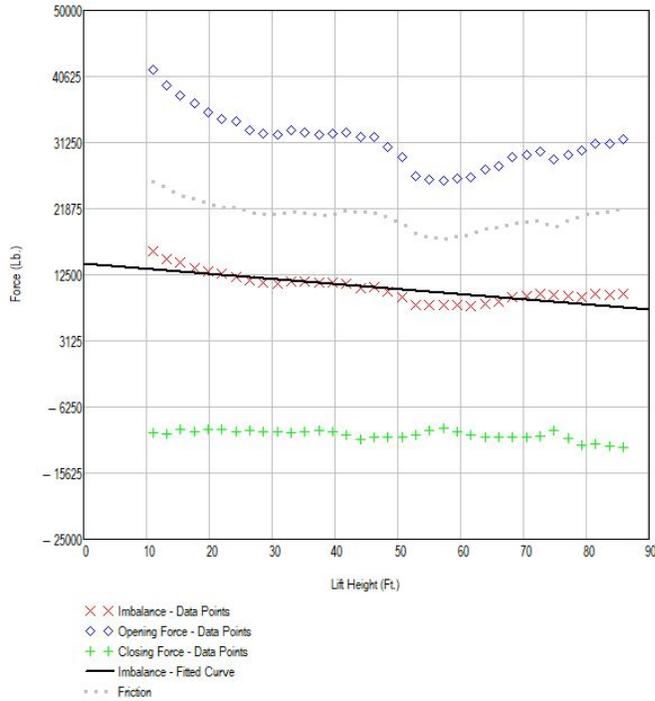
FIGURE 21: Rt. 1&9T over Passaic River. West Tower Imbalance Curve Fit for Two Corners Combined.

The theoretical imbalance behavior, combining the effect of the counterweight ropes and the auxiliary balance chains, results in a linear reduction in imbalance as the span is raised. The combined imbalance trend is shown in Figure 21. A linear trend was apparent in the analyses, but the trend differed at the corners. The imbalance at the northwest corner was reduced as the span

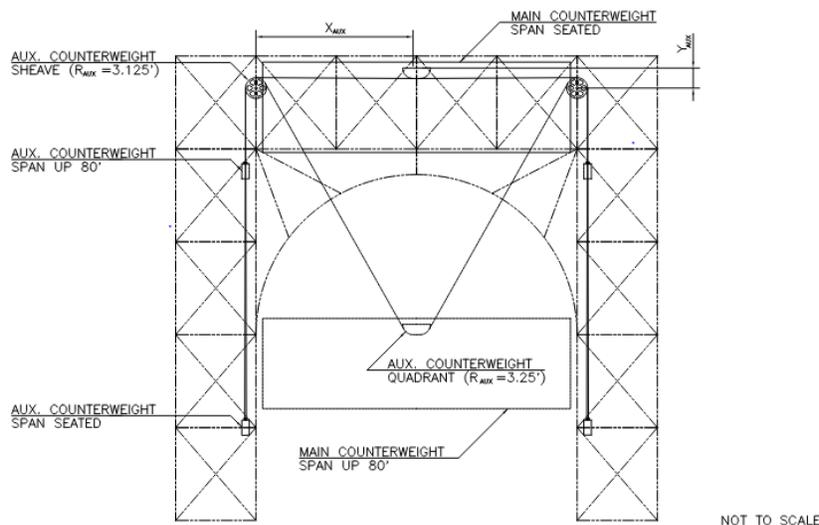
The bridge is a tower drive vertical lift bridge with an auxiliary counterweight system. The operating forces should change with lift height as a result of the counterweight ropes passing over the counterweight sheaves and due to the effect of the auxiliary counterweight system. A mathematical equation for the change in span balance versus lift height was derived based on the geometry and weights provided for the auxiliary counterweight system on the original 1938 design drawings for the bridge. See Figure 24.

FIGURE 24: Harlem River Lift Bridge. Auxiliary Counterweight System Layout Per Tower. Note two auxiliary counterweights per tower.
