**HEAVY MOVABLE STRUCTURES, INC.  
TWENTIETH BIENNIAL SYMPOSIUM**

**James River Bridge – Main and Auxiliary  
Wire Rope Replacement**

Robert Powell and Stephen Grabowski, HDR, Inc.

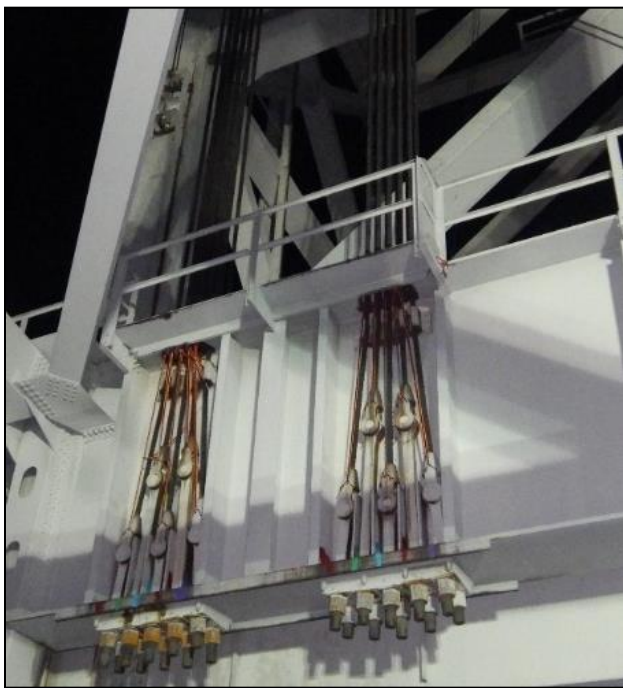
Figure 6: Photo of the main counterweight take-ups connecting the wire ropes at the lifting girder. Note the color coding.

As an added precaution for this particular rope replacement project, VDOT elected to include replacement of half of the main and all of the auxiliary counterweight rope take-ups within the scope of work. The take-ups, for the main counterweight ropes are the portion of the ropes that form the connection to the lifting girder at the lift span end, refer to Figure 6. Apart from making the connection, the take-ups are essential to the configuration of the ropes and provide the ability to adjust the tension within each rope. From past experience, the condition of the take-ups cannot be verified prior to removing the ropes and can pose challenges and costly delays if attempting to restore them and place them back into service in the middle of an outage. Additionally, the pins connecting the rope sockets to the take-ups have been known to seize in place slowing down the rope removal process. To avoid both issues, new take-ups were to be installed during the first outage allowing the pins to be removed and the take-up threads restored in a shop prior to their reinstallation in the subsequent outage.

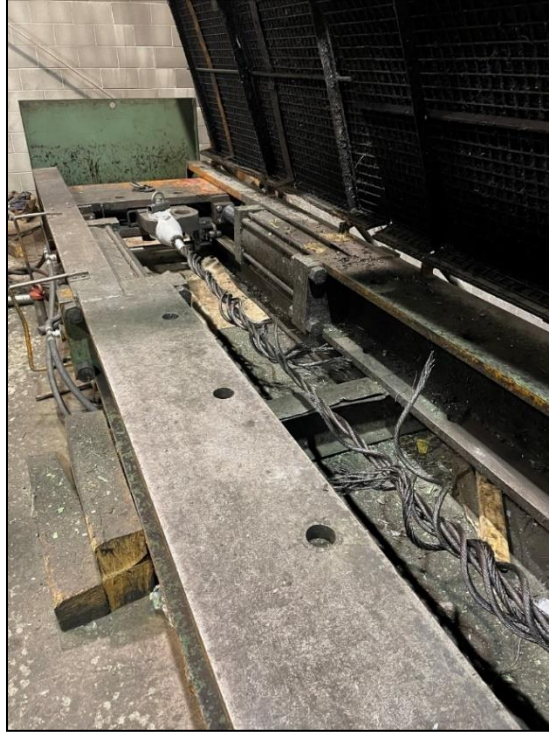
Figure 8: Photo after the break test of the wire rope at Wire Rope Works.

The original wire ropes on the JRB were 2-1/8 inch diameter, 6x25 Filler Wire, Fiber Core (FC), refer to Figure 10. This type of wire rope was fairly standard in the industry at the time of construction, however since then, wire ropes and the fabrication process have improved. The new general industry standard are independent wire rope core (IWRC) wire ropes which provide a greater minimum breaking strength and stretch less both at initial installation and over the life of the ropes, refer to Figure 11. The original, fiber core ropes had a minimum breaking load (MBL) of 358,000 lbs and provided a safety factor of less than 8 given the anticipated average and maximum tensions. IWRC ropes in both Improved Plow Steel (IPS) and Extra Improved Plow Steel (EIPS) were evaluated. IWRC IPS ropes were found to have a factor of safety of just over the minimum AASHTO requirements at the lower limits. For the replacement of the ropes, a 2-1/8 inch diameter, 6x25 Extra Improved Plow Steel (EIPS), IWRC rope was selected. This change provided a significant strength increase with a MBL of 442,000 lbs. When the rope samples were tested by the manufacturer (Wire Rope Works), they were found to break at nearly 500,000 lbs. Figure 8 shows the condition of the wire rope following the break test.

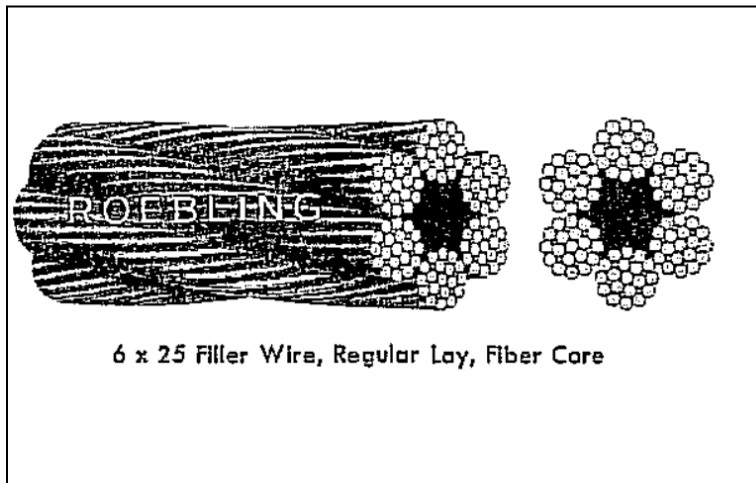
Figure 10: 6x25 Filler Wire, FC Wire Rope

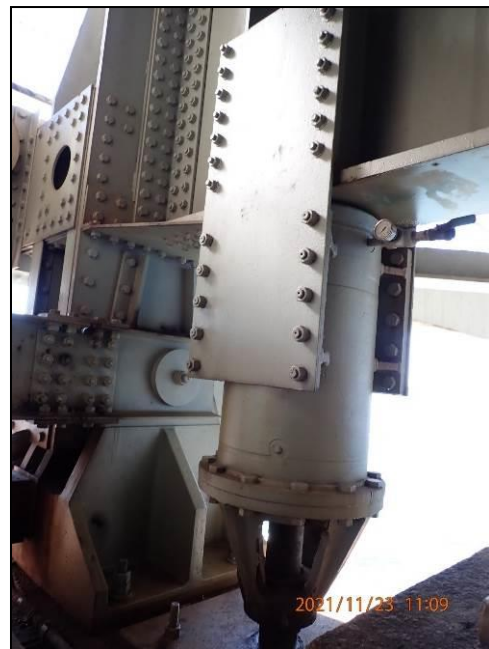
currently mounted on the end floorbeams, refer to Figures 12 and 13. Jacking at these locations would require the contractor to remove and reinstall the buffers, refer to Figure 14, leading to potential delays during the outages. It would also temporarily eliminate one of the bridge's safety features. However, after performing a structural analysis of the end floorbeams, it was determined that, without significant strengthening modifications, jacking at the locations of the existing buffers was the only viable option.

Figure 14: Photo of existing air buffer

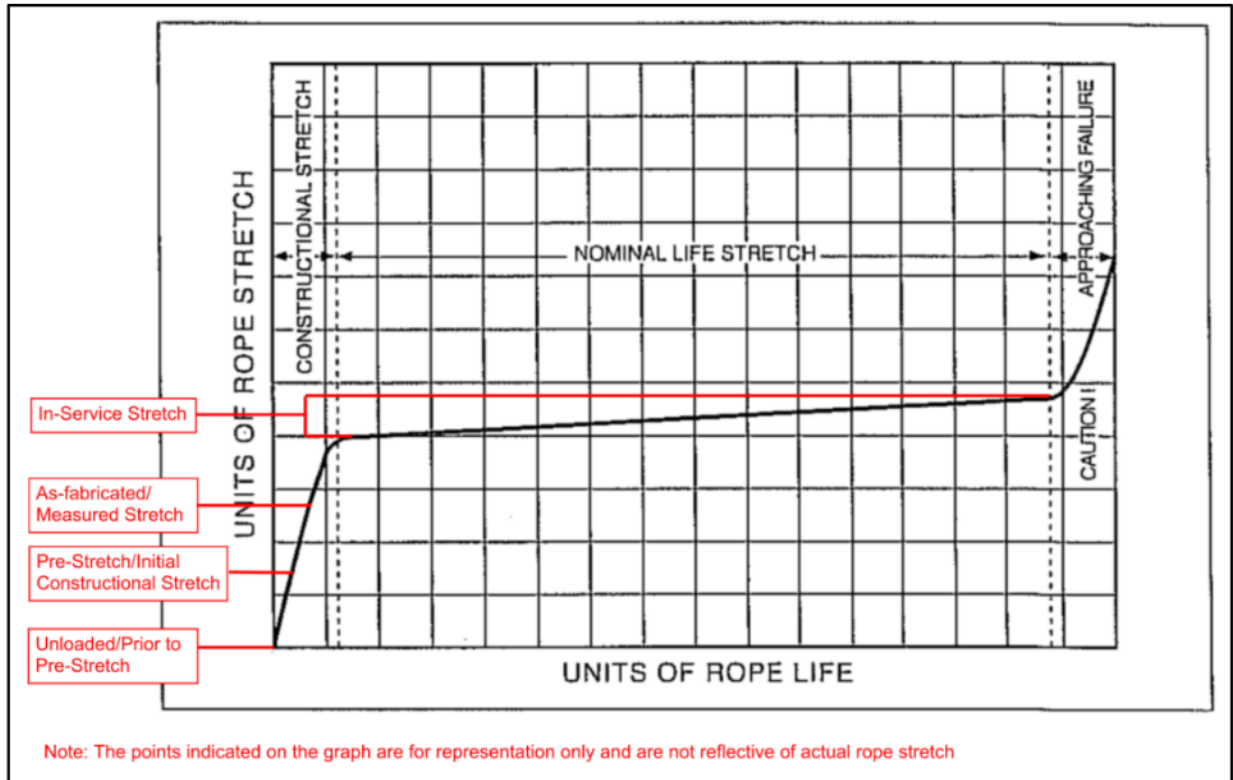
The key differences between these A and B options had to do with the length of ropes that would be fabricated. The A options used the original fabricated rope lengths whereas the B options required laser measurements of the existing ropes to determine the current rope lengths. Over the course of the 40+ year service life, the existing wire rope had seen stretch due to elastic and constructional stretch. Refer to Figures 18 and Table 2 regarding the stretch analysis. The stretch over time was estimated as being upwards of 4 inches.

Figure 18: Graph showing typical stretch rope stretch over the life of a wire rope

During the design phase of the project, a laser survey of the existing ropes was performed. The survey results found the actual rope stretch to be between 5 and 6 inches, further confirming options 5A and 6A to be non-viable options.

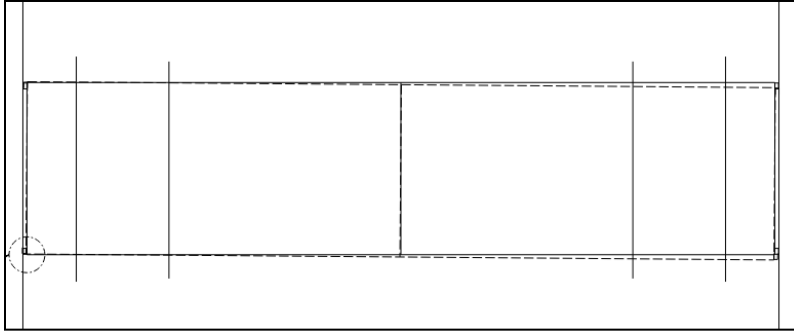
Due to this significant difference from the original fabrication length, there was concern that additional problems during construction could be introduced by using the original fabrication lengths and Option 5A or 6A were not recommended. Because these options replaced only half the ropes in one tower at a time with ropes that were shorter than the existing ropes, there was potential for the counterweight to transversely skew becoming stuck between the guide rails, refer to Figures 19 and 20. When assessing this situation, it was determined that this could occur with only approximately 3 inches of difference between the rope lengths. Because of this concern, Option 5A and 6A were not considered in the final determinations.

Figure 19: Theoretical counterweight skew

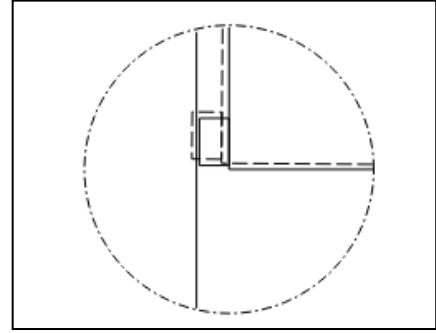
Figure 20: Detail of interference at guide rails

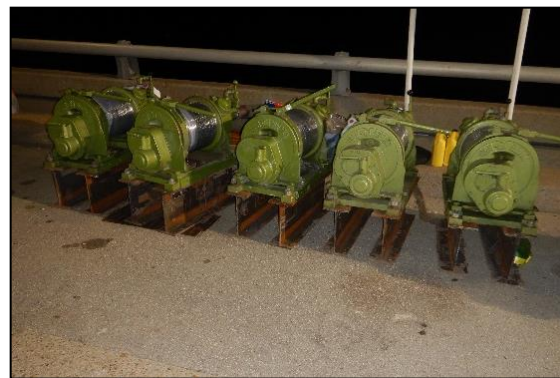
Figure 29: Back-up air winches.
