## HEAVY MOVABLE STRUCTURES, INC. TWENTIETH BIENNIAL SYMPOSIUM

# Rehabilitation of the FEC MP260.93 Single Track Railroad Bridge St. Lucie River Stuart, FL

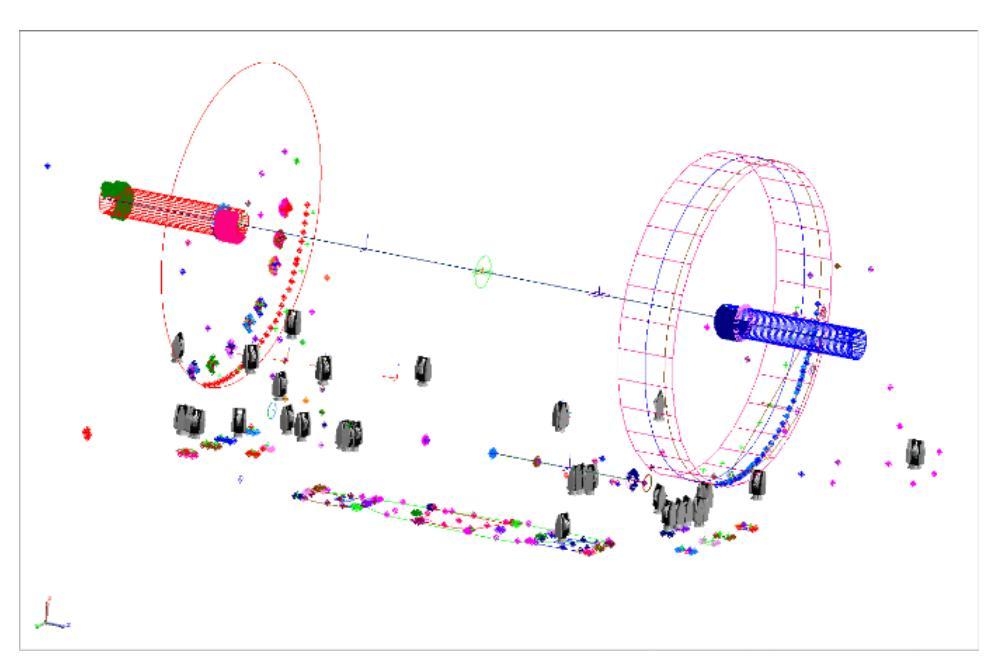
Initial laser Tracker Results

A significant amount of data was obtained during this first survey and the analysis of the data revealed the centerlines of the East and West trunnion shafts did not point at each other. They were each pointing downward and a bit south. Over the 100-year life span it was obvious that the two inboard journals had settled more than the outboard journals and were leaning toward the shore at an angle approximately 180° from the fully open position of the span.

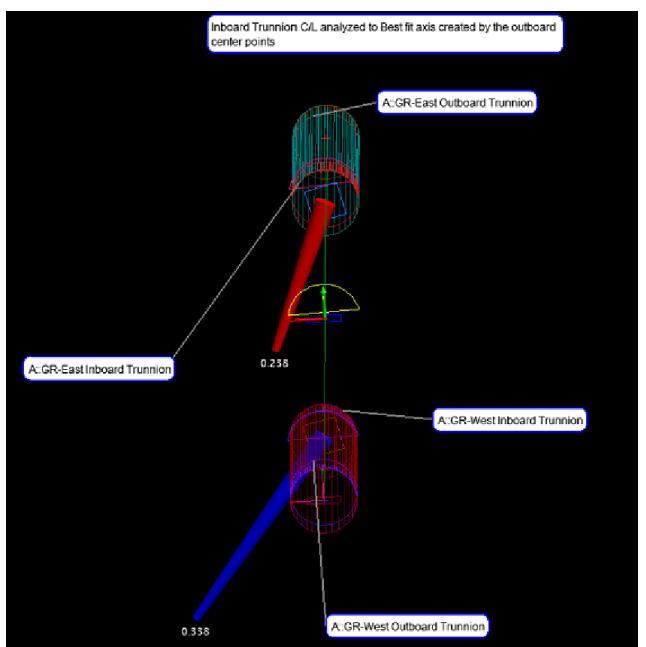
During the outage, however, when full access to the four journals was had, the COR for the (2) trunnion

shafts were confirmed to be pitched at different angles. As measured previously, they were both tilted with the outboard journals higher than the inboard journals and the inboard journals closure

to the shoreline than the outboard journals.

Through 3D modeling software, the misalignment of these (2) independent COR's proved the resultant angle of interface with the (2) pinion shafts would exceed the allowable angular misalignment provided by the new shaft couplings.

To fix or not to fix was discussed and it was determined that an attempt to manipulate the span must be made to ensure both the East Rack & Pinion mesh and West Rack & Pinion mesh would be achievable while connecting them in a straight line through the machinery room.

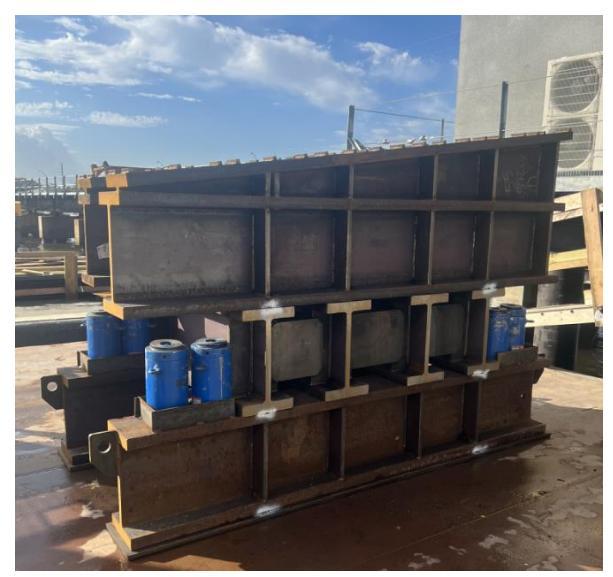
Scott Bridge Designed False Work

Execution of this event included close monitoring of the (4) trunnion journal locations to ensure the span's positioning was controlled without inducing any dramatic forces. Through this monitoring, analysis were made of any changes to the span's framework and the joints between the span's lift rails and the North and South approach rails. The span was jacked evenly at first until all four trunnions lifted about 0.04". Then the inboard edges of the span's girder webs were jacked a bit higher. Jacking in very small increments, we lifted the inboard sides until the lift rail became even with the approach rails. This was visually reported to be an elevation change of less than <sup>1</sup>/<sub>4</sub>" at the rail. At this point the slope of the (2) trunnion shafts had

improved by approximately 50% toward being level but the toe end of the span started to move. The descision to stop was made and the load was fully transferred over to the False Work.

With the span in this slightly modified location, a new set of dimensions were taken and a new 3D model was created and analyzed. *The results were good.* The approximate 0.6° of misalignment had fallen to under 0.3°. This level of missalignment was now within the allowable range listed in the specifications for the pinion shaft couplings.

Day 1 of the 21-day outage, task #1 was to take the load of the span away from the (4) trunnion towers and transfer it to the SBC designed and built false work shown here. It would be through the cribbing of

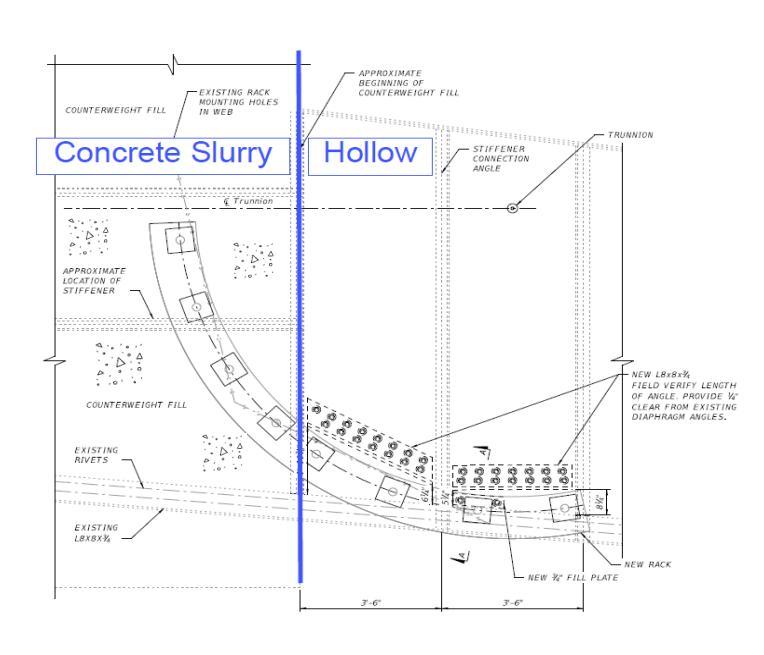
- 1. Total outage time was to be limited to 21 days.
- 2. The existing rack was in the way.
- 3. The girder webs were not parallel.
- 4. The weather damage was significant.
- 5. Half of the landing zone was hollow, and the other half was filled with a slurry of concrete and steel punchings.

The new rack was to be fastened to the girder web using compressive forces generated through turned studs. Half of these studs were to be located over the concrete filled section of the counterweight box while the other half were located over the hollow section of the girder box. Holes through the counterweight needed to be machined through the interior girder web, then through the 55" of concrete/steel slurry, and then through the outer girder web. The holes needed in the hollow girder box only needed to go through the interior web. The rack would then get bolted to each girder box with (4) approximately 65" long studs passing all the way through the counterweight section and (4) approximately 12" long studs passing through to the inside of the box girder. Additionally, all holes needed to avoid hitting the stiffeners of the originally built box.

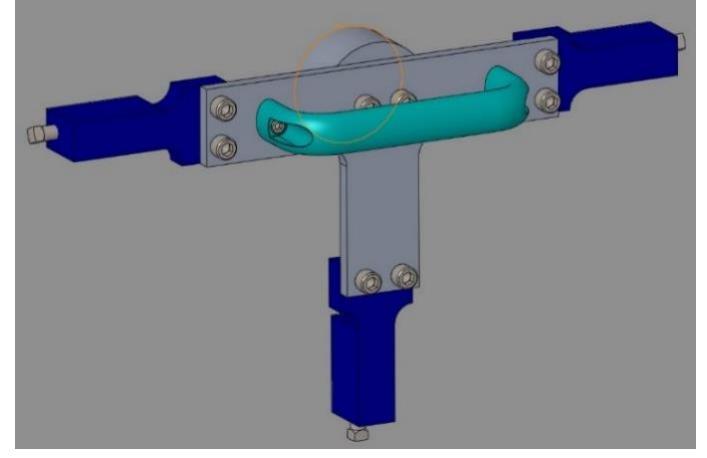
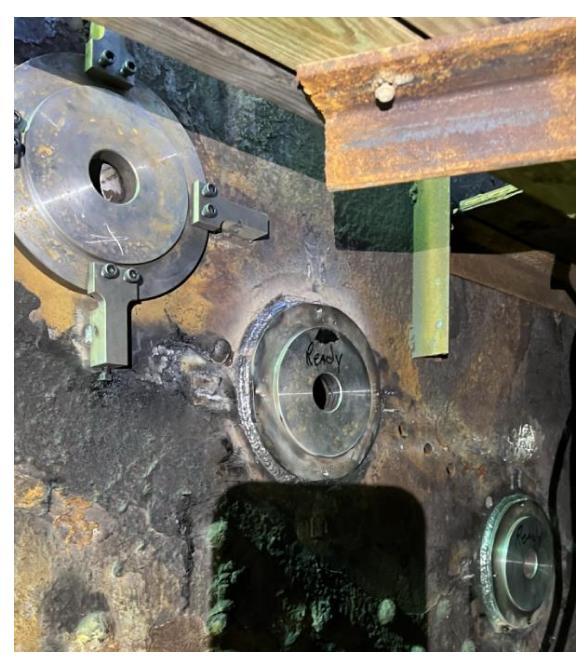
Locating the Pucks

These kickers were used to move the puck around on the skin of the web to place the center hole at precisely the pitch line radius needed for the rack. Alignment through the laser tracker was quickly performed along with a specially designed monument carrier placed in the center of the Puck as shown here. The puck was then welded to the web and the kickers were removed.

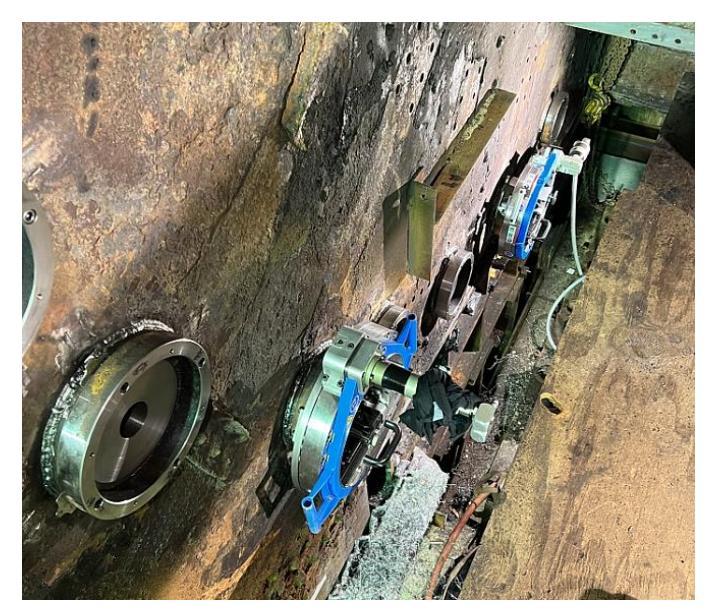
Face Machining of the Pucks

Each puck was provided with a setup ring for mounting the facing machine. This ring bolted onto the Puck using the bolt pattern outside of the rack mounting face. Using the laser tracker, we quickly shimmed the face of this ring to be parallel to the final rack mounting plane desired. Then the machine would bolt onto this ring and cut a face parallel to this surface. With all the planning and design development of the Puck, along with performing a mockup in the shop, we were able to machine the puck faces on our desired plane in record time.

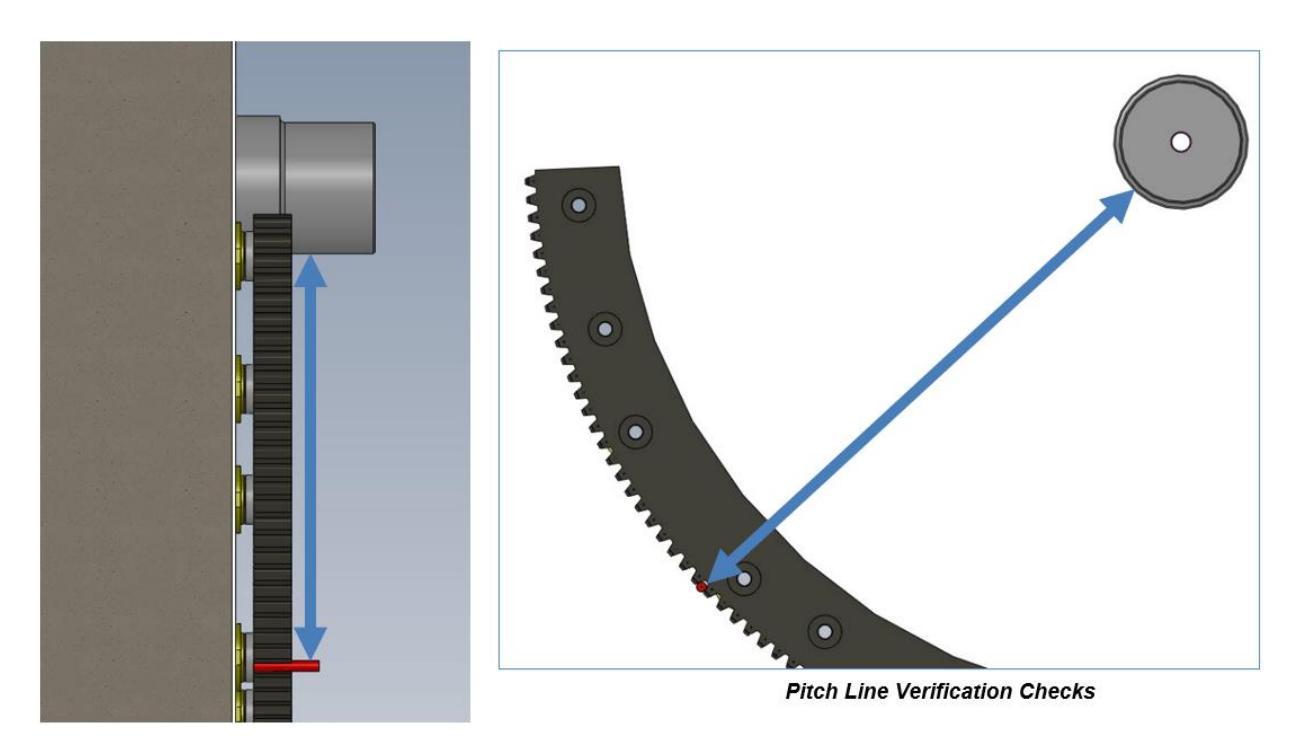
holes accurately located, we assembled the Rack using temporary fasteners. The pitch line runout was inspected with the laser tracker and, for a sanity check, confirmed using the mechanical means of a pitch pin and a direct measurement to the trunnion journal as shown below. With ground pitch pins clamped into the teeth of the rack, tangent to the pitch line, a direct measurement of the distance to the trunnion journal was taken. The results confirmed that the subdrilled mounting holes accurately located the rack.

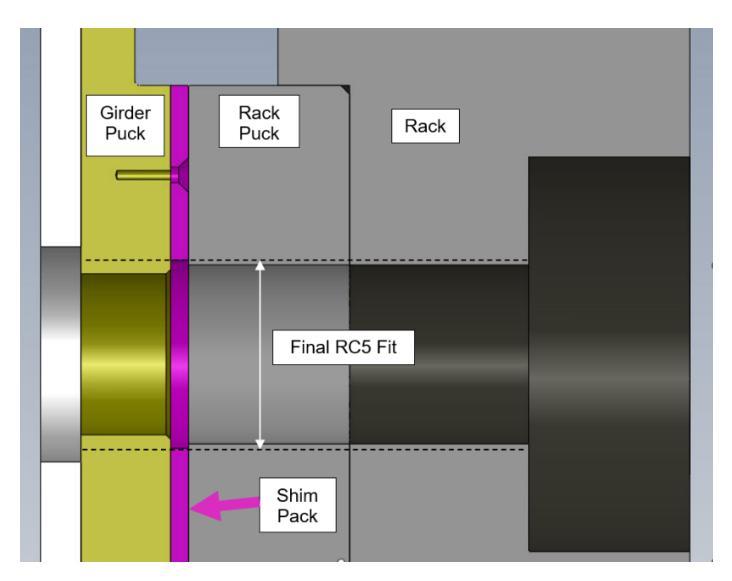
#### Final hole size finished at assembly.

Hole #s 1, 2, & 3 completed with final fasteners torqued. Working on Hole #4.

From there, we removed one temporary fastener at a time, finished the subdrilled holes to the RC5 fit, and installed the final hardware.

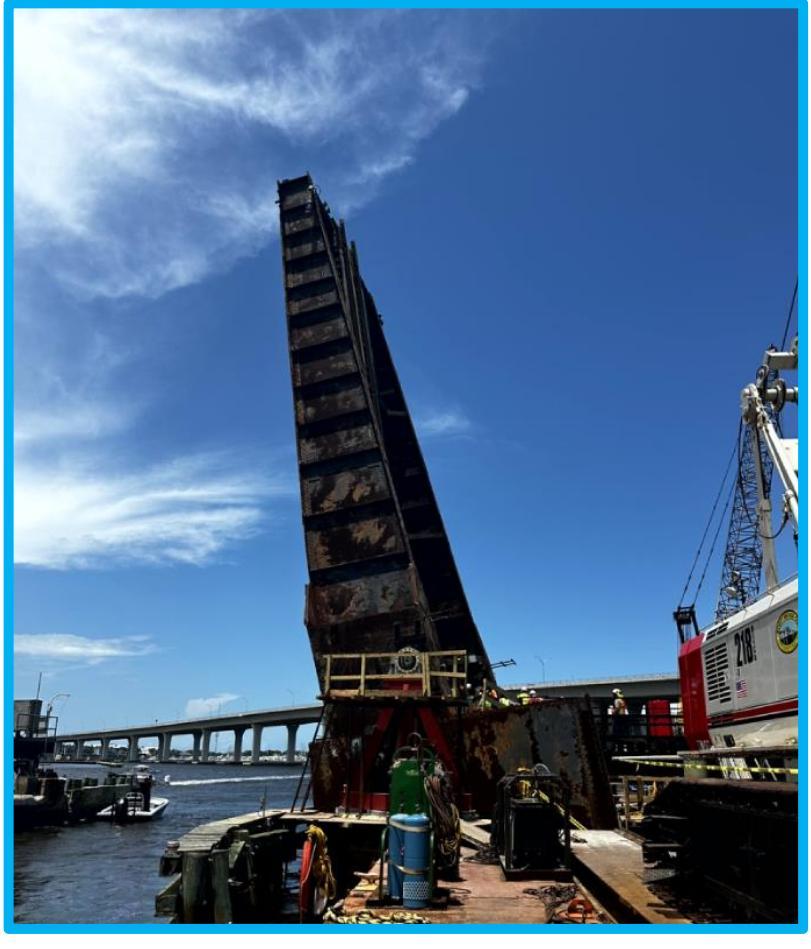
Successful Maiden Lift - May 20, 2023
