**HEAVY MOVABLE STRUCTURES, INC.
TWENTIETH BIENNIAL SYMPOSIUM**

**Over Height Vehicle Collision Repairs to a
Rolling Lift Bridge**

Jonathan Eberle, PE, AECOM

Introduction

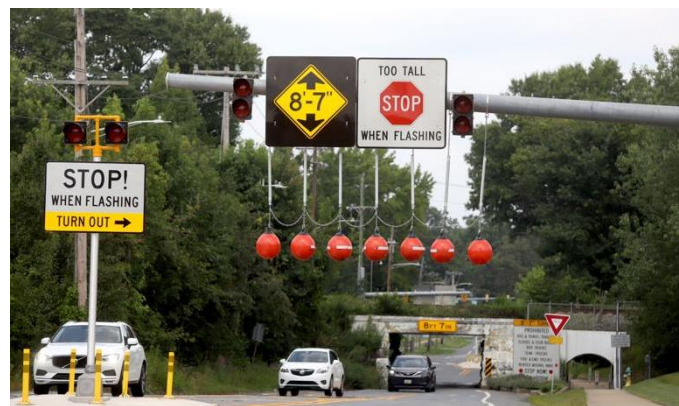
Figure 18: "Clankers" installed in Newark, DE

In addition to the two significant impacts leading to the need for emergency repairs to the bridge, damage was viewed during the inspection which was not attributed to either of the noted impacts. This evidence that impacts to the bridge have been somewhat common throughout the bridge's life indicate that continued damage could be expected if no further measures are taken. DelDOT was able to recently implement a successful over height warning system on another roadway within the state, the Casho Mill Road underpass located in Newark, DE (see Figure 18). This system, referred to as "clankers", was installed in the summer of 2022 and is comprised of hanging spheres which when impacted cause a non-damaging warning to motorists. The system has prevented multiple incidents as evidenced by DelDOT's traffic camera at the location. DelDOT intends to install a similar system at BR 2-021A and is currently in the design phase.
