**HEAVY MOVABLE STRUCTURES, INC.
TWENTIETH BIENNIAL SYMPOSIUM**

**Rehabilitation of LA 82: Vermillion River
Vertical Lift Bridge at Perry, Louisiana**

Dave Kanger, P.E.
Modjeski and Masters, Inc.

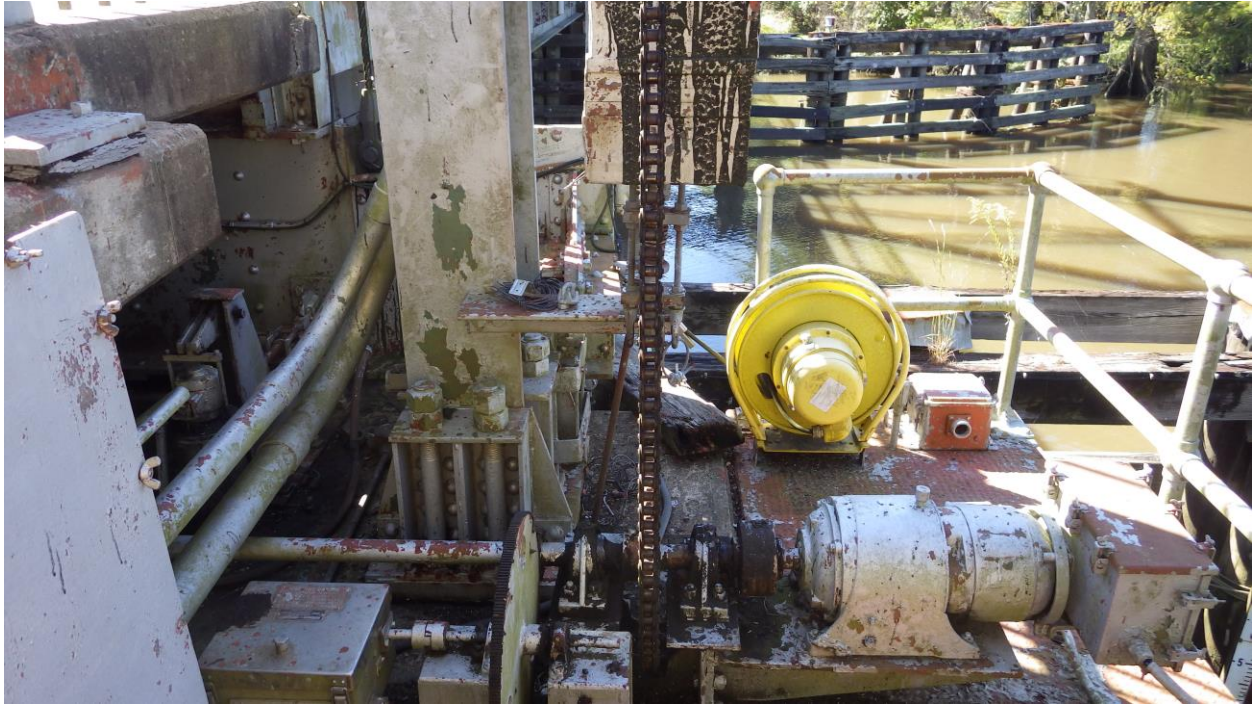
Photo 3 – Tower Pier (barrier motor, tower leg base anchorage, lower tower leg, and general accessibility)

For this reason, the rehabilitation alternative that was chosen was to raise the portal on the tower along with supplemental strengthening of the tower leg lower portion and its anchorage. The strengthening method was comprised of buttoning a new wide-flange section within the span-operating clearance zone of the tower leg that could strengthen the existing tower leg for both additional capacity to resist wind loading as well increase the capacity of the lower portion with a longer unbraced length due to the raise of the portal. (Figure 5)

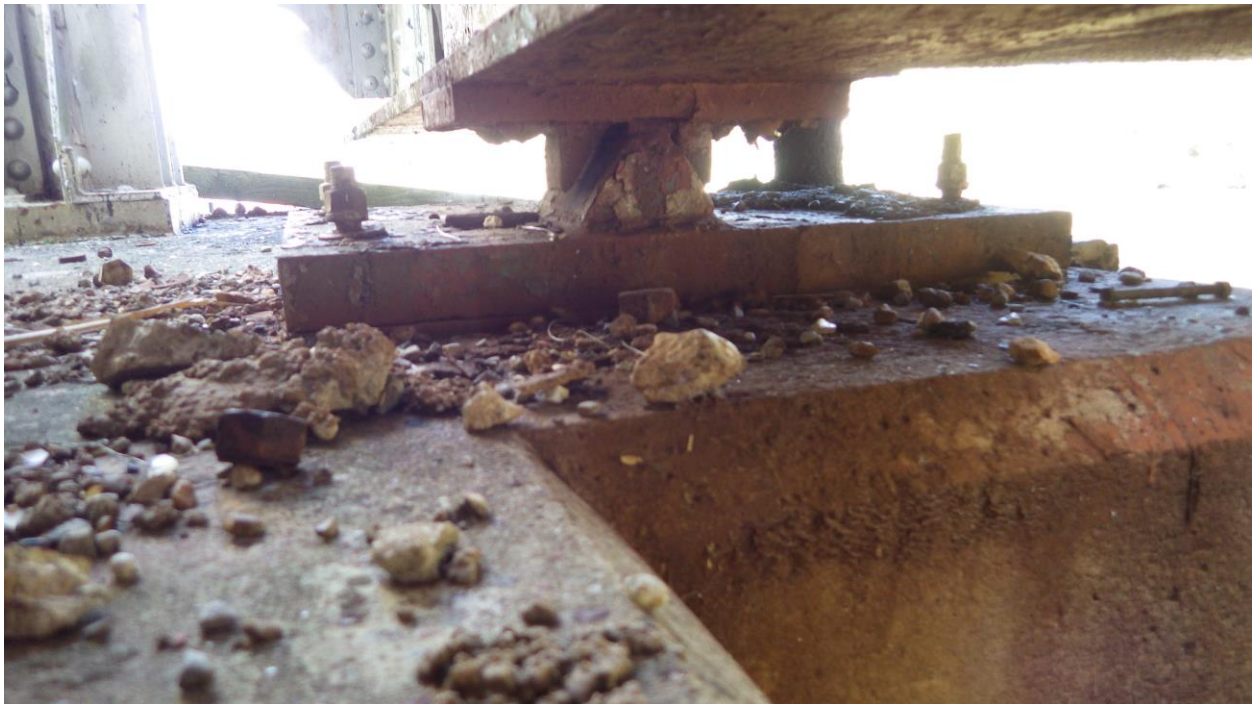
Photo 4 – Lift Span Liveload Bearing

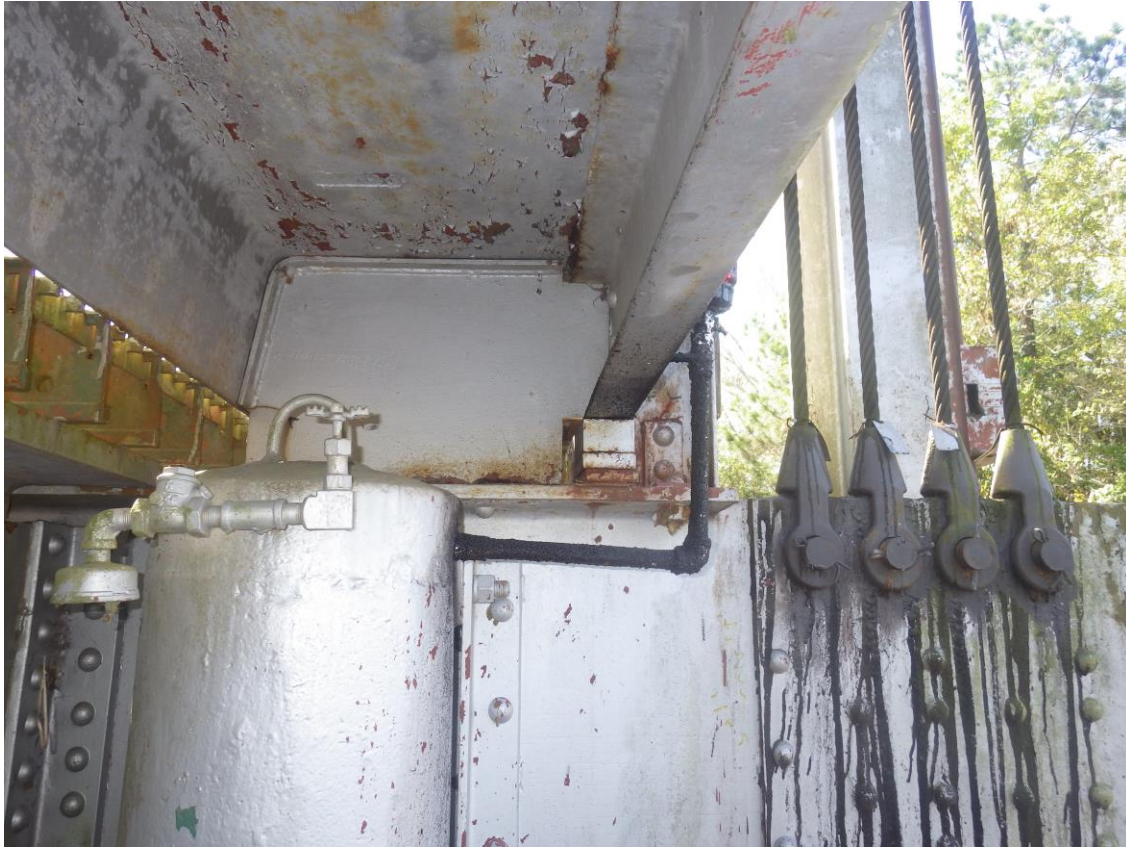
The machinery is generally in fair to poor condition. The main counterweight ropes exhibit excessive wear and little to no lubrication, which is accelerating the wear. Several couplings are misaligned and/or exhibit excessive relative movement during operation, specifically at starting and stopping. This is evidenced by a ticking noise during operation at all of the couplings, which indicates broken coupling grids. Each open gearset exhibits excessive wear, especially on the opening faces. LADOTD personnel indicated that the couplings are opened every few months to re-index the machinery and seat the span correctly. This indicates rope slip and incorrect balance. A contract to replace the span drive machinery is currently in effect. This scope will pertain to those items not covered under the current contract.

Photo 5 – Lift Cable Anchorage

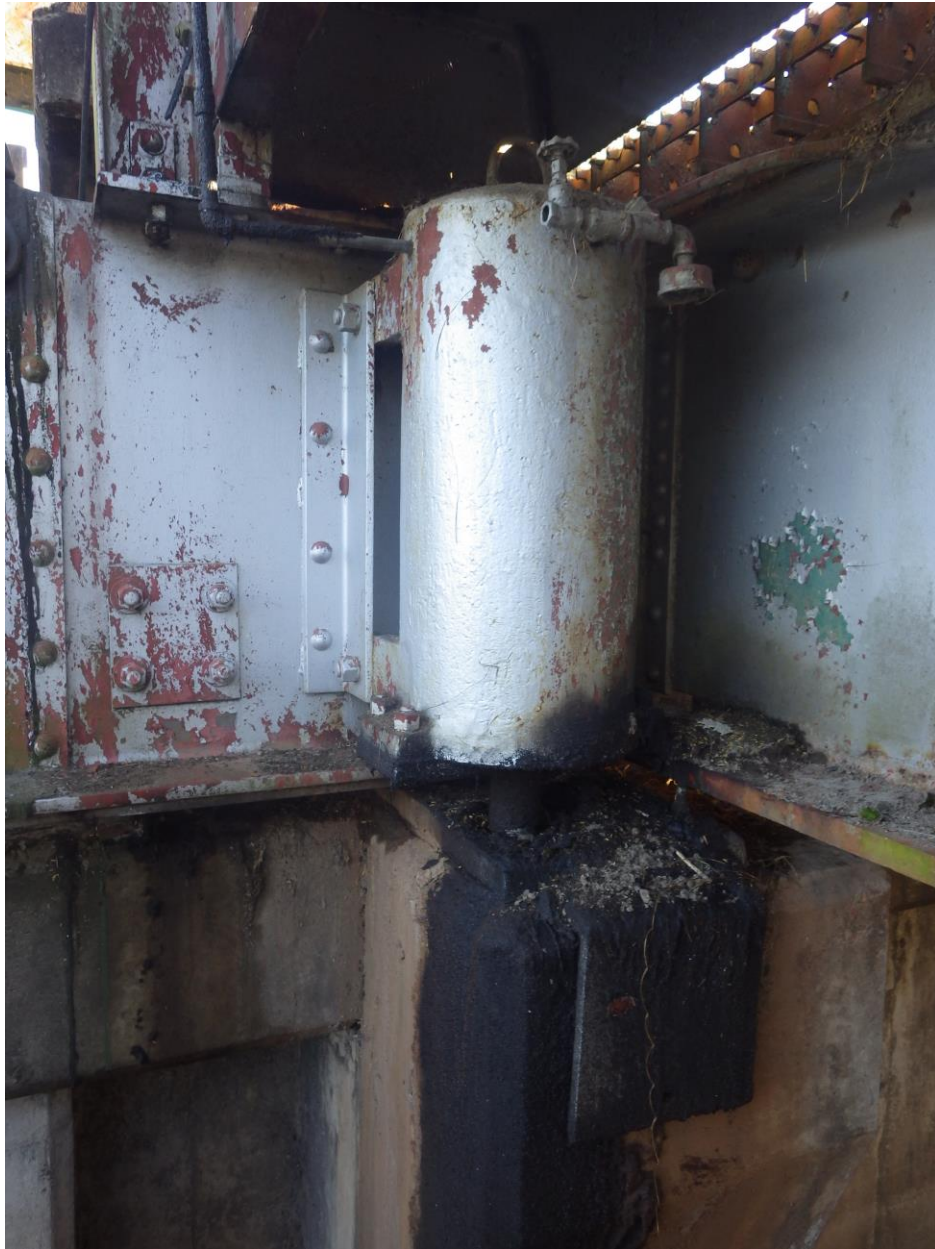
Photo 7 – Air Buffer

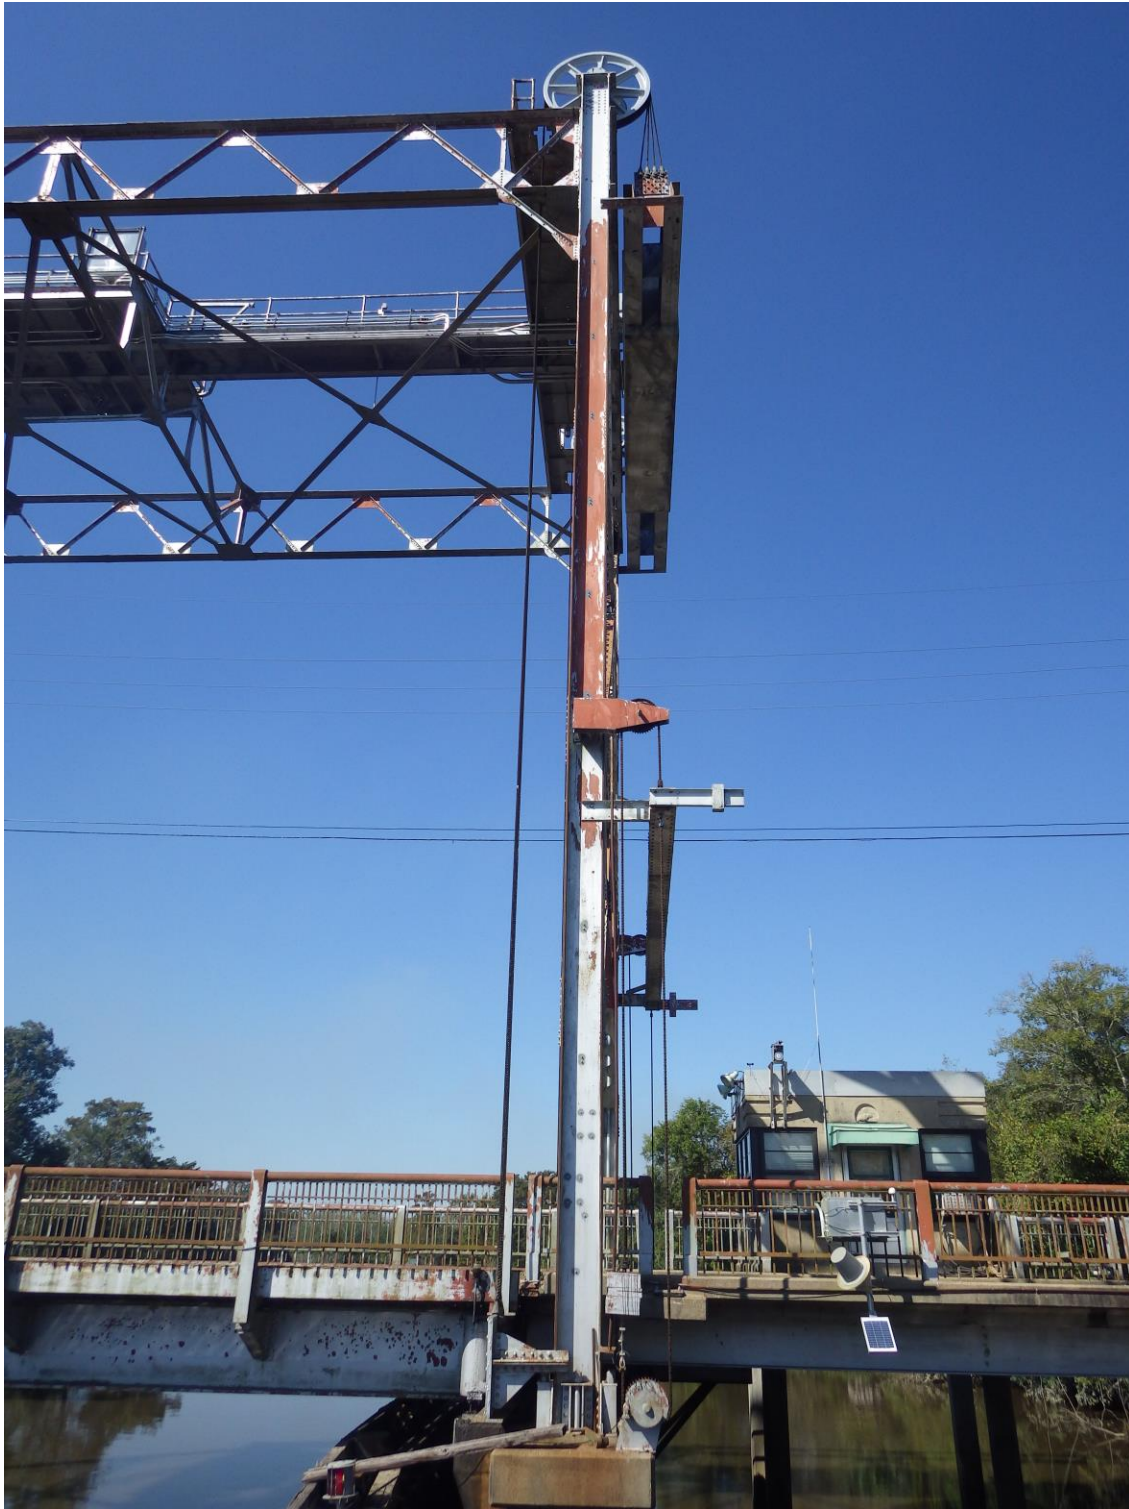
The towers are in generally good condition though there is evidence that at least one tower leg may not be plumb as a result of vehicle accidents with the tower portal bracing. A survey was performed to determine the disposition of the tower legs, and this survey did confirm minimal out-of-plumbness to be corrected. Additionally, the low clearance of the tower portal struts (14 feet) has resulted in numerous impacts which necessitated the replacement of the tower portal struts. The feasibility of raising the portals was studied, and as part of the tower strengthening, the portals will be raised.

Photo 8 – Tower Leg

The lift span tower members needed strengthening to improve their capacity for modern design wind loading and to accommodate raising of the low portal members which frequently get hit, including straightening repairs, and replacement of the portal members.

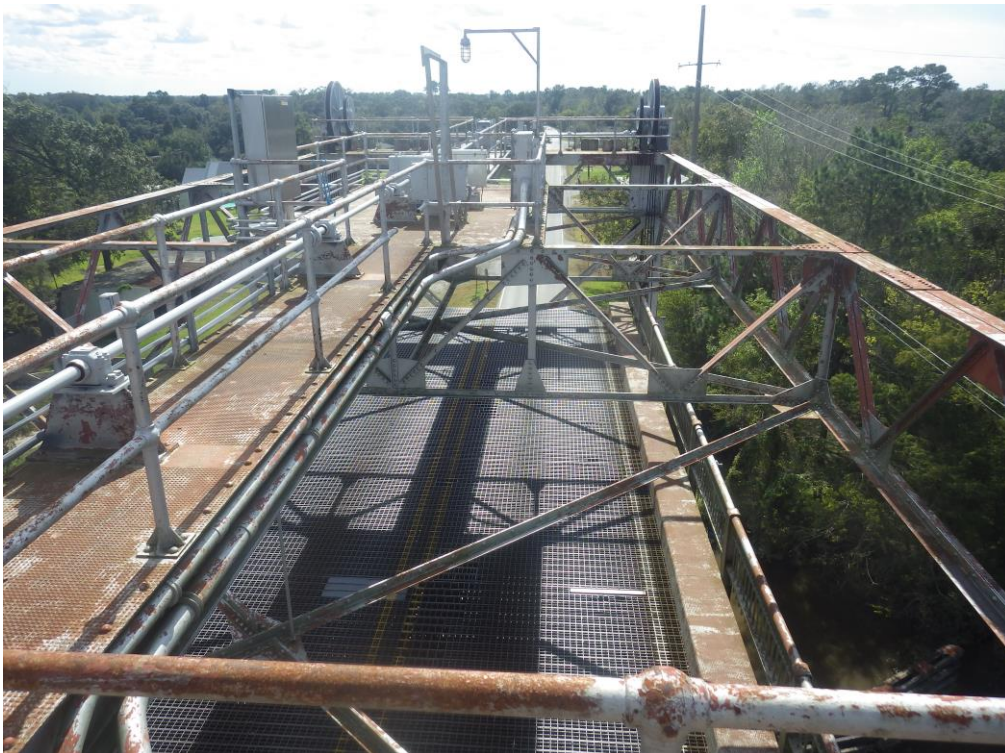
The machinery decks are open to the elements and can be slick when wet and need to be treated with a skid resistant coating. This issue can be compounded by several loose panels that needed to be replaced or reattached.

Photo 10 – Lift Span Machinery Deck Level

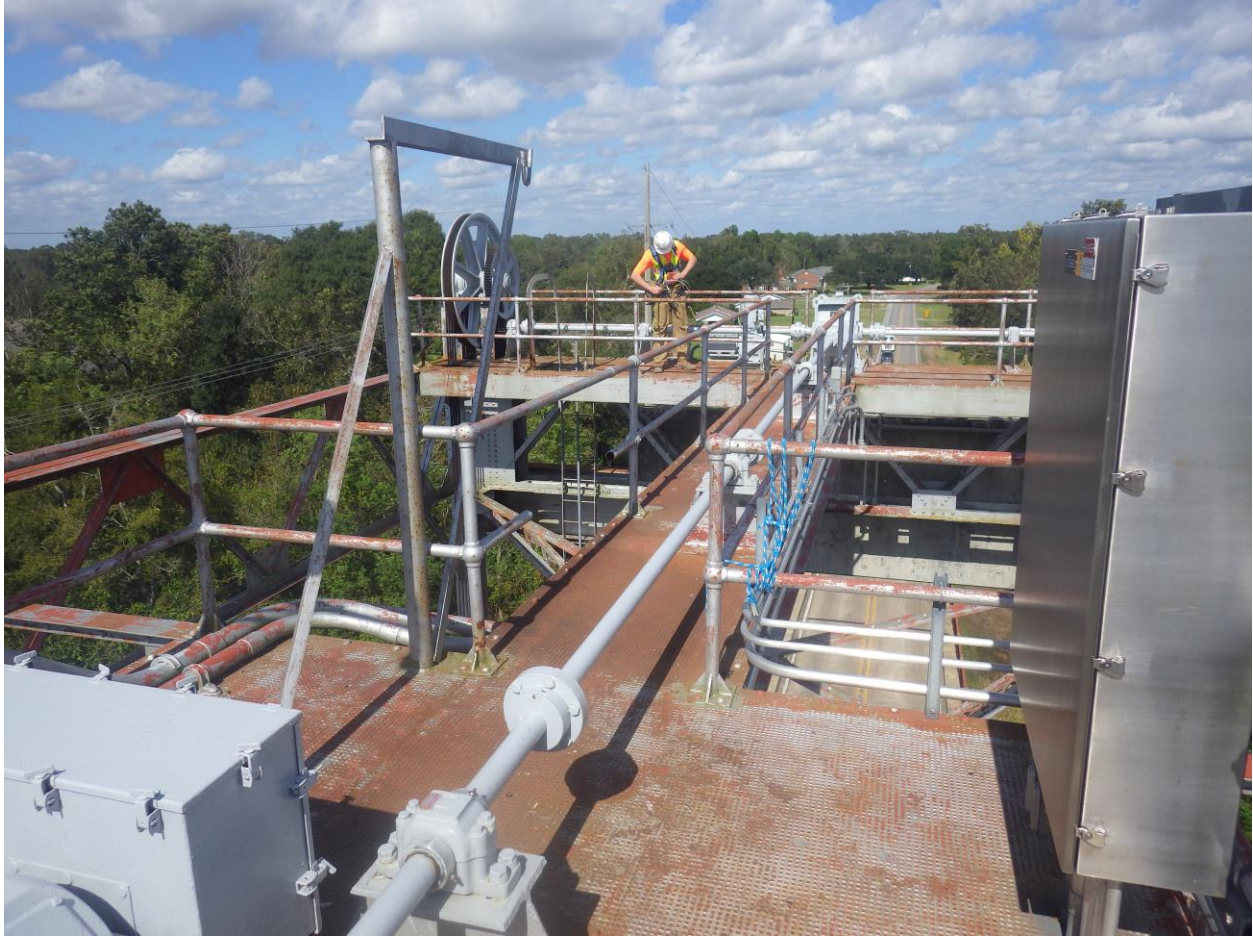
Photo 11 – Lift Span Machinery Deck Level – At Main Drive Motor looking towards Secondary Reducer and Sheaves
