HEAVY MOVABLE STRUCTURES, INC. TWENTIETH BIENNIAL SYMPOSIUM

FDOT Sheridan Street over ICWW Bascule Bridge Rehabilitation Project Jordan N. Robbins, P.E. & G. Alan Klevens, P.E. PCL Construction, Inc. & TranSystems Corporation

Background/Introduction

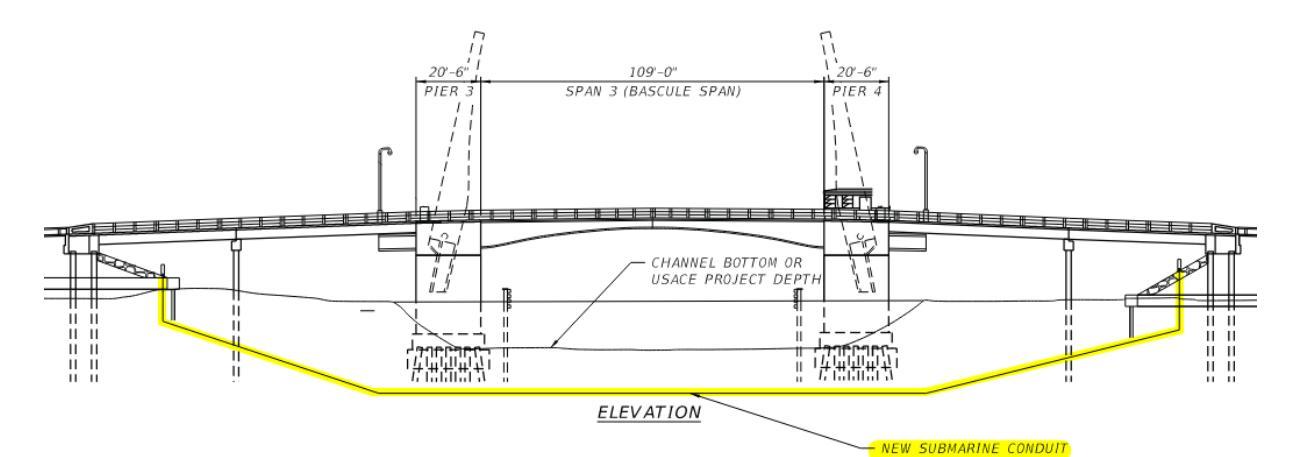
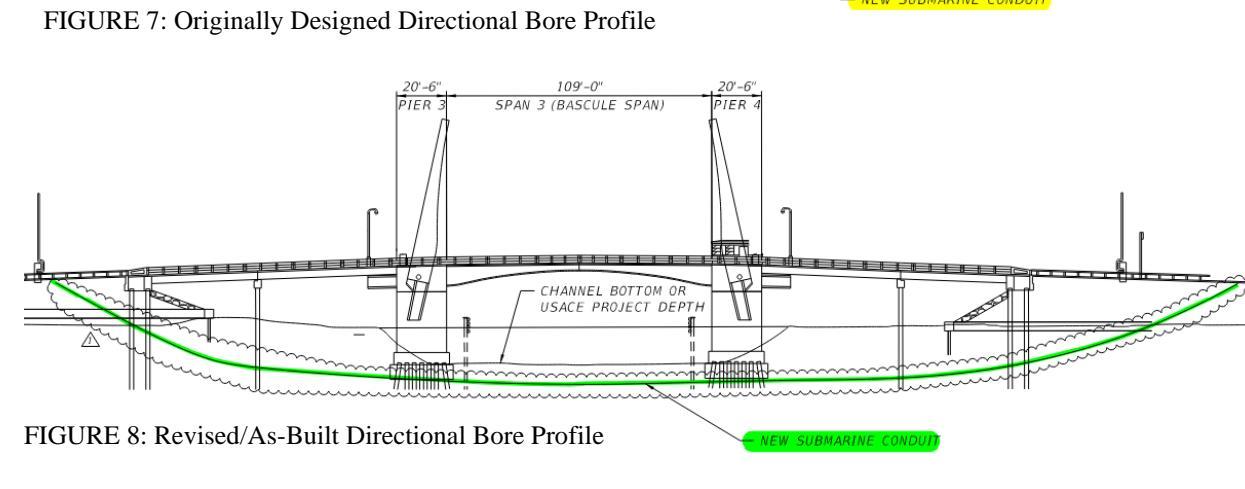
Directional Bore Profile

The original design for the submarine conduit path was developed using the shortest path achievable based on the minimum bend radius for the HDPE conduit, which could be achieved by digging directional bore termination pits within the Intracoastal waterway. This resulted in a submarine conduit run of roughly 400 feet, which is approximately the width of the waterway from seawall to seawall. Due to the potential damage to the seawall that could have been introduced by these construction methods and the additional permit efforts to get these excavation methods approved by permitting agencies, the team was tasked with coming up with an alternate approach that would avoid extending the overall project duration.

The Contractor challenged its directional bore subcontractor to come up with the possible bore profiles that would mitigate cost impacts to the Department. Based on survey of the existing conditions and the capabilities of the directional bore machine drill rods, the directional bore contractor proposed a 577-ft long bore that achieved the minimum-required depth below mudline using the allowable permitted construction methods. The 577-foot option also offset the directional bore exit and entry pit locations to minimize interference with the seawall, fender piling, and new concrete generator pad. In anticipation of the increased length of the submarine conduit, and roughly 400-foot overall increase to the circuit, voltage drop calculations were rechecked for the original conductor sizes. It was determined that the additional length for the main power feed resulted in a need to upsize both the conductor ampacity and the size of the conduit, as well as the addition of sinewave output filters for the far side variable frequency drives. Due to the issue being identified prior to construction, the electrical contractor was able to accurately re-arrange the layout of the electrical cabinets, devices, and raceways, and order the appropriate materials without affecting the critical path of the project.
