HEAVY MOVABLE STRUCTURES, INC. TWENTIETH BIENNIAL SYMPOSIUM

Rehabilitation of CSX Marley Neck Swing Bridge: Construction Challenges Justin Dutreil, P.E. PCL Civil Constructors, Inc. (PCL)

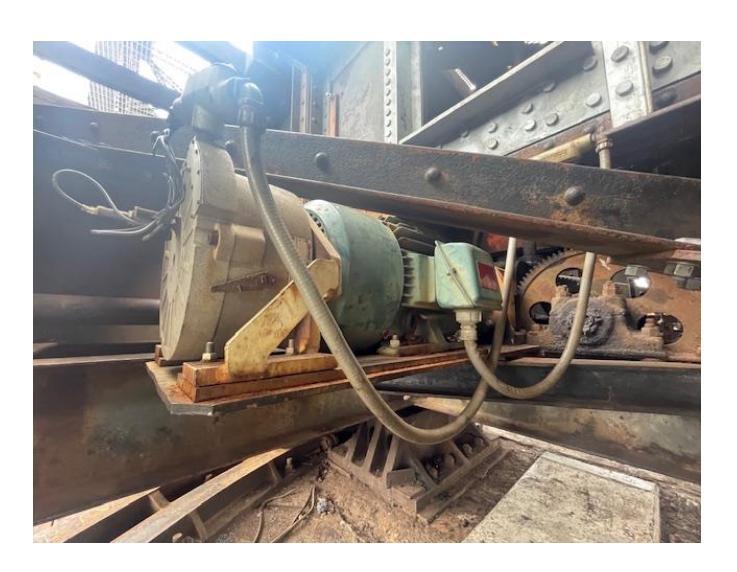
Figure 4: Existing Center Wedge Motor

- Center pivot bearing was worn, no longer centered, and leaking oil due to pieced collar system.
- Span drive system was in poor condition. Brass bushings were pushing out of bearings, gear teeth had significant wear, operations during open and closing operations were loud and movements irregular.
- Centering latch bar would often get stuck in the centering saddle preventing the bridge from opening.
- Motor brakes were unreliable and would fail often.
- Center and end wedge linkages were in incorrect positions.
- Old machinery castings were starting to crack at stress points.

- 3. Pivot Bearing
 - a. Demolition and removal of existing pivot bearing.
 - b. Install of new two piece disc and contained pivot bearing oil box.
- 4. End Wedges
 - a. Replacement of motors and segmental gearing.
 - b. New turnbuckles and pins.
- 5. Center Wedges
 - a. Replacement of motor and motor support.
 - b. New turnbuckles and pins.
 - c. New linkage arms.
- 6. Rail Locks
 - a. Replacement of motor and motor support.
 - b. Install of new rotary cam limit switch.

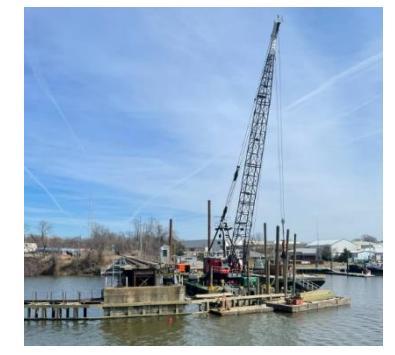
Figure 13: Fender Replacement

- Lack of access to perform maintenance at the ends of the span.
- Two large holes cut out of the stringers required stiffening.
- Platforms to support and access the new controls and signals houses did not exist.
- Existing fender system was in poor condition.

- 1. Platforms
 - a. Support beams for new signals and controls housings.
 - b. End of span access for rail locks and end wedge machinery maintenance.
 - c. Various access platforms to eliminate fall hazards.
- 2. Stringer Hole Stiffening
 - a. Install of stiffening plate around existing torch cut hole.
 - b. Drilling of arrest holes to prevent existing cracks Figure 12: Stringer Hole Stiffening from growing.
- 3. Top Truss Access Platform
 - a. Install of new staircase to top of bridge.
 - b. New access platform on top of bridge to access wireless antenna equipment.
- 4. Fender Rehabilitation
 - a. Replacement of existing fender system in kind.

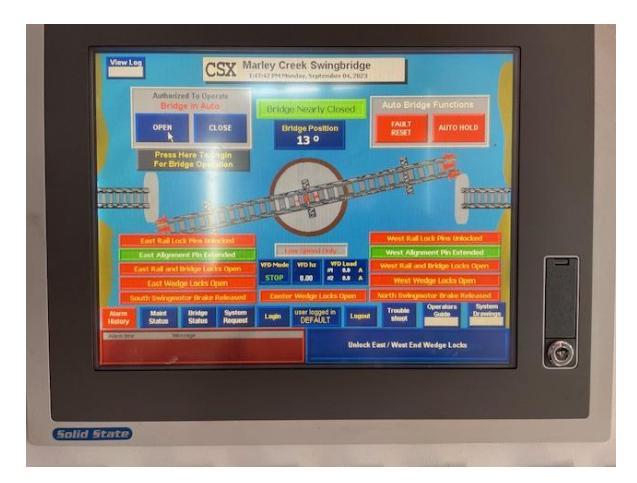
Figure 15: Existing HMI Controls

- PLC equipment was outdated, and unknown faults occurred during operations.
- Motor soft starters were often faulting.
- Control relays were "chattering" or failing.
- The shore stations did not have a screen to show bridge faults. If the moveable span got stuck open, a boat would need to be taken out to the bridge to troubleshoot.
- No remote capability and remote monitoring devices available.
- Navigation lighting insufficient per current federal standards.
- Signals system was outdated, and upgrades were required to enable remote capability.

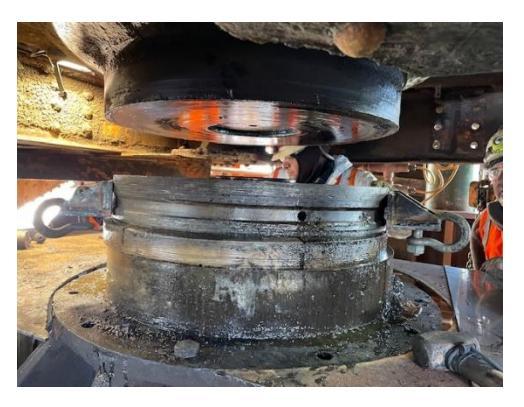
Figure 17: Jacking Bridge to Replace Center Pivot Bearing

The most unexpected issue discovered was how difficult it was to remove the bottom steel disc. A 1.5 hour planned task doubled to 3 hours when 2 ton come-a-longs with a combination of 25-T jacks refused to free the disc of the lower boss insert. The most effective method of removal utilized a series of steel wedges and sledgehammers to slowly pry the disc up. The limited access and manual nature of the method was extremely cumbersome but ultimately successful.

Replacement of the center pivot bearing was a challenging scope of work to complete. Scope included jacking of the moveable span utilizing (4) 250-T jacks, removing the old pivot bearing bronze discs and retaining collars, and installing a new fully contained pivot bearing and oil box system. Several constraints included:

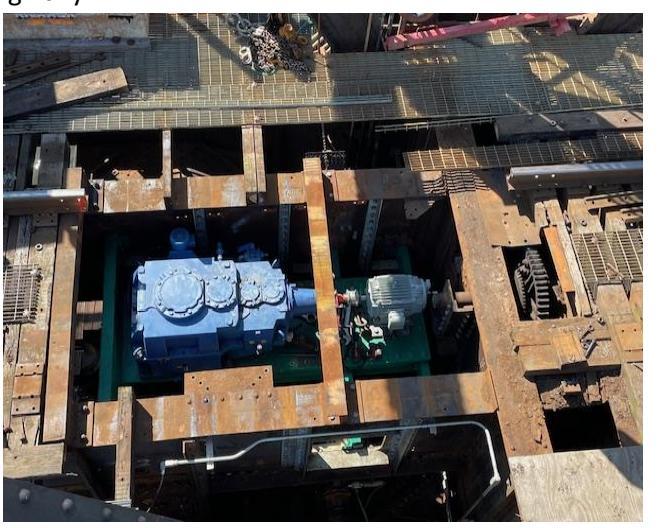
Figure 21: Track Panel Removed and New Machinery Skid Installed

To verify the bridge would be operational on a single motor, the dual drive system was isolated to a single drive system and the span was operated. The single motor test was successful; however, it was discovered that due to the additional torque on the single motor, the existing motor support would deflect significantly. This caused a poor gear mesh when operating. Additional support beams were installed temporarily to prevent the deflection. In case of motor failure, the secondary motor that was demoed was staged next to the running motor and a temporary air winch was installed on the piers to assist in closing the bridge if a major issue occurred. Lastly, an on call local tugboat service was utilized if the all other options failed to open or close the bridge.
