HEAVY MOVABLE STRUCTURES, INC. TWENTIETH BIENNIAL SYMPOSIUM

Resurrection of a Historical Turntable for ORHF

Dale Birkholz (Oregon Rail Heritage Foundation) Tim Hammer, PE (Everett Engineering) Matt McGuire, PE (HDR)

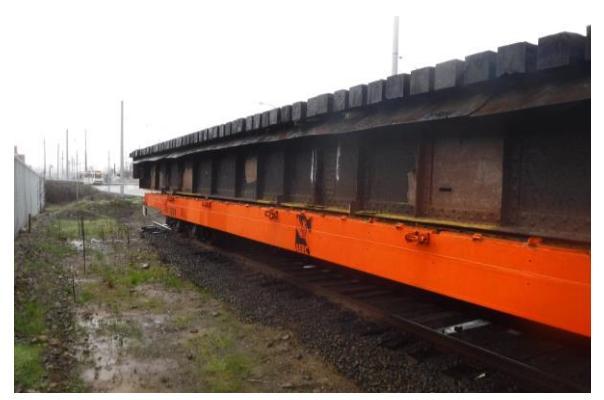
Figure 4: Storage condition of the table on a flatbed rail car. Original ties and paint shown.

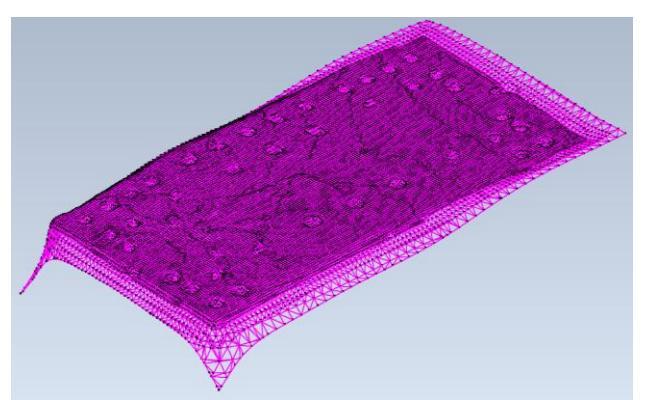
The scanning phase of the work consisted of scanning both the underside of the main cross girder and surrounding steel with LiDAR to an accuracy of 0.005", which is in-turn nominally reduced by the scanstitching process. A physical spot-check operation on the deteriorated surface using a straight edge and depth gauge was also performed to validate the LiDAR scan. The straightness and planar surface of the table main longitudinal girders were also checked using a 48" level.

Design of the custom shim plate was performed in AutoCAD Inventor after importing the point cloud of the (LiDAR) scanned area. A 'cloth drape' digital surface interpolation was performed over the point cloud to create a solid surface representing the contours of the scanned underside of the cross girder. In addition to establishing the surface, some manipulation of the resulting 3D model was performed to reduce the resulting high points of the scanned surface. The reduction of just the high spots up to $\frac{1}{2}$ '' in some locations was to account for inaccuracy of the scan as well as potentially decrease the fit-up time it would take to physically reduce any high spots of the cut shim

Figure 10: 3D 'Cloth Drape' of the LiDAR point cloud to create a solid contoured surface for the top of the shim plate.

plate with the existing cross girder. The reductions were not uniform but applied judiciously in accordance with observed variations across the area in the difference between the scan data and the manual 'spot-check' measurements.

Once adequate adjustments to the model were made for fit-up, the final contour was established for the plate and a review of the capabilities of the CNC mill head used by EEI, and a reasonable load-up time for the cutting program was pursued. The design model was provided in two different levels of detail to check the cutter routing program for a 1/4" mill cutter. In the end, it was found that the higher detail model could be used without significant program load-up time and the model was provided with blank mounting hole locations to account for field fit-up and proper hole location when mounting.

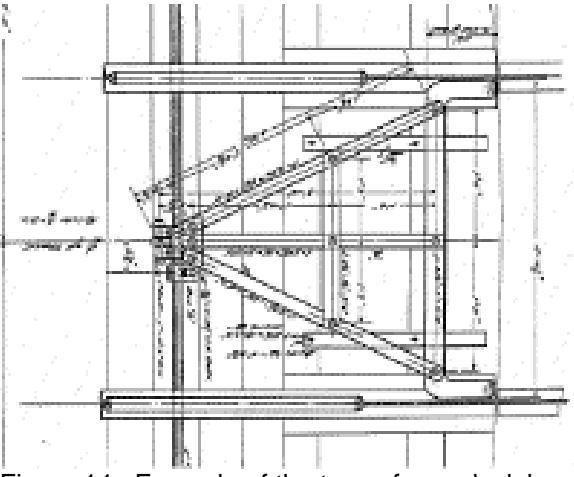
Figure 14: Example of the type of span lock bar desired on the turntable.

The solution to the exclusion of the original brake was a combination of the motor drives decelerating the turntable and deploying a span lock when aligned to a particular track to hold the table in position during parking. A span lock was never part of the original design of the turntable machinery systems, but ORHF

deemed it desirable to have a lock to be able to secure the table in place when aligned with a particular track for extended periods of time, especially considering there would be no brake in the system. An engineering review of several different styles of turntable locks was provided for proof of concept. It was also noted that the inclusion of a lock was more in line with the current AREMA design standard. Lock system details are in development at this writing, but the concept is expected to be similar to a lock plate spanning between the approach track and table track, actuated by a manual lever arm. It is expected that the future controls for the table will incorporate a safety limit switch to disable the turning machinery when the lock is driven.

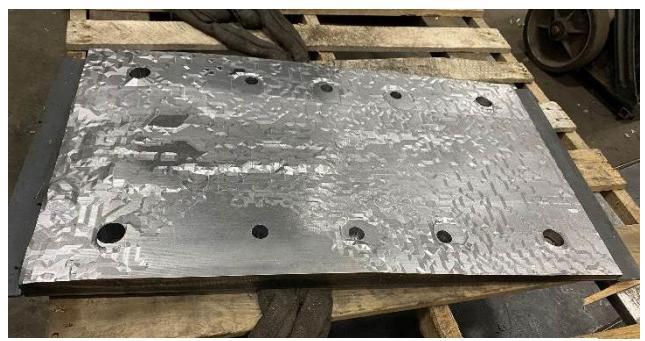
Figure 15. Adapter plate - Post Machining

The surface of the adapter plate that would contact the center bearing saddle was milled flat, flipped, and stitched in a 3 axis CNC mill on the top surface to match the bottom flange of the center cross girder. This would provide a surface that would maximize plate contact between the saddle and the main cross girder. Countersunk holes were drilled thru the shim plate at these locations to enable re-use of the hole locations and reduce extra holes being drilled in the field. The holes for the turned bolts that would secure the saddle to the main

cross girder were drilled undersize to allow field drilling & reaming for turned bolts. Turned A325 bolts were fabricated as well.

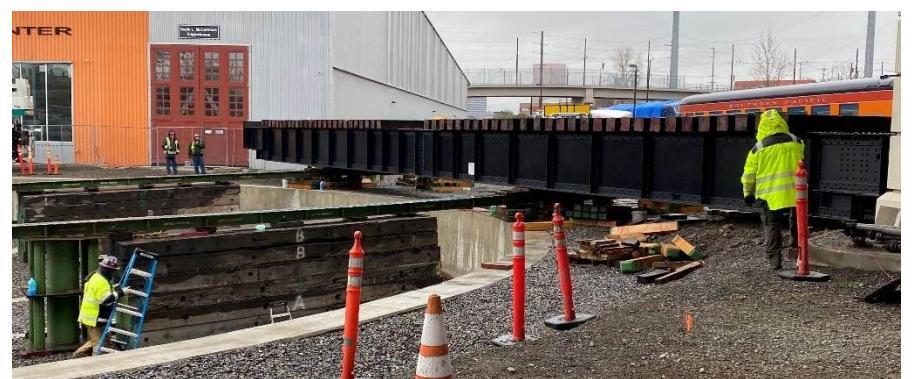
Figure 18. Turntable set on slide gear and maneuvered into place by hydraulic rams.

ends of the turntable aligned to fit between the concrete pit walls on both ends. Slide gear was setup in sections underneath the turntable and transporter, aligning with the cribbing in the pit. Sleds were positioned under the turntable on the slide gear. Hydraulic rams were used to push the table uniformly along the slide gear into the pit until it was centered over the trucks. The turntable was lifted off the slide gear with hydraulic jacks and the slide gear was removed from underneath. The cribbing was removed in stages, slowly lowering the bridge into position between the idler and drive trucks. Special attention was given to ensure the center bearing saddle was aligning well with the base. Due to the tight clearance in the new concrete pit, the end floor beam flanges were trimmed to enable the turntable to drop the rest of the way down onto the center bearing and truck assemblies with minimal clearance.

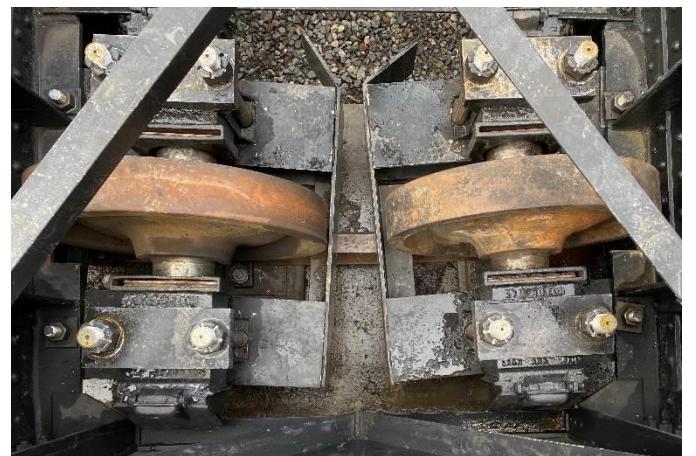
With the turntable fully supported on center bearing and with dunnage on both ends, work began on truck alignment. No wood ties were on the ends of the bridge at this time. Hydraulic 100-ton jacks were used under all 4 corners of turntable to level the ends with the center of table using a laser transit. The corner heights were secured by cribbing in place and shimming on all 4 corners. The top of the turntable was checked for level at multiple locations along the length. The pit track height and radius were also measured, and the track was noted to be approx. ³/₄" out-of-round.

Figure 19. Aligned idler wheel set after turned stud installation.

Drive trucks and idler trucks were cribbed and shimmed roughly in position. The bottom flanges of the bridge girders were marked and notched in place where the flange would interfere with the wheels. The trucks were centered and leveled under the girders with crane support. Idler wheels were flown in from above and installed on both ends of the table. The trucks were aligned under the girders with the wheels equidistant from the girder on both sides. All idler bearing studs were tightened, and bearings secured in place. The original wheel assemblies allowed nearly 3/8" movement of the wheel axially between the bearings, and the trucks and wheels were aligned tangent to the existing radius track, evenly spaced between the bearings. The truck and wheel assemblies were jacked horizontally as necessary to align wheels tangent to track.

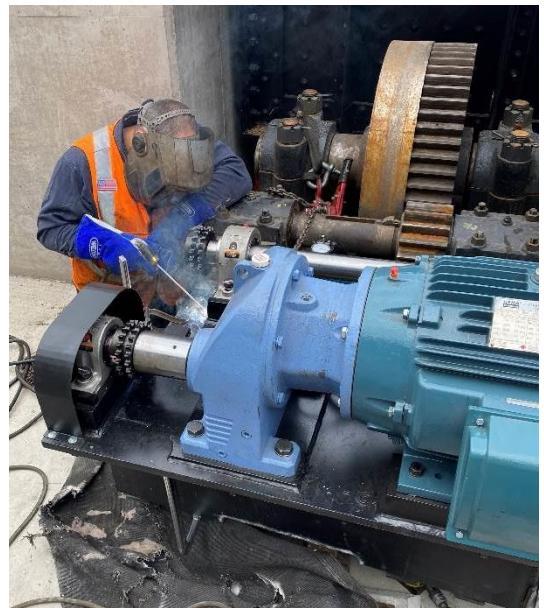
Figure 20. Welding the new machinery bases to the drive truck frames after gear alignment.

With the idler and drive trucks secured and aligned to the radius track, the new drive assemblies were installed. Each individual assembly had been shop fabricated, machined, assembled, and aligned as a unit, so the only alignment to complete in the field was correctly meshing the pinion with the bull gear on each end of the turntable. The assemblies were rigged and lowered into position onto the refurbished drive trucks. The ends of the turntable were jacked up using 100- ton jacks, to allow minimal clearance between the radius track and the drive wheels to enable the drive wheel to spin by hand to test the gear mesh. Comealongs, jacking screws, and clamps were used to align the gears, along with shims between the base and truck frame. Once visually aligned, the pinion was blue-fit and the bull gear rotated to determine the wear pattern. Since the gears were refurbished and still had some uneven wear, the pattern across the face was not completely uniform, but the

best possible contact was achieved toward the center of the bull gear face. With initial alignment complete, dial indicators were positioned on the base to detect movement

of the base during welding. The base was welded out, alternating positions around the base to minimize heat distortion. After welding, the jack shafts required minor shimming to accommodate some minor heat
