**HEAVY MOVABLE STRUCTURES, INC.
TWENTIETH BIENNIAL SYMPOSIUM**

**Vertical Lift Bridge Seating Issues
Rt 1 & 9T Bridge over Hackensack River**

Hammad Mumtaz, Ph.D.
Robert Algazi, P.E.
WSP, USA

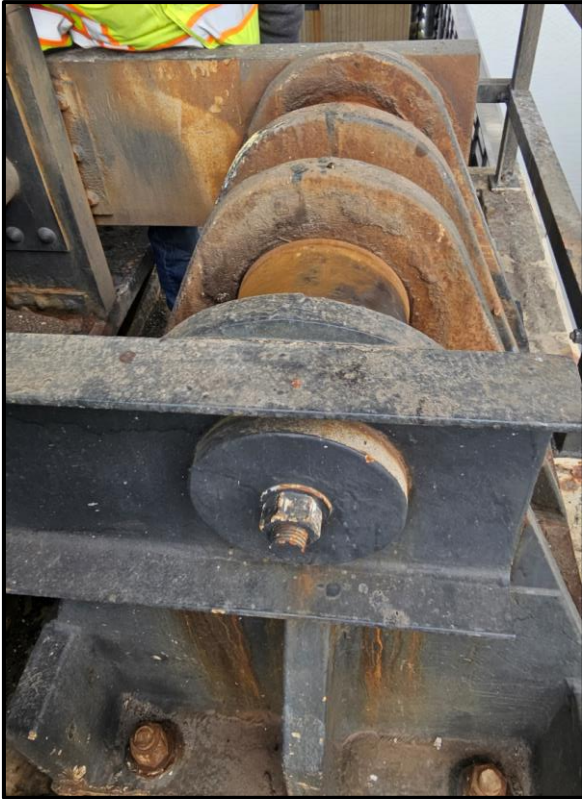
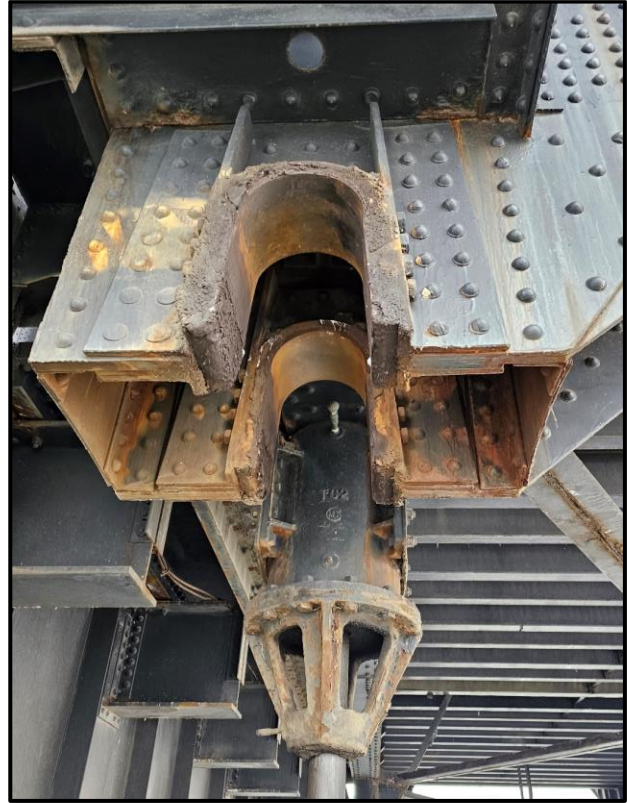
Photo 4: Left - Live Load Shoe Fixed Pin; Right - Live Load Shoe Saddle

While loosening the live load shoe strike plate anchor bolts so it could be lifted to insert shims, one of the anchor bolts sheared, likely due to excessive torque applied by the work crew. The shearing occurred at the surface of the live load shoe base plate preventing the bolt to be reused; however, the bolt portion left in place at this location does provide some capacity for lateral loads.

During the 2020 Contract, it was made a priority to shim the live load shoe assemblies before any other work began. The live load shoe itself is built into the truss of the lift span making the strike plate the only adjustable component. Semi-circular shims on the pin were not deemed feasible as they could impede the proper seating of the live load shoe saddle and prevent intended rotation at the pin; therefore, it was agreed to add shims under the strike plate, atop the concrete pier.

A live load shoe repair detail to supplement the broken anchor bolt additional anchorage was provided by the Contractor. The repair consists of a new channel mounted off a stiffener of the live load shoe strike plate that is anchored to the concrete with a new anchor bolt. The existing failed anchor remains and was caulked and painted to prevent corrosion.
