**NINTH BIENNIAL SYMPOSIUM**  
"Preserving Traditional Values with New Technologies"

COST CONTROL ON BASCULE BRIDGE  
CONSTRUCTION; A PARTNERING APPROACH

Clara Scott, P.E., F.D.O.T., District 4 Construction,  
Raj Rangaswamy, P.E., Target Engineering,  
Mike Yeager, P.E., URS Construction Services,  
Wayne McLennon, P.E., Lichtenstein Consulting Engineers

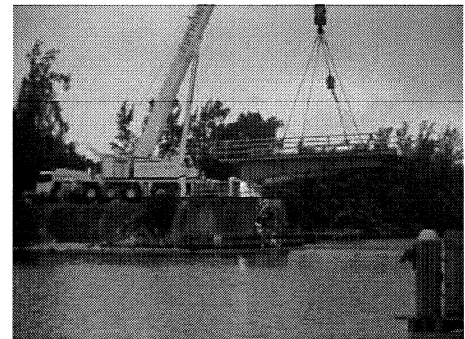
**Demolition of the old bridge.**

The construction of the Boynton Beach Bascule Bridge presented many challenges to the CEI Team, the Contractor, and FDOT. The new bridge was constructed on the same alignment as the existing bridge so the first task was removal of the existing Bascule Bridge. A 300-ton mobile crane was used to remove the old rolling Lift Bridge in two pieces. Demolition of bascule piers is always a difficult task. The piers are founded on large footings, which are poured on the top of thick concrete seals. The time required for this phase is frequently underestimated by both Engineers and Contractors. The Boynton Beach Bridge was no exception. Complete removal of the span, piers, and piling took approximately six months, three months longer than anticipated.
