**HEAVY MOVABLE STRUCTURES, INC.
NINETEENTH BIENNIAL SYMPOSIUM**

**MBTA GLOUCESTER DRAWBRIDGE:
CONSTRUCTION CHALLENGES DUE TO
CHANGING CONSTRAINTS**

Joe Knapp, P.E.
Genesis Structures

John Williams, P.E.
Wiss, Janney, Elstner Associates, Inc.

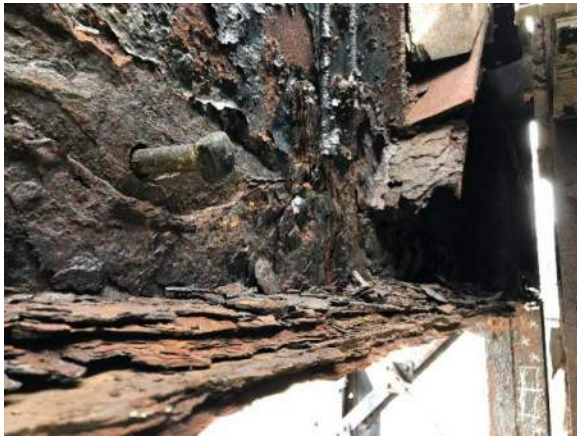
Figure 1: Deteriorated Bottom Flange

1. Once the southern half was removed from the existing timber trestle, it would be an asymmetrical structure that would experience significant lateral movements if not braced externally, including the existing timber rest pier.
2. The existing steel bascule span, steel bascule span support towers and steel approach spans on the west side of the bridge were significantly deteriorated and would require significant strengthening and repairs to maintain traffic once split in half. See Figures 1 and 2.
3. Updated AREMA standards imposed additional demands on the structure that would require extra repairs and strengthening. This included longitudinal braking and acceleration forces as well as lateral forces due to nosing and wind forces where load paths thru the altered structure were compromised.

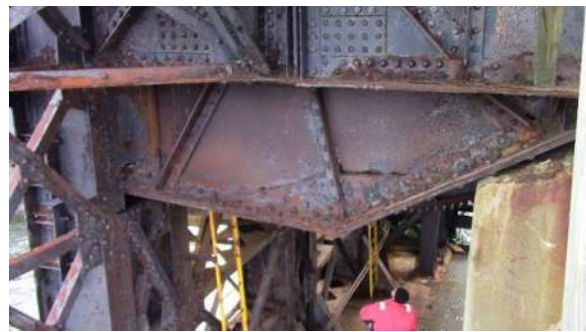
Figure 2: Bascule Girder Web Deterioration

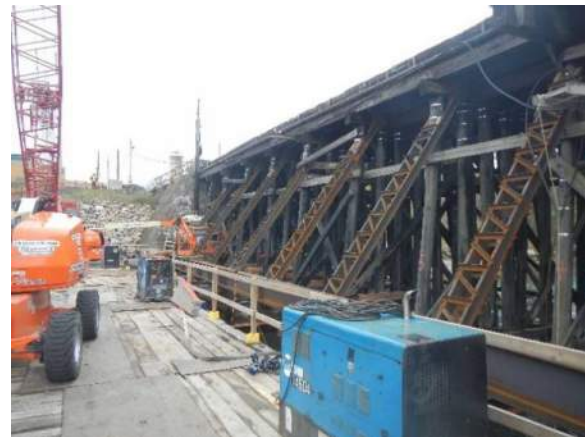
Figure 4: TTBS In Service

Design of an external bracing system for the timber trestle progressed and a Timber Trestle Bracing System (TTBS) was installed to allow the trestle to be split in half while still allowing commuter traffic during construction of the southeastern portion of the new bridge. See Figure 3 and 4. The work on the new structure included construction of the new bascule support piers, precast box spans and support piers as well as the new operator control house. The TTBS allowed for a significant amount of the construction activities to be completed without disruption to commuter operations.

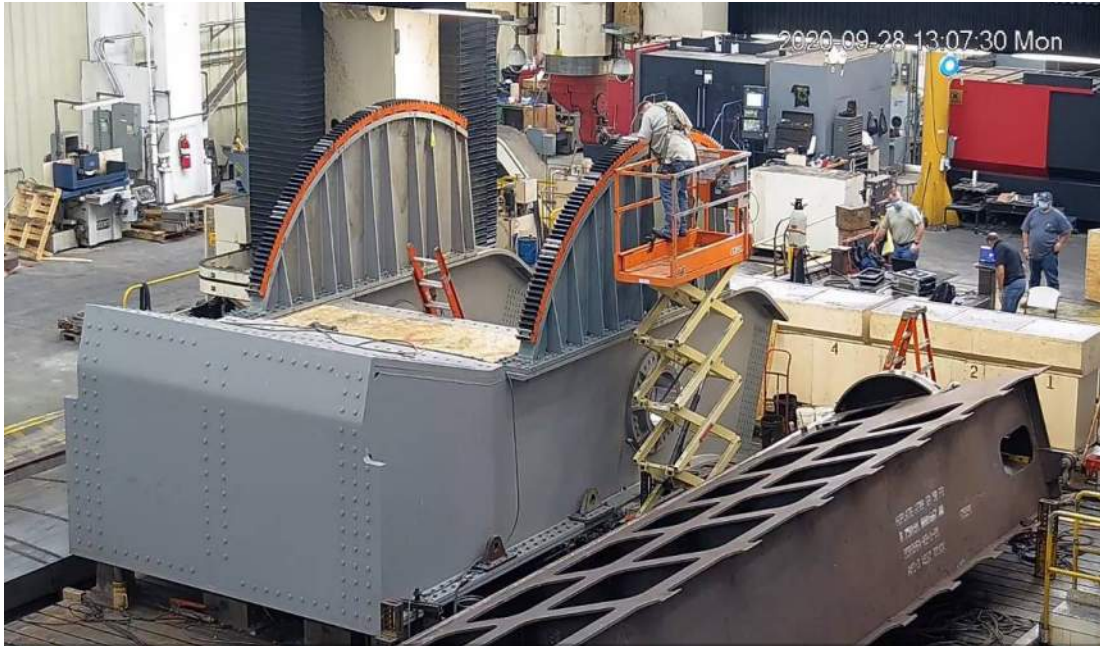
Figure 8: Screen capture during virtual shop inspection of the south bascule leaf

All of this work occurred during Covid lockdowns which presented schedule and logistical challenges. The image in Figure 8 below is a screen capture from a ‘virtual shop inspection’ that was live streamed for the contractor team as well as the Engineer of Record and other representatives for the MBTA.

To check the rack, a pin was set in the teeth and the centerline of the pin was located by sweeping around the ends of the pin with a probe. The pin was sized such that the centerline of the pin was at the pitch line of the rack when it was set in the valley between two teeth. These QC checks identified some issues that required rework that were related back to thickness variations in the paint on the faying surfaces between the rack and girder, which demonstrated the value of the checks and also highlighted how tight the tolerances are for the alignment of the racks.

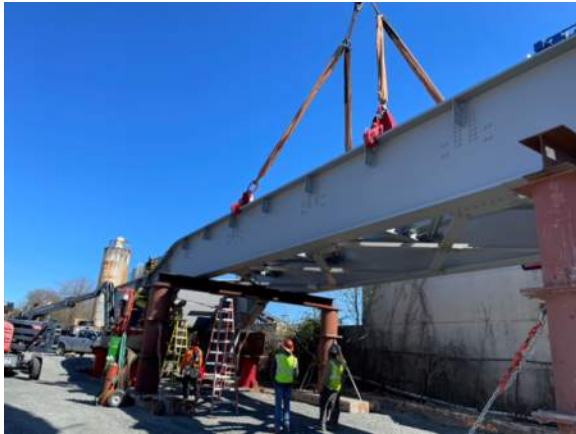
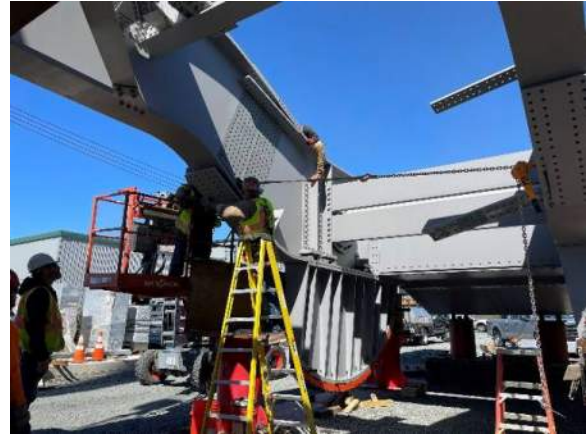
Figure 14: Leaf Assembly on the right of way. Setting the toe section (Left) and making the toe splice (Right)

6. The leaf was delivered to the site. Assembly of the leaf was performed a few hundred yards from the pier along the right of way. The heel section and toe section were spliced, and the racks were bolted to the bascule girders. See Figure 14. A laser tracker was used to recheck the rack alignment and adjustments were made as needed to obtain acceptable rack runout both radially and transversely.

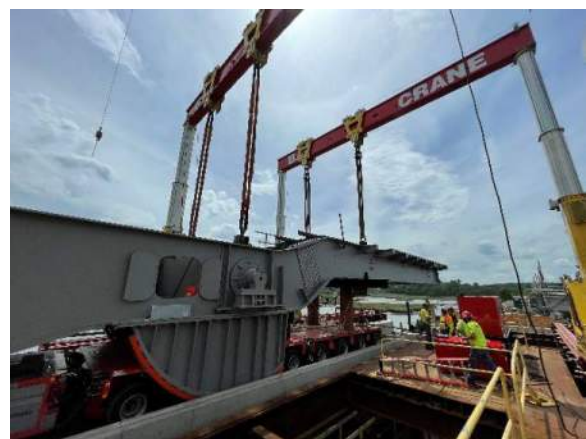
Figure 15: The leaf being moved under the hydraulic lifting gantries via a self-propelled modular transporter (Left) and rigged to be lifted by the hydraulic gantries (Right).

7. The construction of the leaf proceeded according to the plan for “Phase 1” balance. This located the leaf center of gravity around 10 feet forward of the trunnion to be centered between the pick points to be used by the gantry. Phase 1 balance included:
 - a. installation of all ties and the running rail, but not the guard rail.
 - b. The concrete floor and back wall of the adjustment pocket were also formed and poured and a portion of the lead ballast plates were installed.
8. The Enerpac hydraulic lifting gantries with side shifting header beams were brought to site and installed on the construction trestle.
9. A self-propelled modular transporter (SPMT) was driven under the leaf. The SPMT then raised up to lift the span off of its supports. The SPMT was used to drive the bascule leaf down the approach and into position underneath the hydraulic lifting gantries. See Figure 15.

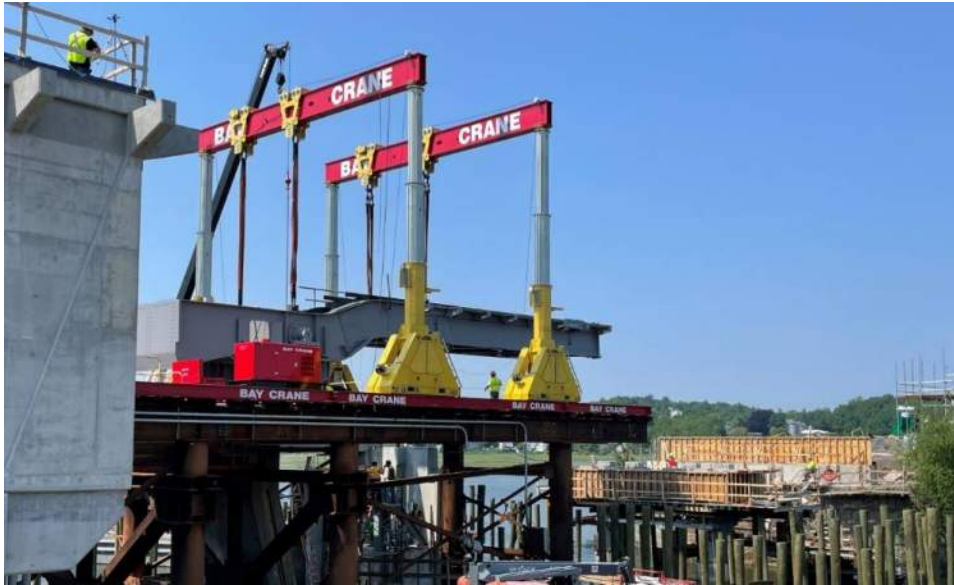
Figure 16: The leaf being moved over the pier via the hydraulic lifting gantries.

10. The leaf was lifted off the SPMT by the hydraulic lifting gantries. The hydraulic lifting gantries were then used to position the leaf over the pier. See Figure 16.

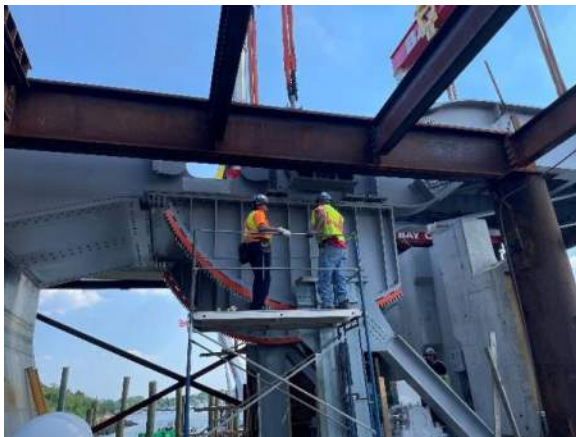
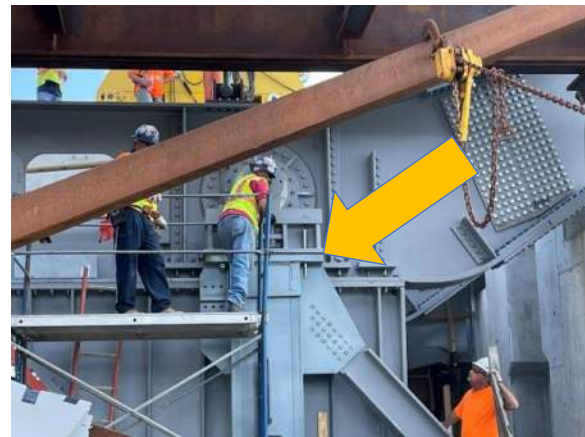
Figure 17: The leaf being lowered onto the tower (Left). The arrow indicates the alignment pin used to locate the leaf (Right).

11. The leaf was lowered onto the towers. As this was done, a tapered alignment pin was used to line up the fixed trunnion support on each tower. See Figure 17. Once the leaf landed, survey checks were performed to ensure that no adjustments to the leaf location were needed.

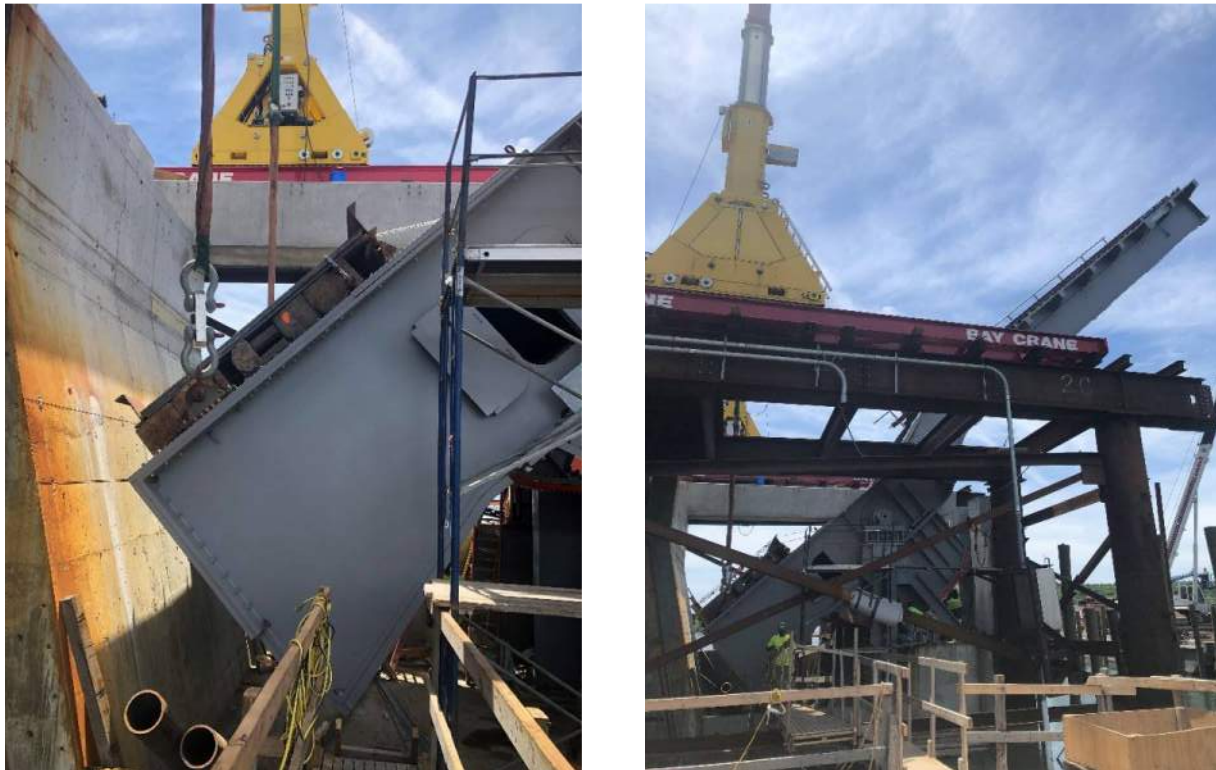
Figure 18: Two views of the leaf being raised via the gantry. The view on the left shows the temporary ballast for stage 2 balance.

12. The counterweight was filled for the “Stage 2” balance condition. The goal for the stage 2 balance was to make the leaf counterweight heavy to ensure that the leaf would remain in control when being operated via the gantry for the range of movement even if the wind direction was such that it would cause the leaf to close. The design wind pressure was 3 psf, which equates roughly to a 25 mph wind speed.

- a. The remaining lead plates were installed. Stage 1 balance had 26 plates and stage 2 had an additional 102 plates. Each lead plate weighs 1,600 lbs.

- b. Once the leaf plates were installed, a preliminary balance test was performed by jacking the toe of the leaf to measure the reaction. At this point it was determined that the actual imbalance was higher than the theoretical imbalance, likely due to variations in density of the timber ties. Some additional lead plates were installed to account for this variation.

- c. Concrete was poured to fill the rear compartment of the counterweight and the cover was installed.
 - d. Shoring posts were installed under the counterweight to support the leaf when it was made counterweight heavy temporarily for the gantry operation.
 - e. A timber crane mat was placed on top of the counterweight, along with some large steel plates that had been placed on the railroad ballast for the SPMT to drive on.
13. A gantry was positioned over the counterweight, the pad eyes were installed, and the gantry was hooked up and lifted to take the load off of the shoring posts under the counterweight. The gantry then lowered the counterweight, raising the leaf to the open position.

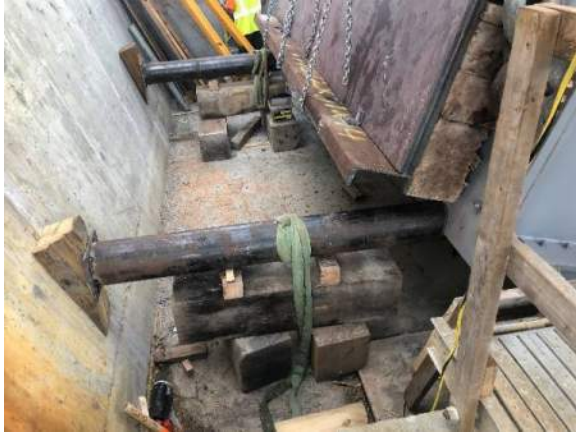
Figure 19: Restraints installed to secure the leaf in the open position.

14. Once in the open position, the leaf was positioned against the bumper blocks and the gantry was disconnected and removed. Since the leaf would remain in the open position for an extended period, pipe restraints were added between the counterweight and the pier wall to secure the leaf against high winds. See Figure 19. The Contractor met the deadline to have the leaf open for the weekend boaters.
