**HEAVY MOVABLE STRUCTURES, INC.
TWENTIETH BIENNIAL SYMPOSIUM**

**Glimmer Glass Bridge: A Moving Piece of
History – A Comprehensive Guide to
Preservation Techniques for a Uniquely
Historic Structure**

Joseph R. Strafaci, PhD, PE. MBA
HNTB Corporation

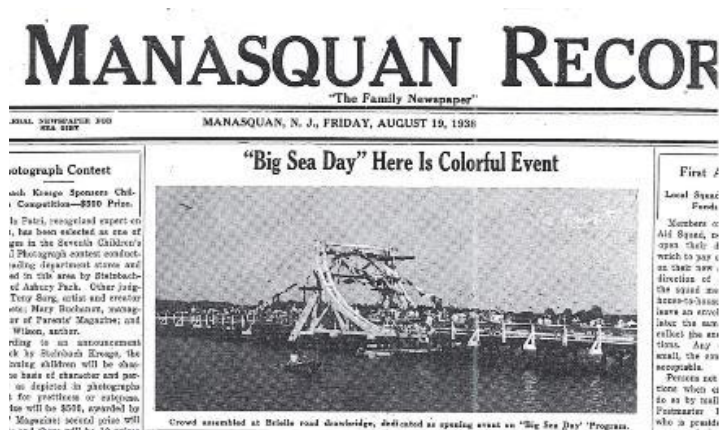
Manasquan Record, August 19, 1938 showing the Glimmer Glass Still Under Construction

The Glimmer Glass was originally constructed in 1938. This is supported by the NBIS inspection report, and various records in the County's archives. Including a photograph from the Manasquan Record showing the bridge under construction on August 19, 1938. Following its initial construction, W-9 was raised approximately 5 feet at the navigation channel in 1949 resulting in the reconstruction of timber pile bents, bulkhead roadway approaches, and the tender house.

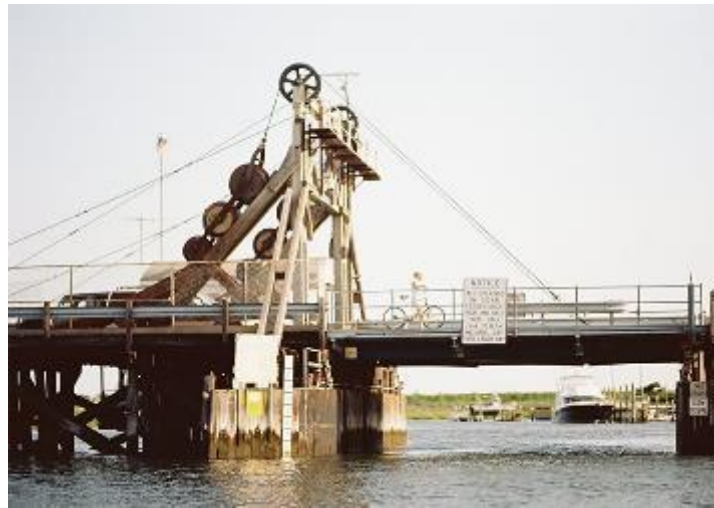
Elevation View of the Glimmer Glass in 1970's
