# "Design Considerations for Replacement of Two Historic AMTRAK Movable Bridges"

by Christian J. Brown and Mark W. Green HNTB Corporation

# Structure Type Selection and Design Considerations for the Replacement of Two Historic AMTRAK Movable Bridges

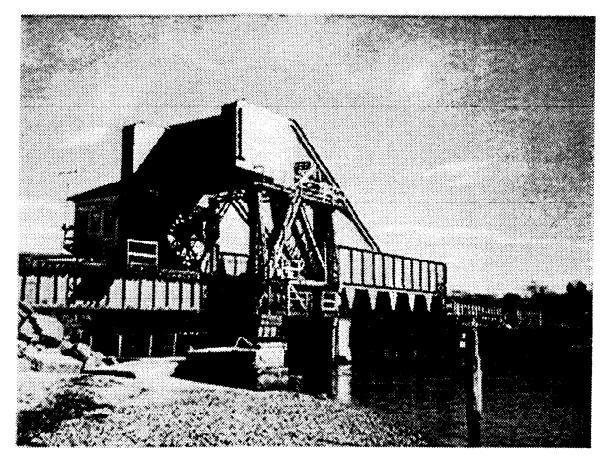
Figure 2 - AMTRAK Bridge 116.74 over the Niantic River

The King Bridge Company of Cleveland, Ohio, constructed the Niantic River Bridge in 1907, however, Mr. William Scherzer originally patented the design in 1893. Due to the historical nature of the draw span, the Niantic River Bridge has been documented to Historic American Engineering Record standards and is archived at the Library of Congress. A photograph of the bridge is shown in Figure 2.

The existing bridge consists of five spans as follows:

Span 1 50'-0" Deck plate girder span

Span 2 26'-0" Deck plate girder span

Span 3 69'-3" Through girder draw span (movable span)

Span 4 70'-3" Deck plate girder span

Span 5 76'-2" Deck plate girder span

The spans total 291'-8" of bridge length from centerline of bearing to centerline of bearing at abutments. The double track bridge is supported on masonry piers and abutments. The historic bascule span is a through girder structure that is 68 feet long from center of roll to centerline of bearing at the rest end. The structure provides 11 feet of vertical clearance above mean high water elevation. The existing horizontal navigational clearance is approximately 40 feet.

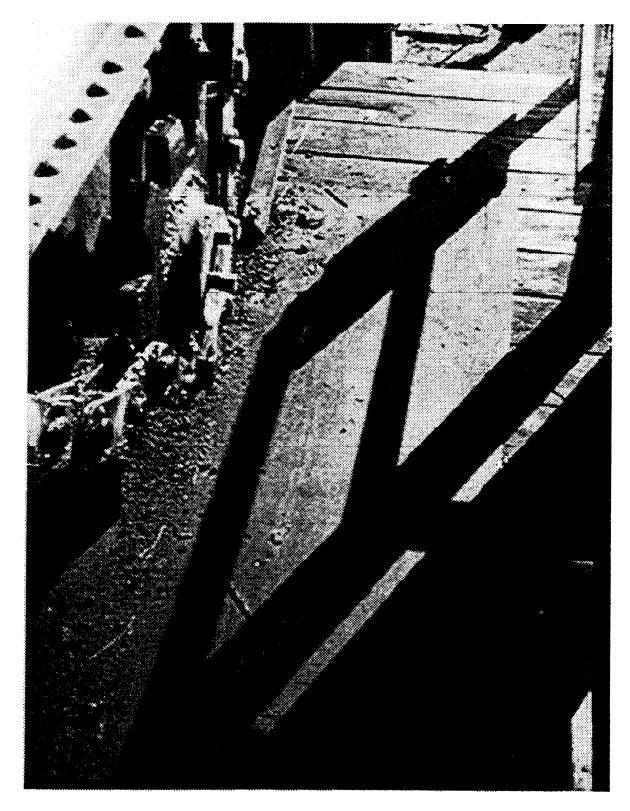
Figure 3 - AMTRAK Bridge 116.74 Chain Drive

The principal features of the bridge are its historical nature, and the chain drive mechanism, shown in Figure 3, that operates the movable span. The chain drive mechanical system has caused some operational difficulties in the past 15 years. Efforts to adjust or tighten the chains have caused uneven roll and some misalignment during seating of the bridge. In addition, the segmental rolling girders have had some performance problems, and misalignment of the girder on the track pintles has been observed. This continued misalignment has further caused accelerated wear in the operating gear train which compromises the ability to reliably open and close the span. In its current condition, the draw span runs a risk of failure to operate as required by the United States Coast Guard.

Of the bascule bridges on the Northeast Corridor, the Niantic River Bridge is the only chain driven version. The chain driven bascule was an innovation at the time, and was developed to allow the drive mechanism to be located below the track. The drive mechanism is typically located with the counterweight on a rolling bascule bridge. By placing the mechanism below the track, accessibility for maintenance and repairs is easier. The belowtrack location also affords more protection from weather and vibration. These special variations of the Niantic River Bridge were designed in January 1907. In March of that year, a local contractor, John Y. Higginson of Niantic, constructed the masonry piers. The structure was erected in August of 1907 by the American Contracting Company and the King Bridge Company of Cleveland.

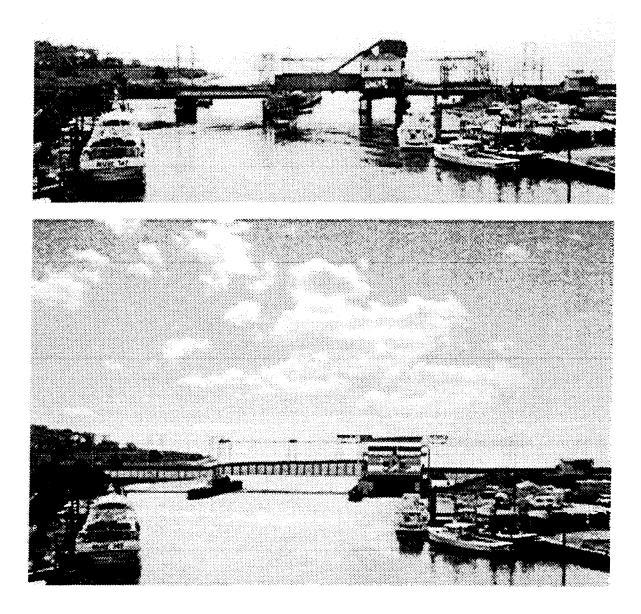
#### Figure 4 - Existing (top) and Proposed Bridge 116.74 over the Niantic River

From the Evaluation Matrix results, Option 6B was identified as the most appropriate option for replacement. The recommended option, which calls for replacing the existing bascule span and approach spans off-line with a trunnion bascule span, will provide a new draw span with increased horizontal and vertical (span down) clearances offering many years of reliable service with minimal impacts on the environment. The existing bridge and a rendering of the proposed bridge replacement option are shown in Figure 4. It is also recommended that the new approach alignment be placed on a fill embankment.

The bridge off-line replacement study assumed a new bridge with the following features:

- A centerline approximately 50' south of the centerline of the existing bridge.
- The bridge layout would consist of three deck plate girder approach spans and one 120' through plate girder bascule span providing approximately 110' of horizontal navigation clearance.

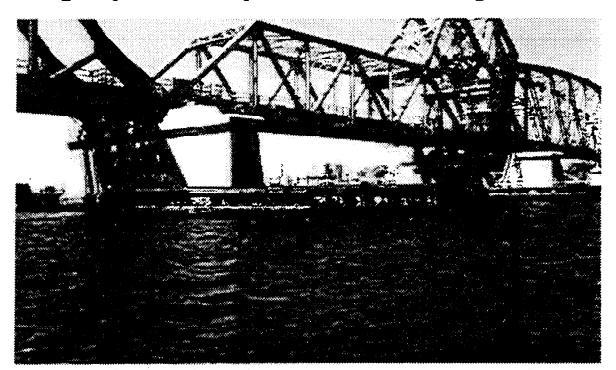
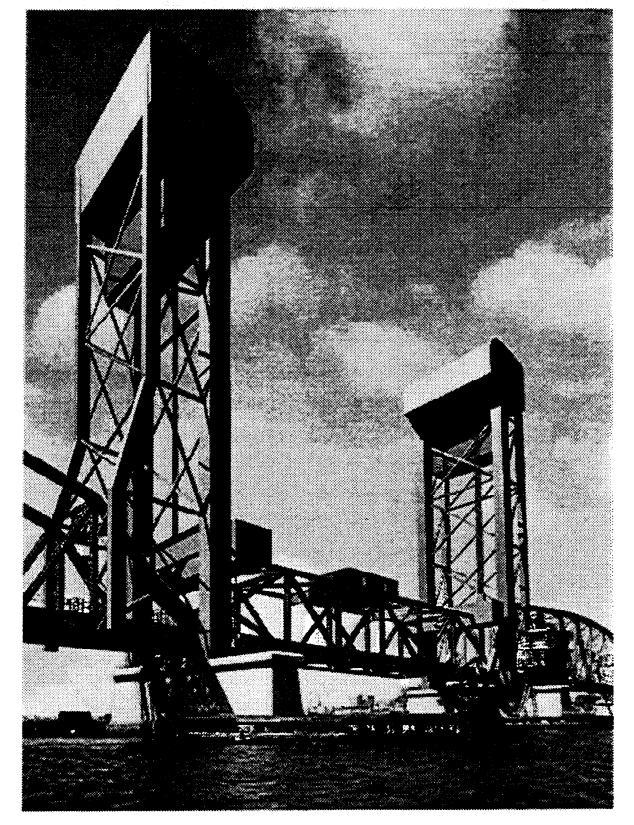
#### Figure 5 - Existing (top) and Proposed Bridge 124.09 over the Thames River

The American Bridge Company constructed the Thames River Bridge between 1917 and 1919 for the New York, New Haven, and Hartford Railroad. AMTRAK Bridge 124.09 over the Thames River was deemed eligible for the National Register in 1977, and was formally placed on the National Register on June 12, 1987. The bridge consists of two through truss approach spans at each end of a through truss bascule span. The five spans total 1,394 feet in length.

The structure is a double-track bridge supported by masonry piers and abutments originally constructed to accommodate four tracks. The 188-foot long bascule span is a Strauss heel trunnion design. The Strauss design was patented by Joseph B. Strauss in 1905 and is one of the two remaining in the State of Connecticut. Vertical clearance over mean high water is approximately 29 feet. Timber fenders extend both sides of the bridge on each side of the 150 foot wide channel. In the open position the draw span angle of opening is 82° 30', providing a 150 foot horizontal clear channel; however, the vertical clearance at the west fender is limited to about 130 feet. Approximately 12 feet out from the west fender the vertical clearance is unlimited. The structure is unusual in that the bascule span is supported by the approach truss spans at either end. The main trunnion bearing is supported by a cantilever extending from Span B, and the toe of the bascule span is supported by a cantilever extending from Span D.

The existing bridge and a rendering of the proposed bridge replacement option are shown in Figure 5.
