HEAVY MOVABLE STRUCTURES, INC. THIRTEINTH BIENNIAL SYMPOSIUM

Rehabilitation and Remote Controlled Operation of a 115 Year Old Swing Span

Geoffrey L. Forest, P.E.

Rehabilitation of Norfolk Southern Bridge No. HE-3.77 (Shellpot Bridge) Rehabilitation and Remote Controlled Operation of a 115 Year Old Swing Span

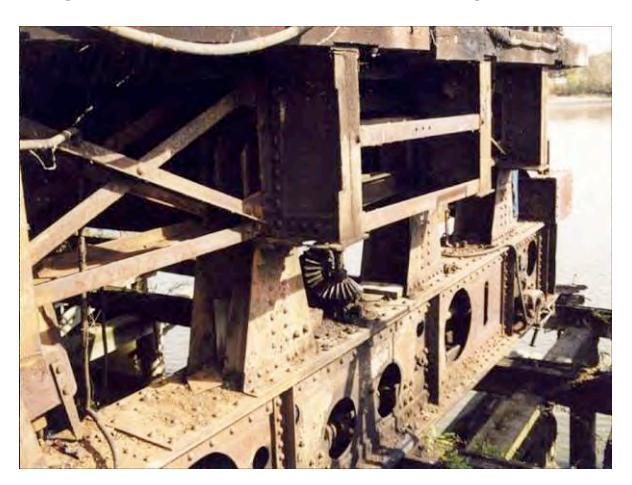
Existing End Floorbeam Machinery

An in-depth inspection and rating was performed and in 2002, the existing span drive system consisted of a single electric motor and open gearing to operate two pinions which engaged a curved rack gear fixed to the pivot pier. Severe wear was prevalent in the machinery. The end floorbeam machinery was comprised of wedges, end lift rollers, and rail lifts. All of the end floorbeam machinery was driven by a common shaft, which was operated by a single electric motor at the center of the span. The level of corrosion and wear present in the end floorbeam machinery was unknown prior to disassembly. Despite the severe wear in the existing machinery, the span drive machinery and end floorbeam machinery was still operable.

The end floorbeam machinery was disassembled cleaned. Upon inspection, severe wear was discovered on a majority of the parts. The heavily loaded end lift and wedge pivot pins and shoulder bolts had large steps and grooves. It became obvious that nearly all of the end lift machinery would need to be replaced.

To avoid delaying the construction schedule, it was decided to design new components to replace the existing machinery in-kind rather than design a new machinery arrangement. Newer methods of accomplishing the machinery movements desired would have been simpler, but would have taken more time to design. Therefore, the machinery design from 1888 was re-created with new components.

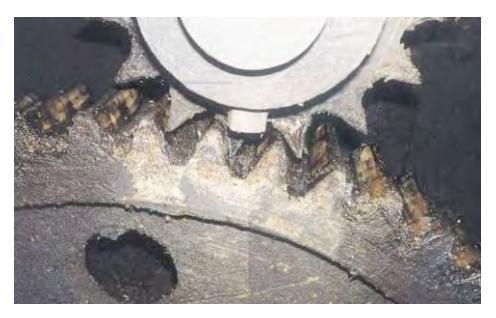
Severe Wear on Open Gearing

The span drive machinery arrangement was to be completely replaced with two independent drive trains for redundancy which would load share electrically. The end lift machinery was to be disassembled, inspected, and cleaned, with new components fabricated as needed. The rim bearing rollers were to be cleaned, inspected, and re-used, while new upper and lower tread plates were designed to match the new drum girder and pivot pier cap. A new center post was also designed to center the new drum girder as well as a new rod assembly to keep the rim bearing rollers centered.

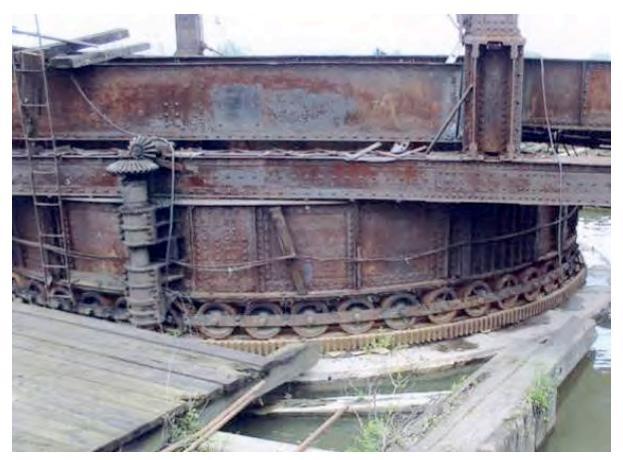
The span support and turning machinery consisted of 55 conical rollers, with tapered upper and lower tread plates. The rollers supported a circular drum girder which, in turn, supported the swing span trusses. The axles of the rollers were connected to rods which connected to a ring at the center of rotation. The drum girder was supported by eight

Existing Drum Girder and Rim Bearing Rollers

beams oriented radially from the drum to a center pivot post, which dictated the center of rotation of the span. The drum girder was in poor condition with cracked weld repairs and significant corrosion of the steel. The pivot pier top was at an elevation that was susceptible to flooding, which deteriorated the rollers and lower tread assemblies.

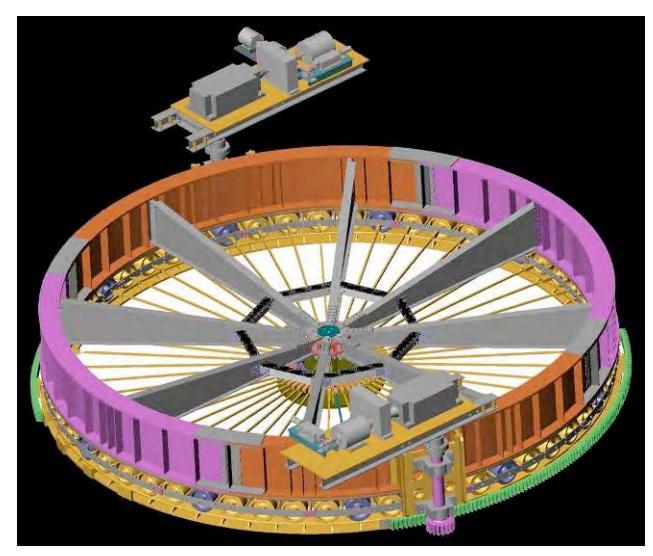
New Span Drive and Rim Bearing Assembly Model

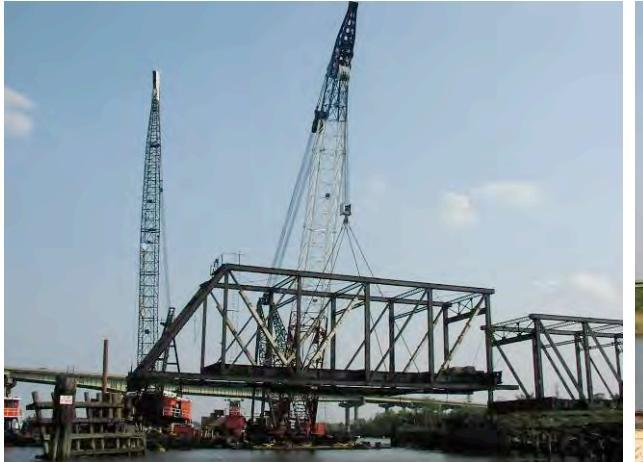
Removing the First Half of the Swing Span Truss

The first step in construction was to remove the swing span from the pivot pier. The swing span was moved to the closed position and the two arms were separated. Instead of using tidal action to float the

spans out of position, the Contractor elected to use a 200 ton crane to pick each arm of the swing span and place them on barges. The barges were then moved, via tugboat, from Wilmington, DE to the Contractor's yard near Baltimore, MD where all of the structural repairs to the swing span trusses were able to be performed.

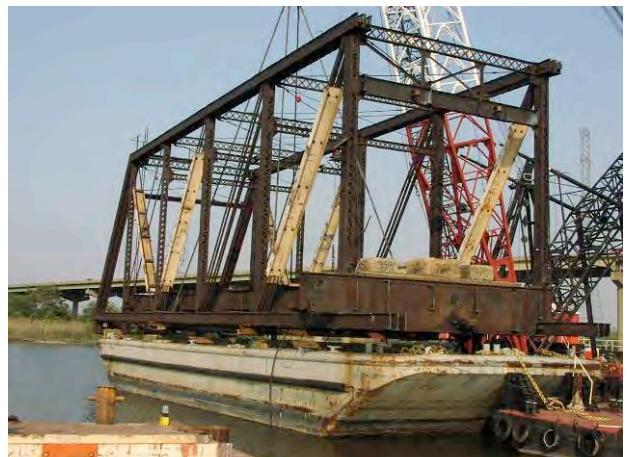
Half of Swing Span Truss on Barge Ready for Shipment to Baltimore, MD

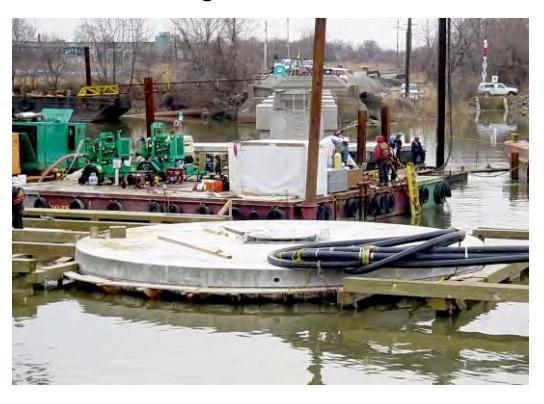
The approach span beams were removed from the approach bents and barged to the Contractor's yard. With the swing span removed, the remaining machinery was removed from the pivot and rest piers, and new pier caps were poured to raise the elevation of the swing span.

New Pier Cap on Pivot Pier to Raise Elevation of Swing Span

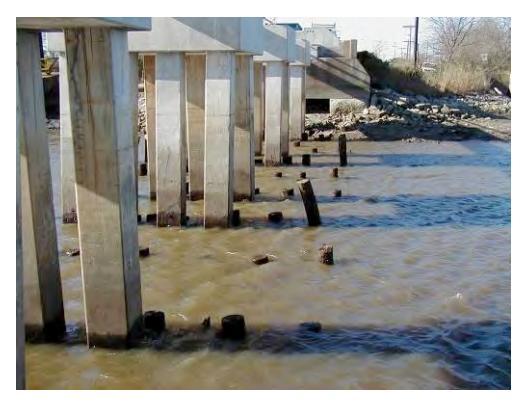
New Approach Bents Built Among Existing Piles

New approach bents were built by driving prestressed concrete piles and placing pre-cast concrete caps on the piles. The pre-cast caps were fabricated with holes to fit over the tops of the piles, which were filled with concrete once the caps were placed on the piles. A challenge when driving the new piles was interference from the old timber piles from the original timber approaches (which were replaced in 1950).

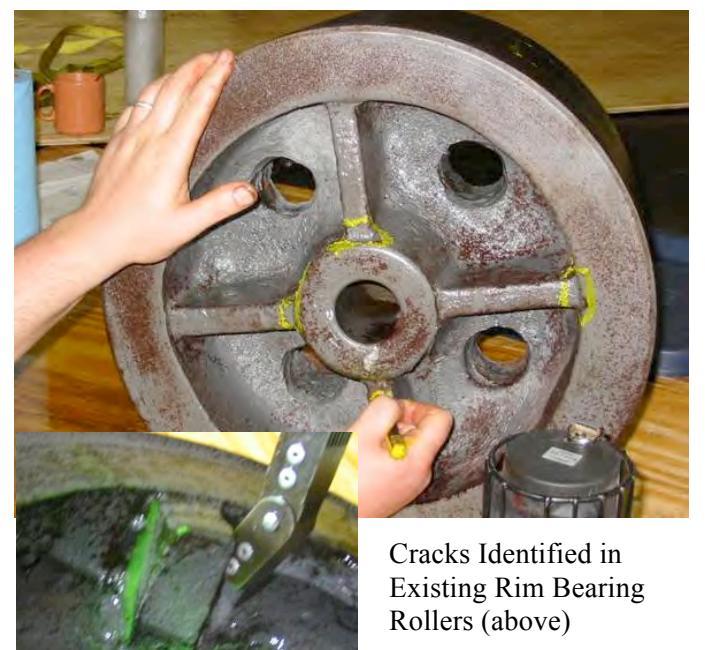
Close View of Crack in Web near Stiffener (left)

The rim bearing rollers were sent to the machinery fabricator for cleaning and inspection. Mag-particle tests discovered cracks at the junction of the web stiffeners and the hub as well as the wheel rim were widespread among the rollers. It was decided to scrap all 55 of the existing rim bearing rollers and fabricate new rollers. The design for the new rollers was created and sent to the fabricator. The new rollers were cut from a

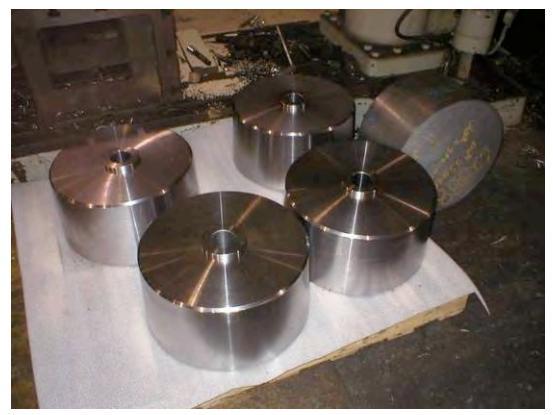
solid cylindrical forging and machined to the final dimensions. To ensure even distribution of the live load and dead load of the span across the rim bearing rollers, the pitch diameter of the conical rollers was held to ± 0.002 ".

New Rim Bearing Rollers

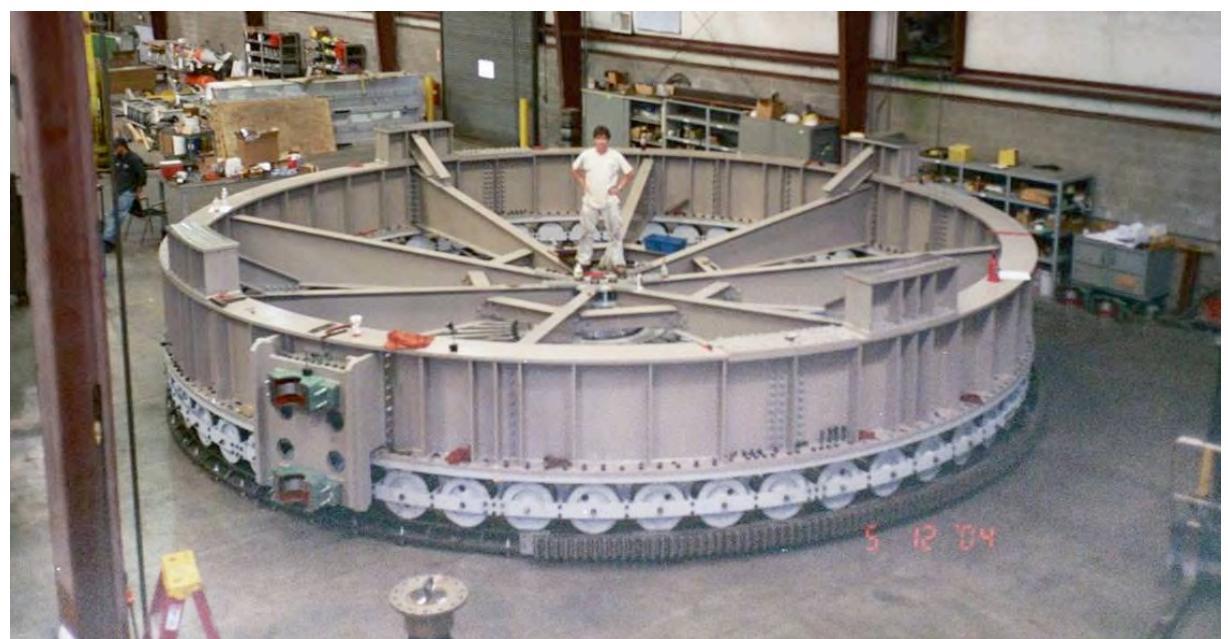
The entire span supporting assembly was assembled in the fabricator's shop to check fit of the components and concentricity of the rack gear with respect to the center of rotation of the drum girder. The backlash between the rack and pinion gearing was also verified and maintained in the proper range of 0.090" to 0.120".

Rim Bearing and Drum Girder Assembly Shop Test

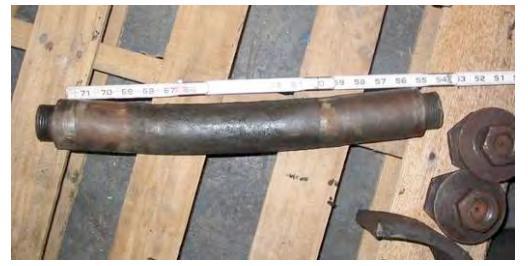
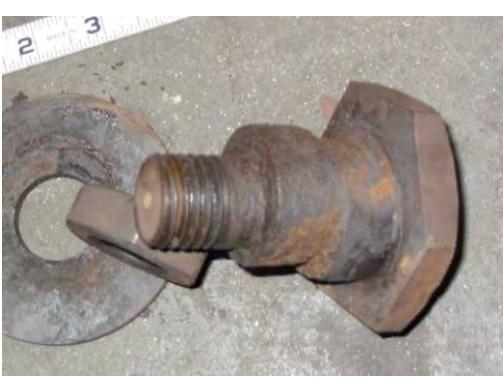
End Floorbeam Machinery Components with Severe Wear

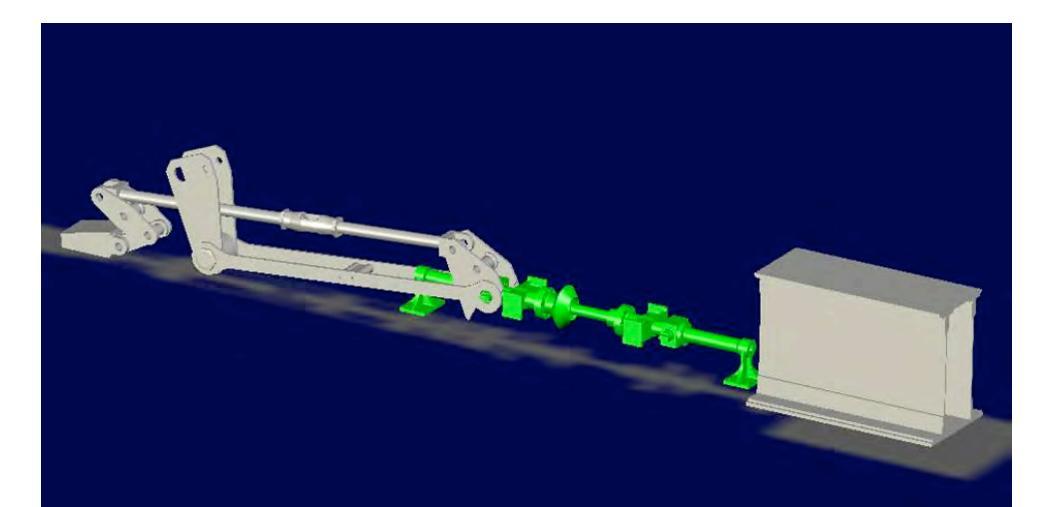
The end floorbeam machinery arrangement is a complex system of power screws, cams, and linkages. With only one input shaft, the machinery accomplishes three tasks:

- End lift rollers swing to lift the end of the swing span and then lower it back down after the wedges have driven/retracted
- End wedges drive or retract
- Rail lift beam raises or lowers the rails

These tasks must be timed appropriately so that the wedges drive or retract while the end of the span is lifted.

Model of End Floorbeam Machinery Assembly

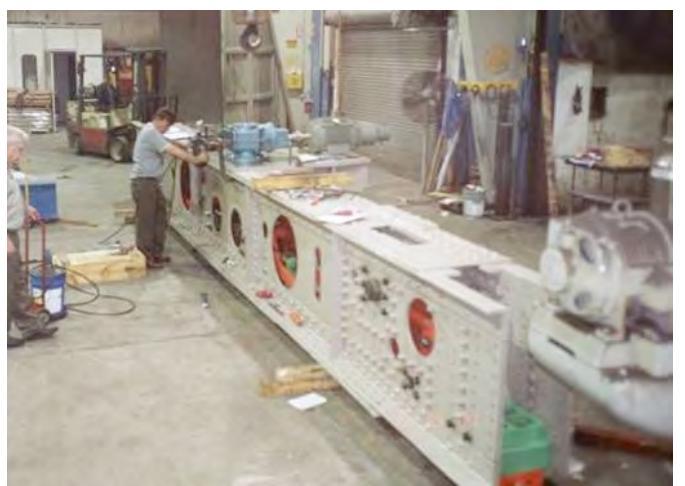
The end floorbeam machinery was treated as a design-build to save time on the schedule. Shop drawings were developed and delivered to the machinery fabricator who made the parts and assembled the end floorbeams in the shop. The assemblies were operated in the shop in a no-load condition to verify operability and check for any clearance issues or binding.

End Floorbeam Machinery Assembled in Shop

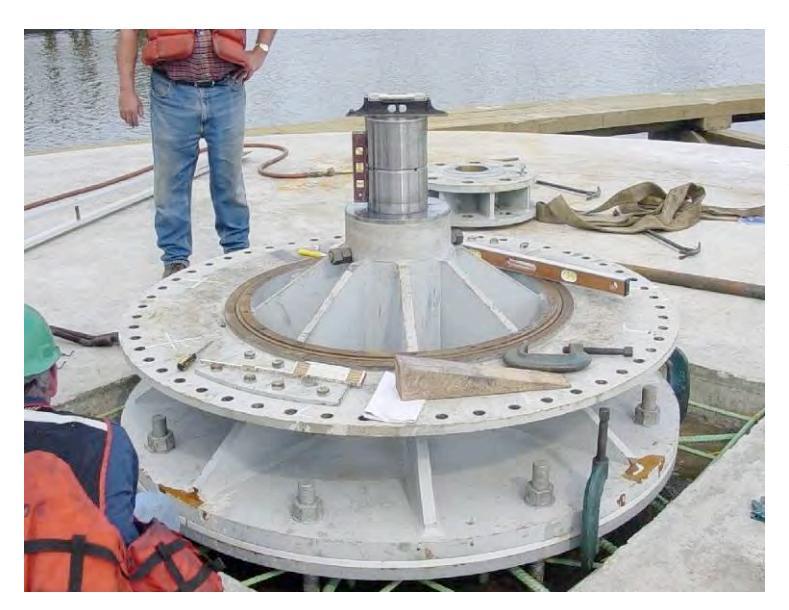
Installation of the span support machinery on the pivot pier began with the center post. Accurately setting the position and elevation of the center post was crucial to proper alignment of the tracks where the swing span met the approaches. Once the location was finalized, the center post was leveled and anchored to the center of the pivot pier.

Center Post Assembly Set and Leveled on Center of Pivot Pier

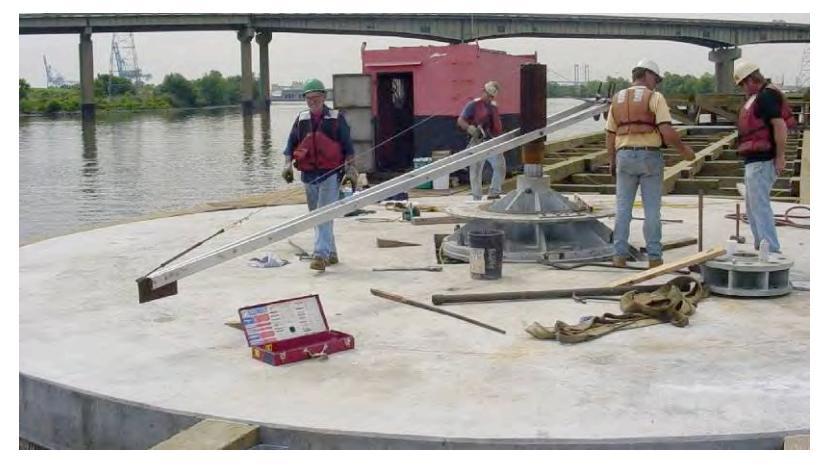
With the center post installed, a measuring jig was placed over the machined portion of the post. This jig, basically an over-sized compass, served to measure the radius and runout of the lower tread plate. Dial indicators on the end of the jig were able to measure changes in radius and elevation of the lower tread plate by swinging the jig around the center post. During the installation of the tread plates, the concentricity of the upper and lower tapered tread plates was held at 0.060" T.I.R. with respect to

Measuring Jig Installed on Center Post

the center of rotation of the span, and the elevation of the lower track was to be held to ± 0.010 ". This precision was an attempt to ensure contact between all rollers and the upper and lower tread plates at all opening positions of the swing span.

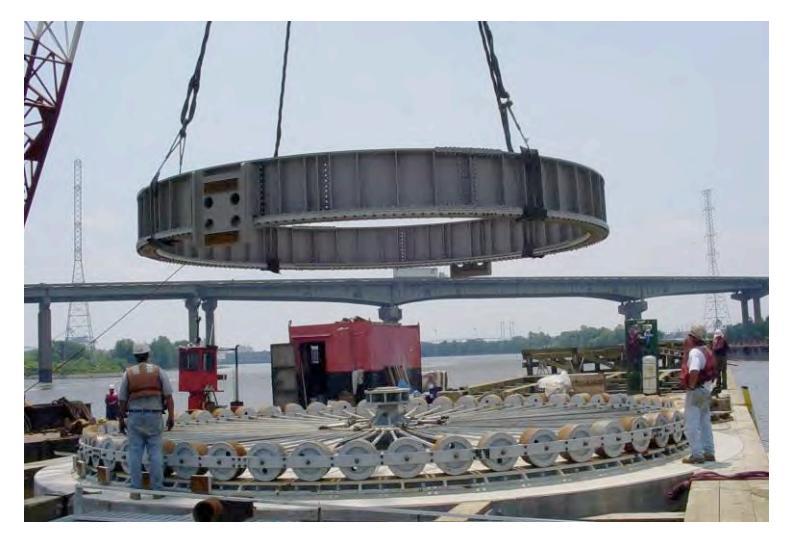
Drum Girder being Placed on Rim Bearing Rollers, Previously Installed on Pivot Pier

While the lower tread plate was aligned on the pivot pier, the drum girder was assembled on the adjacent pivot pier fender system. When the lower tread alignment was complete, the 55 new rim bearing rollers were placed on the tread plate and attached to the central ring on the center post support. The drum girder was then placed on the rollers.

Checking the contact between the rollers and the upper and lower tread plates was a lengthy process which involved checking for clearance with feeler gauges at every wheel for several rotational positions of the drum girder. Once measurements were taken, the

rollers could be individually adjusted radially in or out as needed. After adjustments were completed, the majority of the rollers had good contact through the 90° rotation that the swing span would operate within. During operation, some rollers would stop rotating and start again, indicating variations in either the elevation or radius of the lower tread plate that were large enough to create a space between the roller and the tread plate. However, since no single roller consistently lost contact, no further adjustment to the radial position of the rollers could be made.

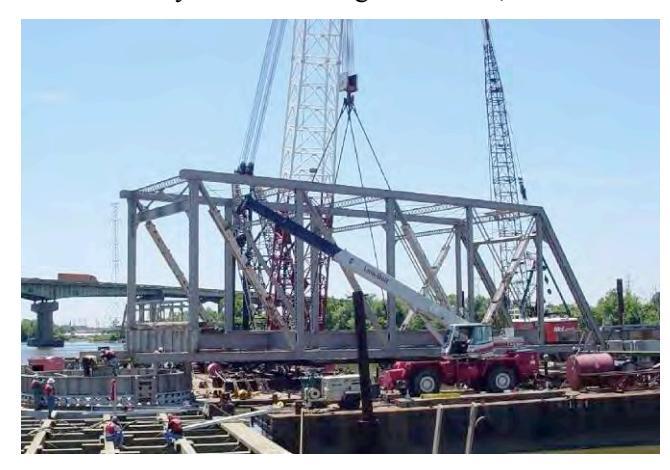
South Arm of Swing Span Truss placed in Position

end floorbeam was placed on the south rest pier and wedges were used to hold the floorbeam in the proper position. Bolsters were bolted to the top of the drum girder and the south truss of the swing span was placed in position on the drum girder and the end floorbeam and held there by crane until the attachments were completed. The end floorbeams attach to the end panel of the swing span truss with pins, which were driven once the span was in position. The end floorbeam machinery was operated manually to drive the wedges so that the dead load of the span could bear on the rest pier properly. With the end floorbeam truss pins in place, the stringers were installed in the end panel of the truss.

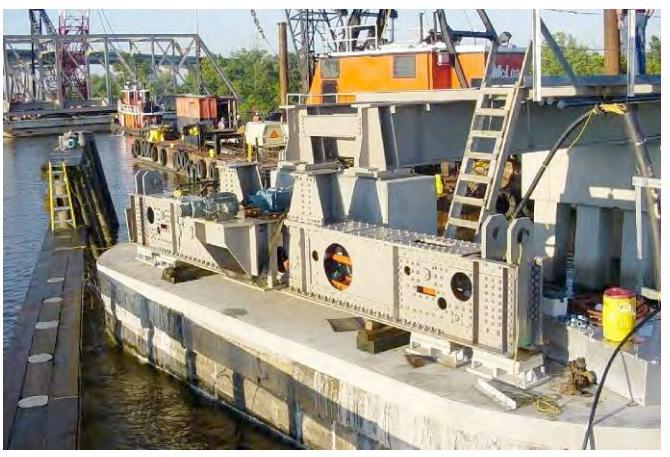
South End Floorbeam Placed on Rest Pier Awaiting Swing Span truss Placement

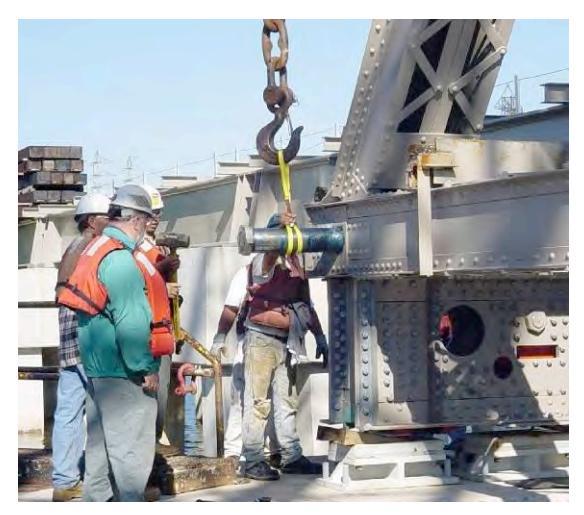
Over the next two days, the eyebars which connect the upper chords of the two arms were installed. Four eyebars make up the connection at each upper chord. To install the truss pin through the truss joint and all four eyebars, the end of the one of the swing span arms was jacked to align the pin holes, and the pins were installed

Installing End Floorbeam Truss Pin

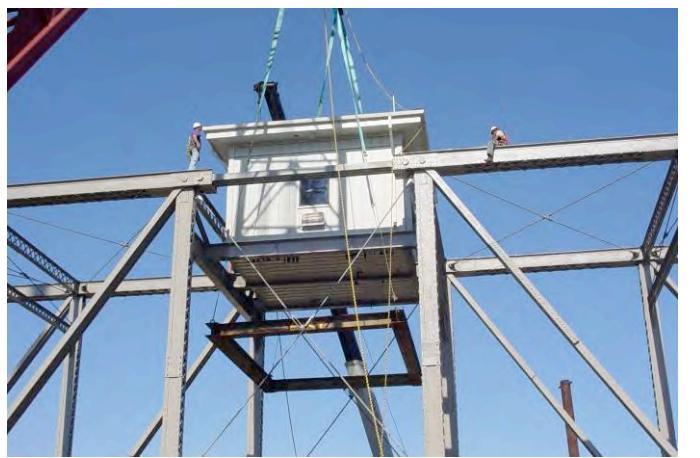
New Operator's House being Placed into Position

While the swing span trusses were being rehabilitated, a new operator's house was built near the north abutment of the bridge. The house and support platform were constructed on a lifting frame of steel beams. Once the two arms of the swing span were installed and rotated to the open position, the operator's house was lifted into position on the truss and bolted to the upper lateral bracing at the center panel of the swing span truss. With the house in place, the installation of the electrical drive and control equipment could begin, all of which would be contained in the operator's house.

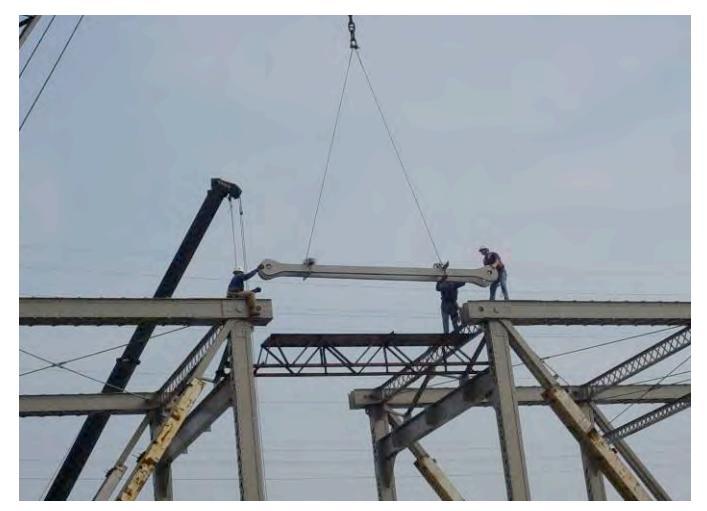
Installing Eyebars at Truss Upper Chords

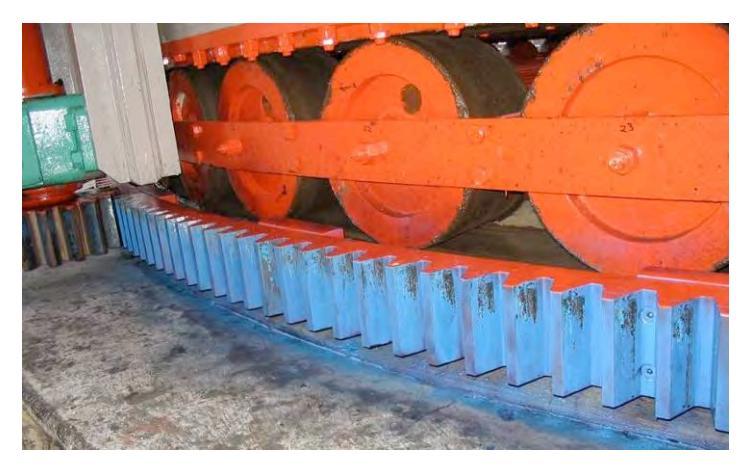
The span drive machinery installation began with the main pinions which are integral with their shafts. Since the swing span would only rotate in one direction, two rack gear segments, each spanning an arc of 90°, were bolted to the lower tread plate support. The pinions were aligned with the rack gear segments and the pinion bearings were bolted to the drum girder with undersized bolts. Alignment was initially checked by measuring the backlash between the pinions and racks, however

cleaning the gear teeth and applying blue layout dye was the most direct method to observe the contact pattern.

Blue Layout Dye on Rack Gear Teeth to Check Contact pattern

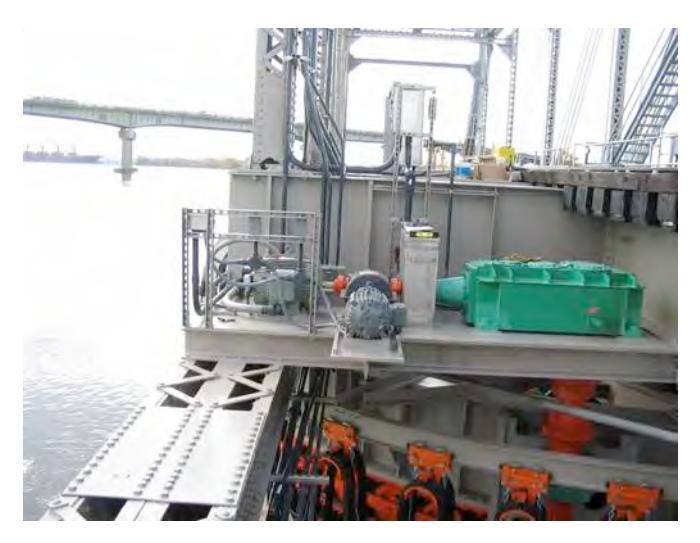
Span Drive Machinery, Shop Aligned on a Common Bedplate, Installed on Span

Once the pinions/shafts were located in the correct positions, the span drive machinery was positioned above the pinion shaft. The span drive machinery was previously installed on a common bed plate and aligned at the shop. A short vertical floating shaft served to connect the span drive machinery to the pinion shaft.

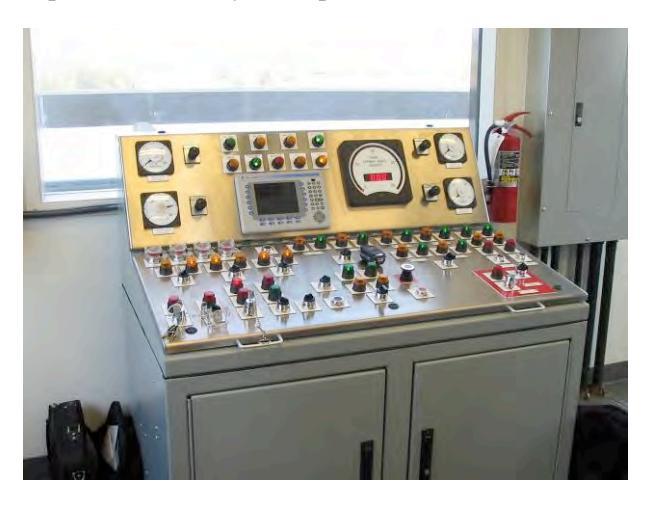
The PLC based control system was installed in the operator's house, along with the two motor drives and the main control console. Since the span would be operated remotely, the operator's house would

Control Console in Operator's House

normally be unmanned. The span would remain open to marine traffic until an approaching train would require the span to move to the closed position. The operation would be controlled from the dispatch station approximately 100 miles away in Harrisburg, PA. In order for maintenance personnel to access the swing span, a small control console was installed in a cabinet on the south rest pier. Control from this console was limited to span operations using the main drive motors or the auxiliary drive motor. Any system faults that would require safety bypasses to be engaged had to be performed from the main control console inside the operator's house.

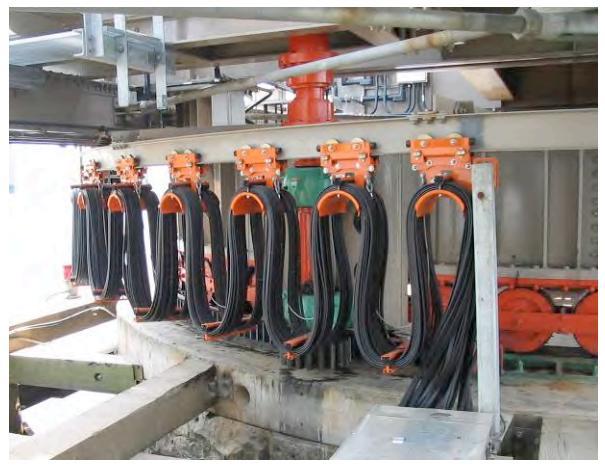
terminal cabinets anchored to the fender. Power and controls were transferred to the swing span using a festoon cable system. The festoon cable trucks ride on a curved beam attached to the swing span. When the span is open, all the trucks are gathered close to each other. When the span closes, the cable pays out by pulling the trucks farther apart.

Festoon Cable with Span in Open Position

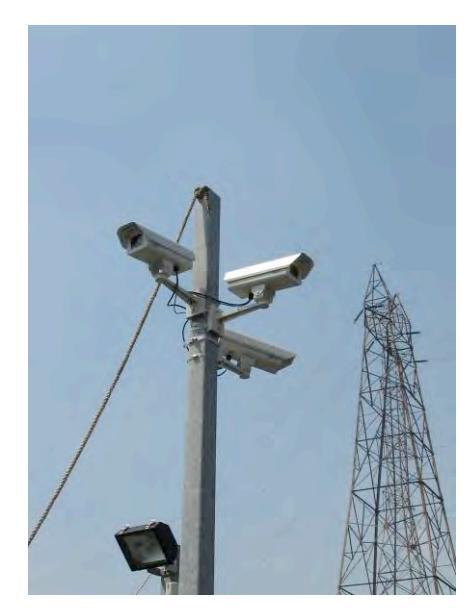
CCTV Cameras for Remote Monitoring of Channel and Bridge Area

For safe remote operation of the swing span, CCTV cameras and a PA system were installed so that the railroad dispatch could monitor the bridge site and communicate with someone near the bridge. Boat detectors (infrared transmitters and receivers) were installed on the fenders which would halt the current operation of the span and move the span back to the open position if an object moved into the channel during a bridge operation. A normal remote-controlled operation process starts by the dispatcher initiating an operation 10 minutes prior to the operation. An audible warning sounds and an automated recording states that the bridge will be opening in 10 minutes. There are similar audible warnings for 5 minutes and 1 minute. The span swings to the closed position and the end floorbeam machinery activated to drive the wedges and lower the rails. When this occurs, the dispatcher receives a signal

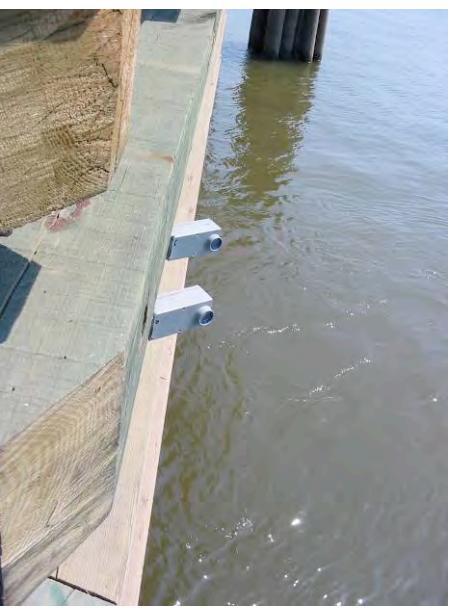
Fender-Mounted Boat Detectors to Ensure the Navigational Channels are Clear during Bridge Operations
