Counterweight Rope Replacement On The Murray Morgan Lift Bridge

By: Frank Marzella, PE Hardesty & Hanover, LLP

HEAVY MOVABLE STRUCTURES, INC. 13th Biennial Movable Bridge Symposium

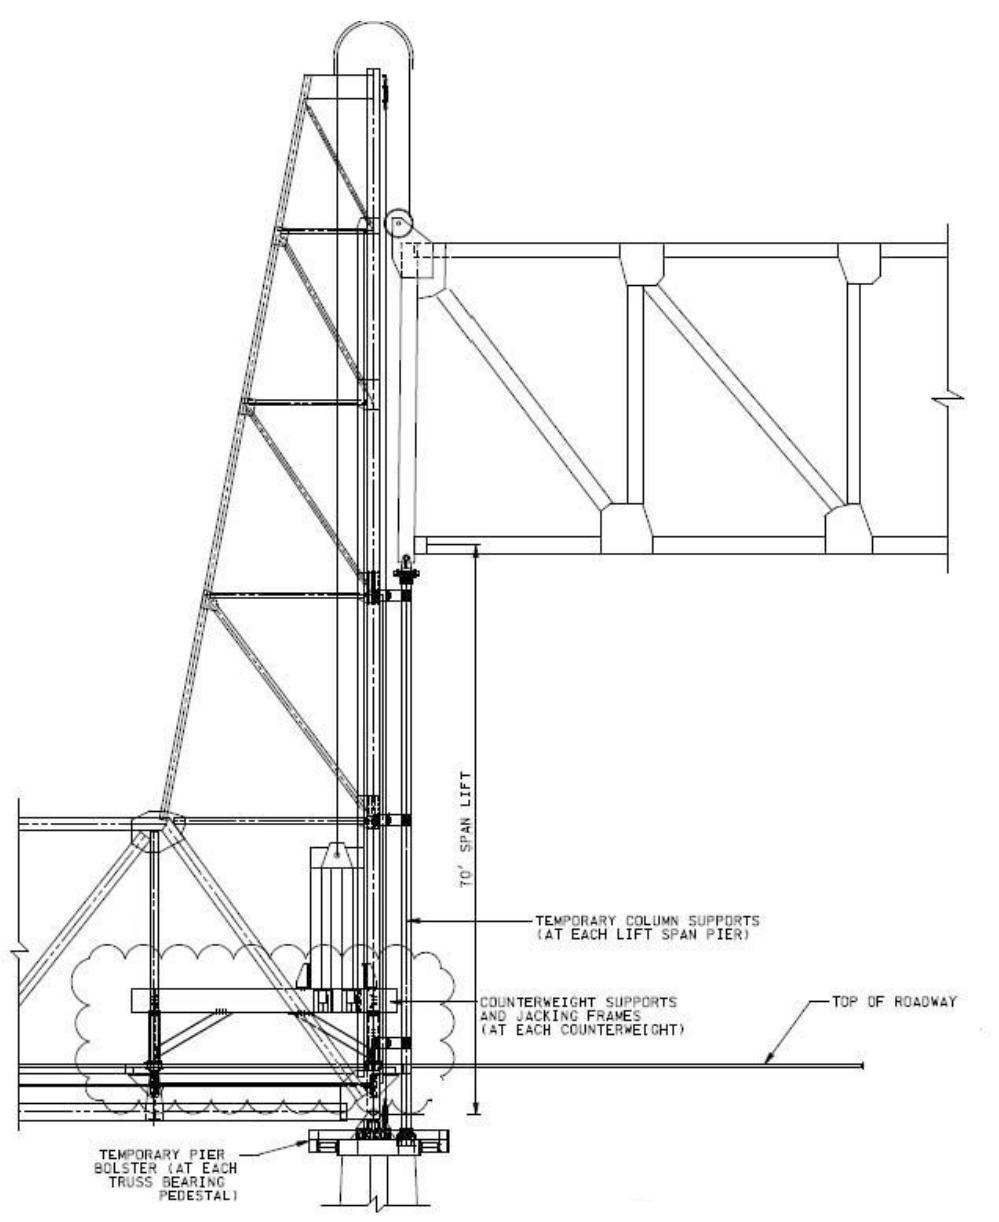
Figure 1: Lift Span and Counterweight Support Concept

The general arrangement of the temporary lift span and counterweight supports is shown in Figures 1.

Four steel W14 x 120 columns were placed under each live load shoe of the lift span. Each column was anchored longitudinally to the front lift tower leg structural steel and the column bases were anchored to the pier cap concrete.

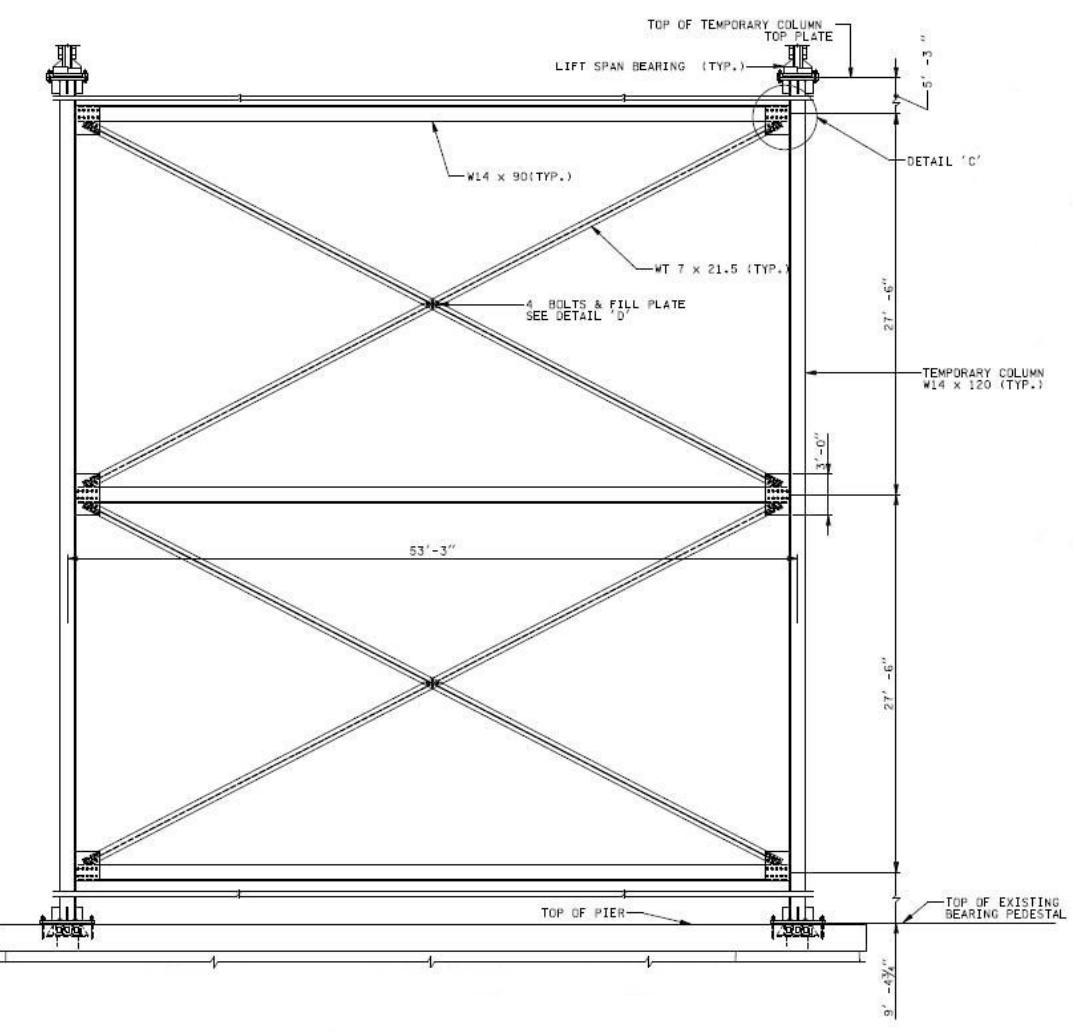
Figure 2: Lift Span Support Transverse Beams and Bracing

A braced frame was created using W14 x 90 sections for the beams and WT 7 x 21.5 sections for the X bracing (see Figure 2).

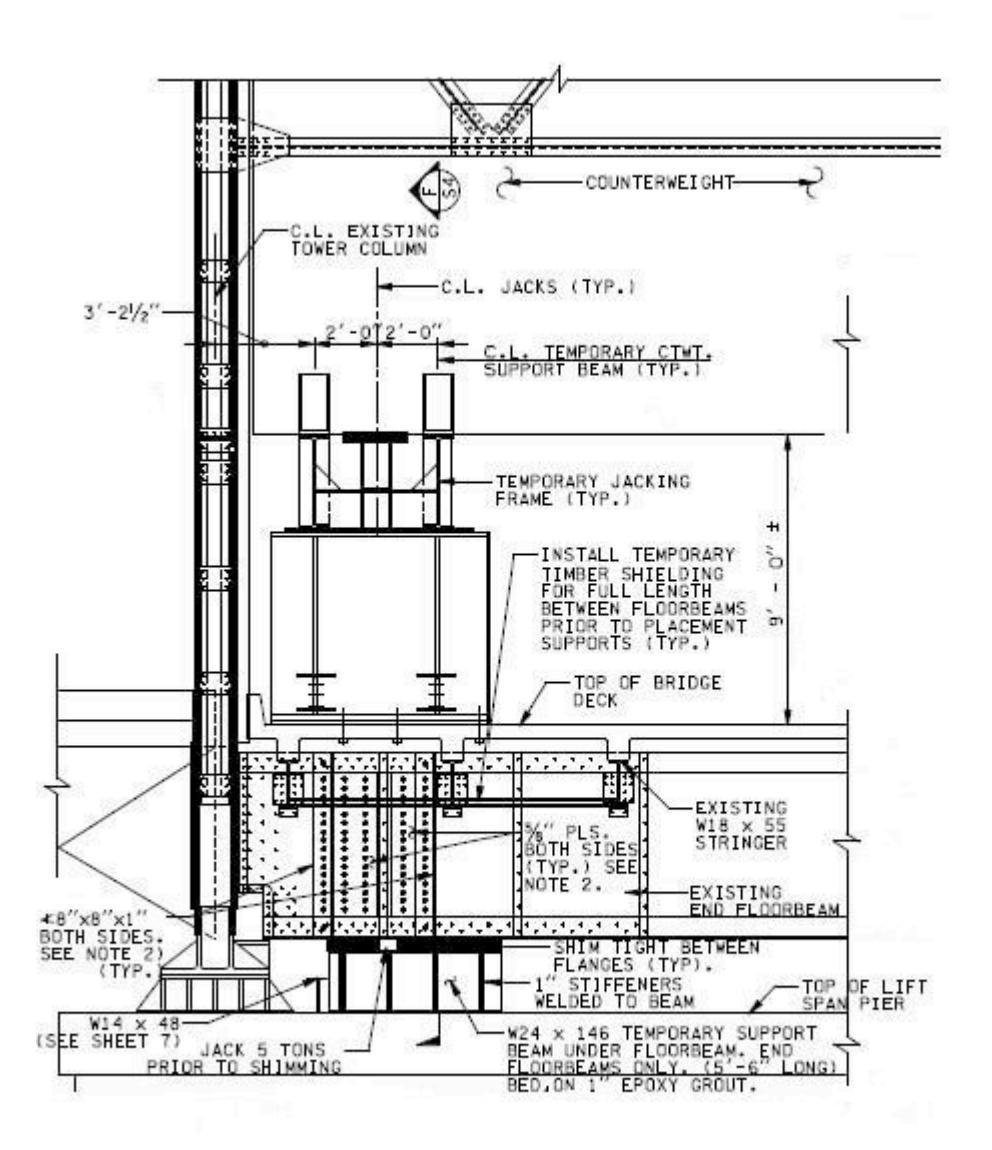
Figure 3: Counterweight Support System

The bridge deck was badly deteriorated and simply shoring up the 900 kip counterweights from the deck alone was not possible. A design of a pair steel counterweight support/jacking beams was developed to support the counterweights. This system transferred most of the counterweight load to the under deck channel side floorbeam and down to the pier cap.

Strengthening of the channel side floorbeam webs was required. The channel side floorbeam bottom flanges were rigidly shored to the tops of the lift piers at the load transfer locations directly beneath the counterweight supports (see Figure 3).

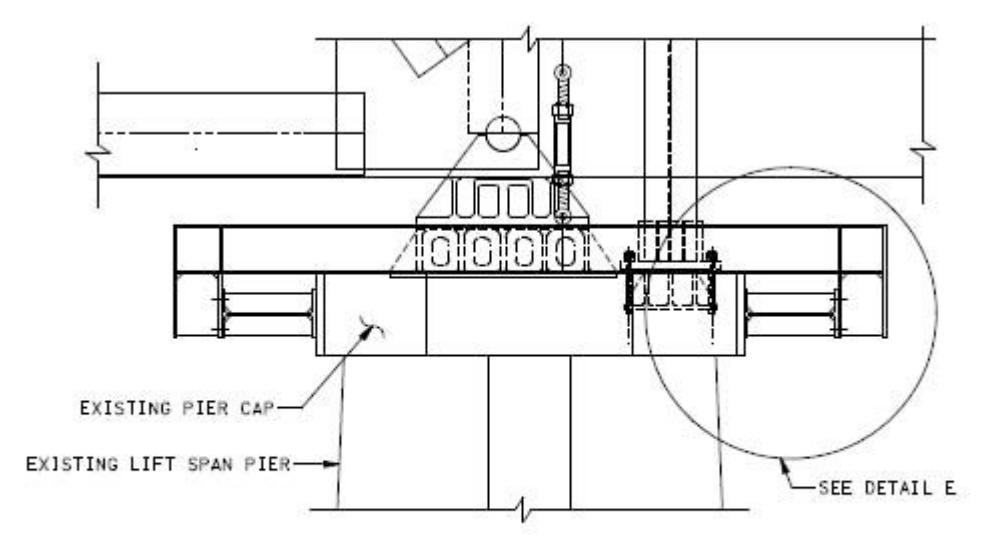
Figure 4: Elevation View of Pier Concrete Bolster

Lastly, due to the age of the concrete piers, a bolster system was designed to provide additional strength at the live load shoe locations where the lift span dead load would be transferred to the piers. Although the existing pier and embedded live load shoe strike plates theoretically have the capacity to support the temporary loads, bolstering the pier concrete was deemed necessary (see Figures 4 and 5).

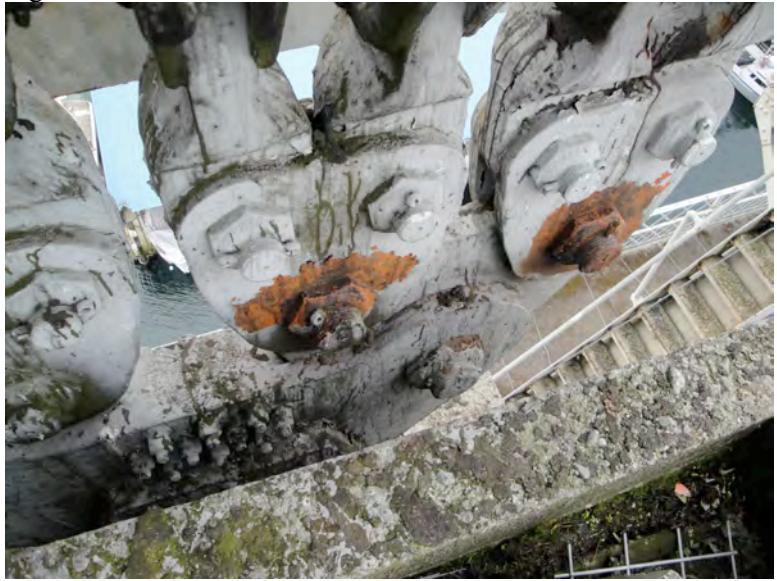
The pinned equalizer assemblies were frozen and heavily deteriorated. Since there was no freedom of movement, rope tension equalization was very poor with some counterweight ropes varying by as much as 38% from the average tension value.

Photo 1: Original Equalizer Assembly

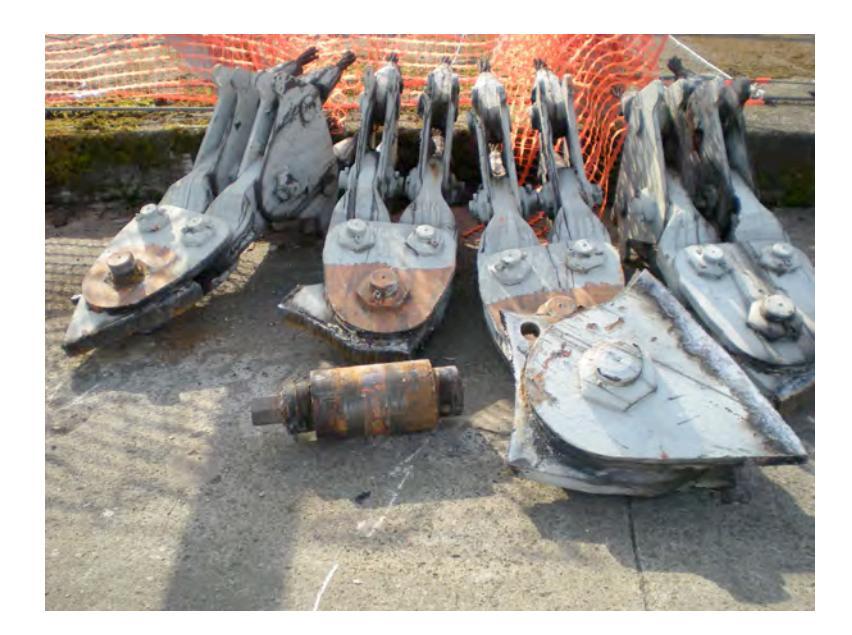
Photo 2: Frozen Equalizer Assembly Removed By Flame Cutting

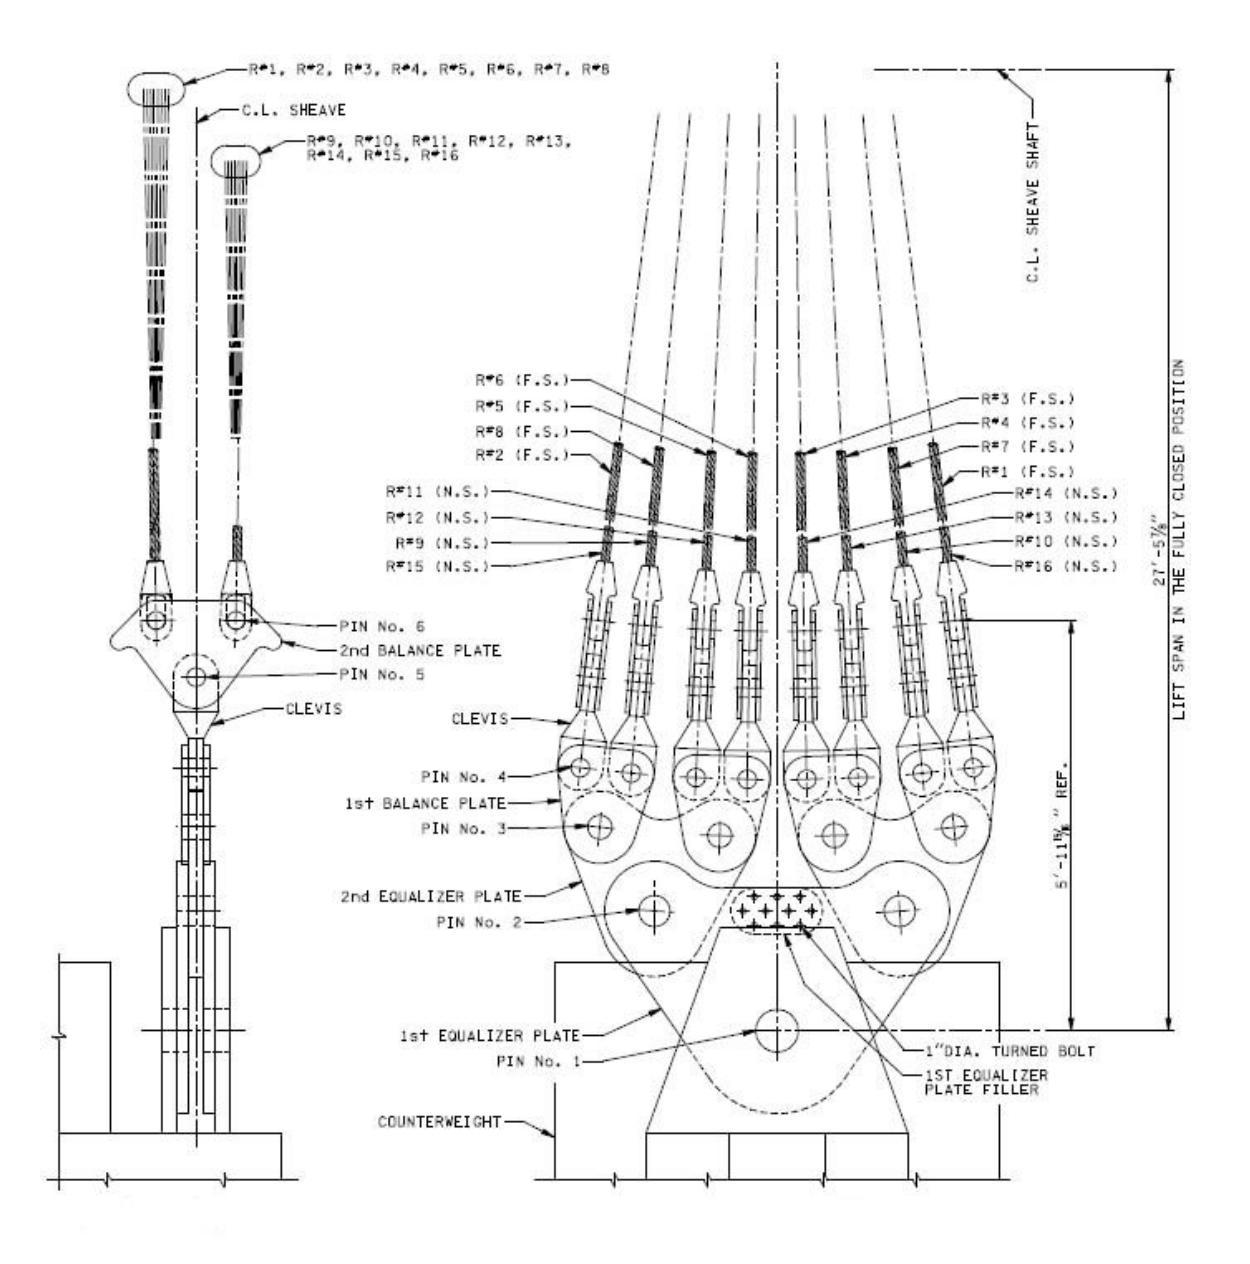
Figure 6: New Equalizer Assembly Detail

Details were developed for replacement of the equalizer assemblies utilizing high strength steel plate and forged steel pins. Rope orientation and layout diagrams were also developed and shown in the plan set (see Figure 6).

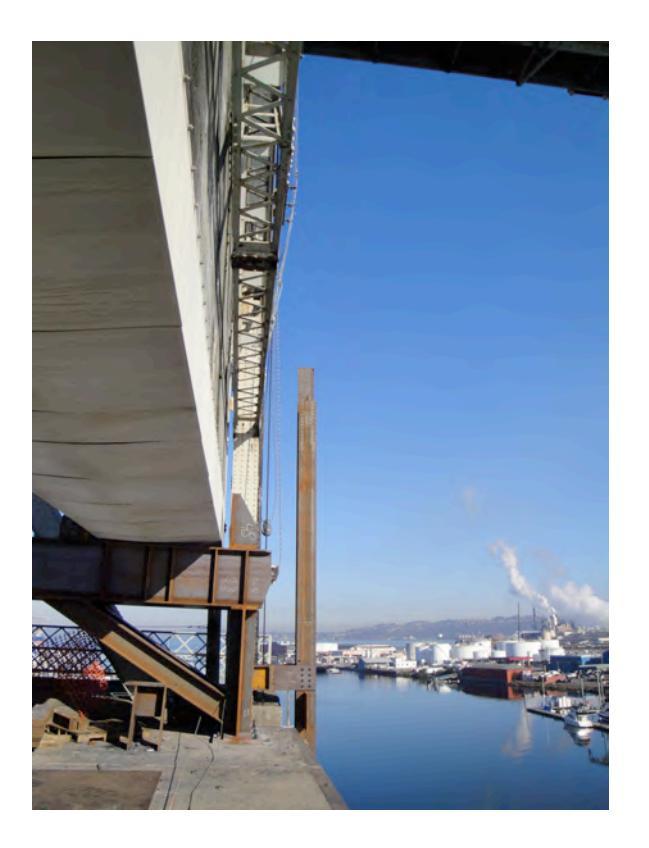
In order to avoid the high costs of utilizing a barge crane, Rognlins modified the temporary lift span support columns to include a spliced connection. This made it possible to stick build the lift span supports without heavy equipment and without working from the channel (see Photo 3).

Photo 3: Erection of Lift Span Temporary Support Column

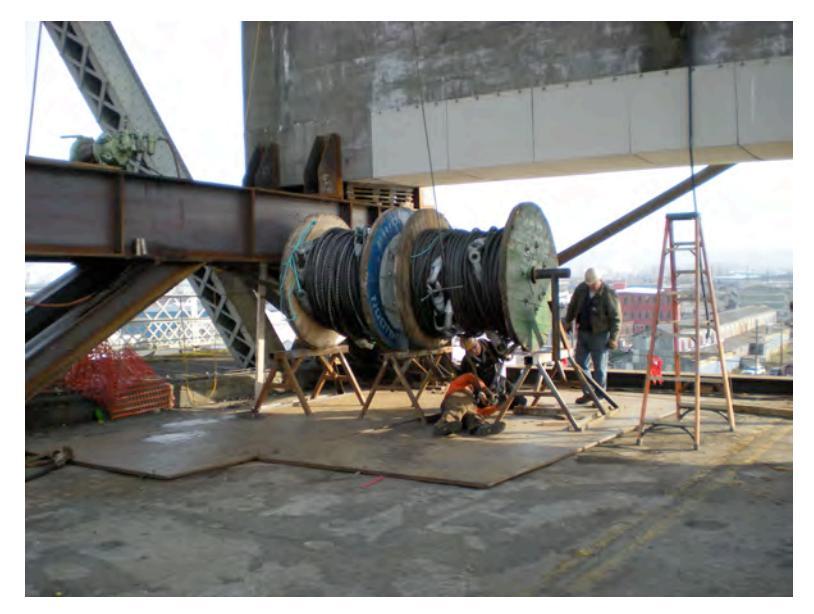
One by one, an old counterweight rope was lowered to the ground and its replacement rope was then raised and laid into its place on the counterweight sheaves (see Photo 4).

Photo 4: CTWT Rope Installation Using Air Winch

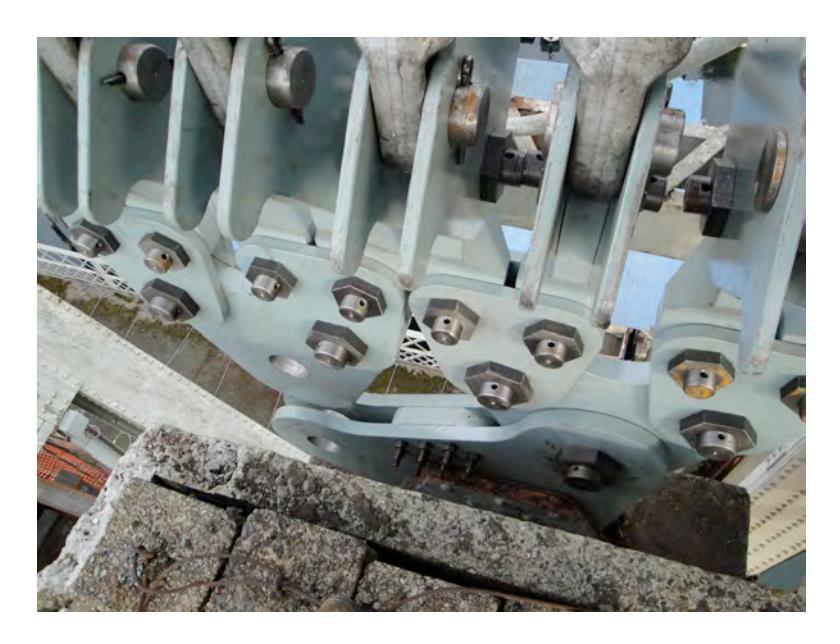
After the counterweight ropes in all four corners were attached to the lift span, the equalizers were installed. The new counterweight ropes were fabricated to the original design lengths. After nearly 100 years of service, the existing ropes were stretched by approximately 15 inches. In order to make the final equalizer to counterweight connection, each counterweight was jacked vertically until the final equalizer pins could be installed (see Photo 5).

Photo 5: Final Connection of New Equalizer Assembly
