# HEAVY MOVABLE STRUCTURES, INC. ELEVENTH BIENNIAL SYMPOSIUM

# Unique Florida Swing Bridge Replacement Jeremy Mackling PCL Civil Constructors, Inc.

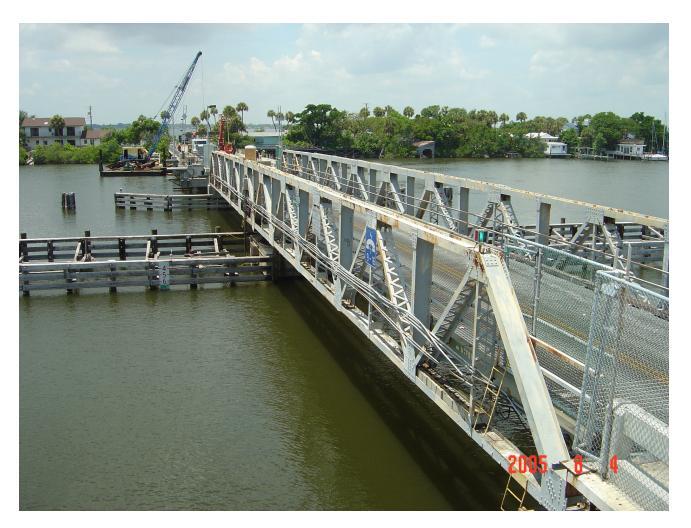
Existing Mathers Swing Bridge Prior to Reconstruction

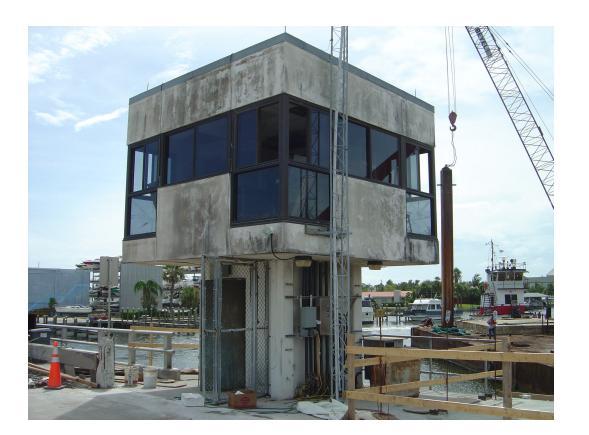
**Old Control House**

ceiling tiles to avoid having random cockroaches drop on them. As deconstruction started on the second floor, it was found that excessive mold growth existed in the walls and insulation. It also was found that the steel framework was completely rusted through in some locations. All of this was initially found by mistake, as the electrical subcontractor was removing some old equipment and bumped into the wall, he partially went all the way through the wall. The contractor was issued a change order to remove more sections of wall, insulation, etc to rid the house of contaminants and provide a solid foundation from which to build.

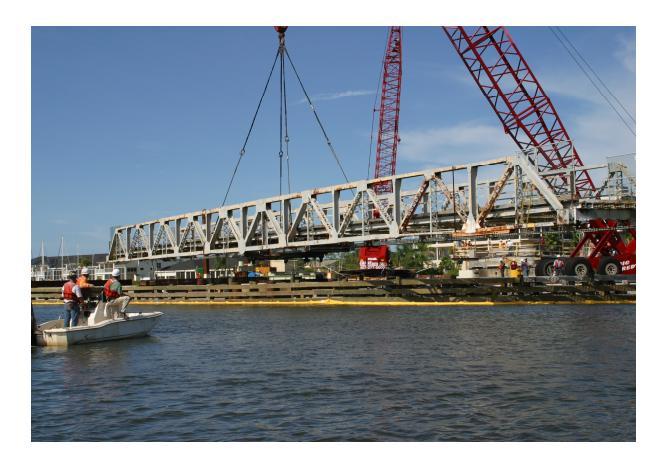
Single Pick Removal

to absorb the additional direct and indirect costs to perform this task in place to mitigate the perceived risks of barging the structure across state in hurricane season. To squeeze the schedule back to the allowable six months, the contractor solicited a crane company to remove the existing bridge and pivot

pier in one pick each. This helped expedite the demolition schedule by two weeks, but the majority of schedule was made up in overtime and continuous monitoring and pushing for field improvements, especially on the pile driving and pier reconstruction which the contractor was experienced at performing.

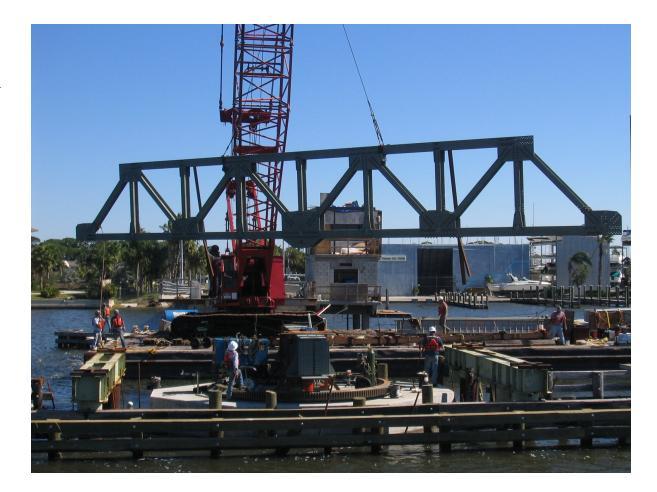
**Erecting in Place**

Fortunately no other storms came through the area during the subsequent 6 weeks of erection. The most vulnerable time of the erection procedure was when the six truss sections (3 to each side) were being placed prior to the floor beam connections being made. To secure the trusses during erection, the contractor placed diagonal support bracing from the trusses down to the falsework support system that the contractor had installed to support the erect-in-place procedures. Once the floor beams were installed the diagonal bracing could be removed. Utilizing the 'erect in place' option required the contractor to do additional construction engineering to come up with a falsework support system that would facilitate erecting in the field and also absorb the necessary loads of the structure prior to it being lowered onto the pivot pier assembly.

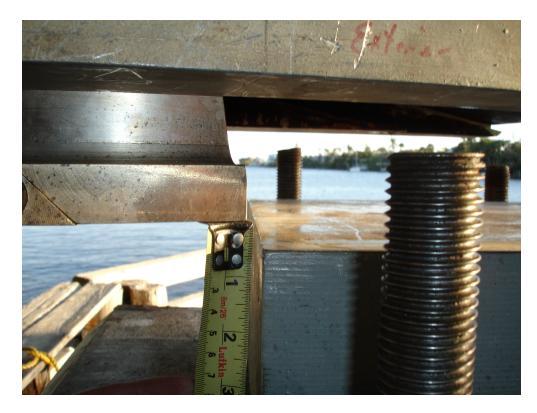
Lower Wedge Prior To 1/2" Beveling

As the contractor was wrestling with the elevations and balancing, a concern developed that if the temperature affects on the bridge are greater than anticipated, then the shoes of the actuators may not drive because they would be lower in elevation unsupported than the lower wedge elevation on the approach rest bents. As the contractor was setting the final elevations in January, it was impossible to know what the true effects of the extremely hot summer months of July and August would be on the nice new 200' by 30' bridge deck and trusses. The engineer/contractor came up with a relatively simple solution for this undeterminable problem by beveling the lower approach wedges by ½" to increase its acceptance capabilities of the driving shoe by 33%

(the shoe height differential was  $1 \frac{1}{2}$ " by design). The drivability of the shoe in the summer months may never have been a problem, but the team planned ahead and mitigated the concern in advance.

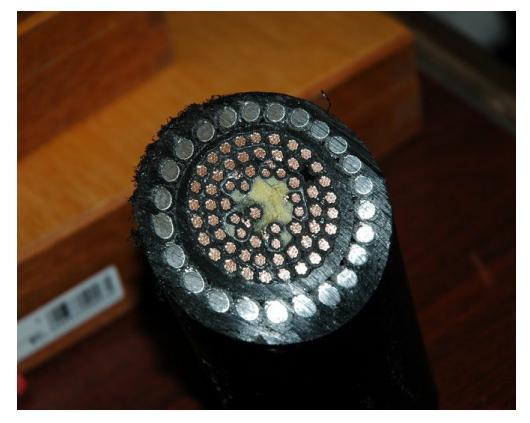
Submarine Cable

contractor was instructed to 'replace in kind'; however, when the contractor provided the new supplier's engineering drawings, matching that which was installed, the Department was unsatisfied that they were going to be sent a cable that did not match their engineered drawings. After sending 6" sample sections of the cable to the EOR, FDOT District 6, and the electrical subcontractor, it was finally determined and agreed that in the haste of pending Hurricane Wilma, the supplied/picked up submarine cable was different than the drawings had shown. Fortunately, upon receipt of the cable at site the electrical subcontractor reviewed the cable and discussed with the EOR to make sure it would satisfy the Mathers Bridge requirements prior to the installation in the channel. The contractor got final approval to fabricate the replacement cables in January 2006.

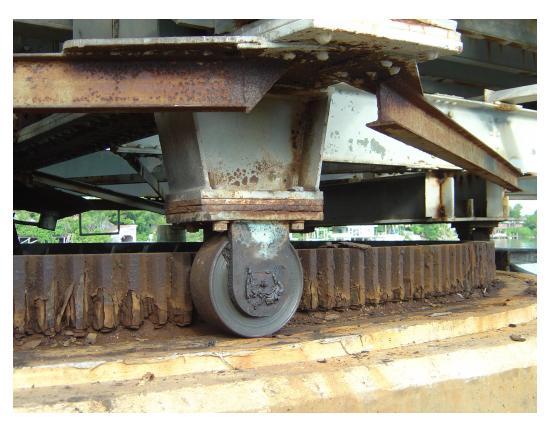
Old Track and Balance Wheel

structural steel portions were severely rusted so the bridge had a relatively low capacity rating. The signs for the bridge allowable capacity were lowered during the first three months that the contractor was onsite but the bridge was still in operation. The bridge scored 4 out of 100 in the last grading done by the government. The seasoned director and professional engineer for the County commented that after each major storm or hurricane, he was surprised to still see the bridge and control house still in place. The bridge was consistently out of service and continually being 'maintained' just to keep it in operation. The bridge wheel arm which set the location of the bridge had lost its hydraulics and allowed the bridge to roll past the centerline easily. The

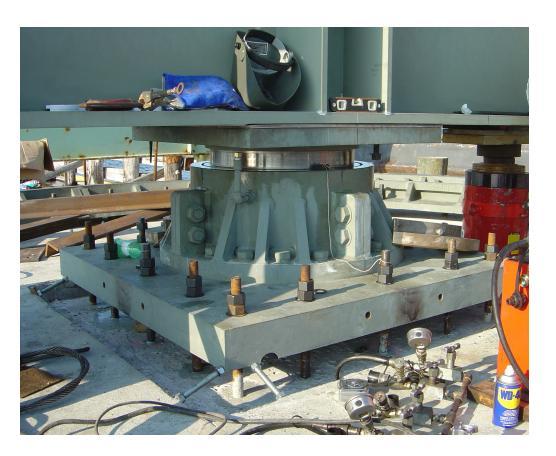
New Pivot Assembly

- Dual span mechanical and electrical drives offering tandem load sharing operation or switching to single drive operation
- Locating the span drive reducer closer to the pivot girder with roadway hatch for future removal
- Pivot assembly included a larger spherical bronze pivot bearing with oil bath
- (2) 90 degree rack segments integrated with balance wheel track

- (2) more additional balance wheels for a total of (8) and (2) additional center rollers mounted under the center of the main girders for live load support
- Individually mechanical actuated wedges with emergency hand wheel operation eliminating long hydraulic piping runs from center to span to ends of bridge which were prone to leaks
- End pier mounted rigid stop for accurate and consistent positioning of span seating in closed position
- Larger backup power generator
