HEAVY MOVABLE STRUCTURES, INC. 12TH BIENNIAL SYMPOSIUM November 3-6, 2008

REPLACEMENT OF THE HAMILTON AVENUE BRIDGE, A RARE HANOVER SKEWED BASCULE

Keith R. Griesing, P.E., Principal Associate George A. Foerster, P.E., Associate Hardesty & Hanover, LLP

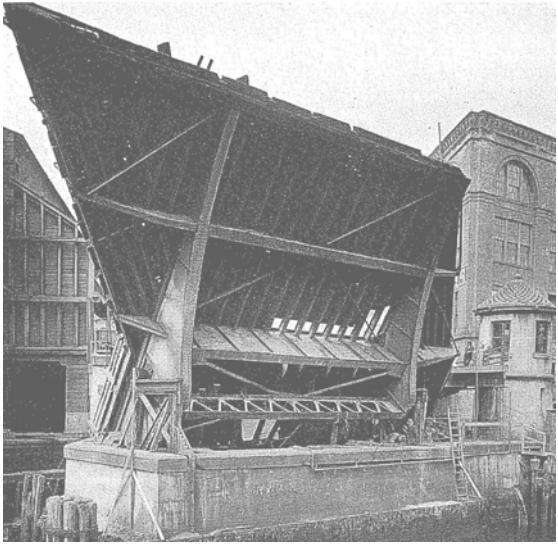
Figure 3-Original Skewed Deck Bridge in Open Position

prior structure was a rolling lift bridge with a skewed deck. This type of framing was common for moderately skewed crossings with the deck in the shape of a parallelogram to match the channel crossing. The main structural elements of the rolling lift span (girders) are normal to the channel and are not parallel to the edges of the deck.

There are a number of disadvantages to this framing configuration. The two large triangular portions of deck are cantilevered from the bascule girders with varying length floorbeam extensions. This results in variable flexibility of the deck system. In addition, the girders must be placed closer together than desirable in order to circumscribe the parallelogram about the rectangle formed by the girders and end floorbeams. This reduces the available space for both the counterweight and operating machinery. The efficiency of the bracing system is also moderately reduced but this is not of significant impact.

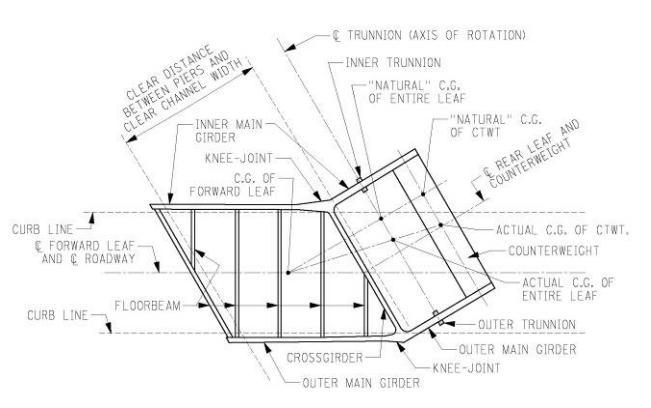
Figure 5-Key Elements of the Structural System

The tendency for warping is counteracted by the cross-girder and the framing layout of the floorbeams. The cross-girder carries moments from the tension and compression forces in the bascule girder flanges at the knee joints. Since the angular relationship of the bascule girder and tail girder portions for the two sides are equal, the moments induced are additive. The resulting counterbalancing forces of the cross-girder are then an upward force on the outer girder and a downward force on the inner girder at the knee joints. These forces tend to locate the center of gravity of the span nearer to the inner trunnion and the "natural" center of gravity discussed above.

The floorbeams connect to the outer main girder at points further from the knee joint than the corresponding ends do on the adjacent girder. As the deck weight is nearly uniformly distributed, this results in higher moments at the knee joint of the outer bascule girder than at the inner bascule girder. This differential in moments between the inner and outer girders is offset by the cross-girder counterbalancing forces discussed above.

The combination of the cross-girder effect at the knee joint and the framing of the floorbeams relative to the knee joints alters the cumulative loads so that the loads at the trunnion are nearly equal and the center of gravity of the counterweight is located nearer the geometrical center.

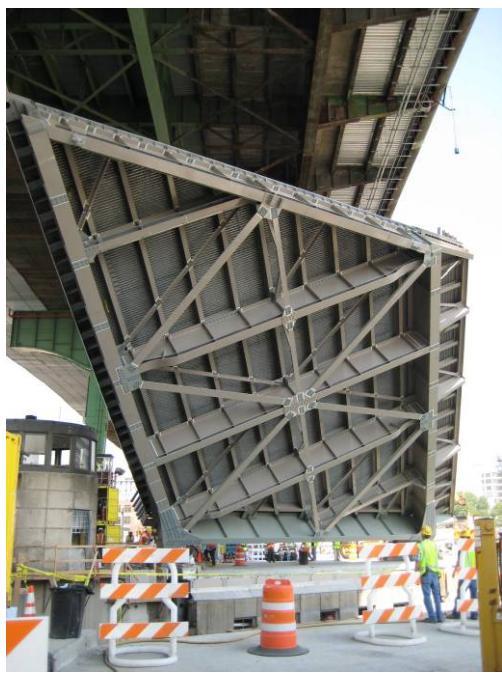
Figure 6-New East Span-Gowanus Expressway Above

The replacement bridges share many of the same geometric characteristics of the original spans. Each leaf spans the Gowanus Canal with a clear channel width of 14.3 m between the fenders. The clear distance between the bascule and rest piers is 15.5 m with the piers oriented parallel to the channel. The roadway is skewed to the channel crossing at an angle of 56.3° and includes four-3.35 m wide lanes (total roadway width of 13.4 m on each leaf increased from 12.8 m on the original). Each leaf also includes a 600 mm access walkway for operation and maintenance personnel at the median side and a 2.45 m sidewalk at the outboard fascia for pedestrians and cyclists.

The bascule girders are spaced 13.4 m center to center and the distance from the centerline of trunnion to the toe bearings is 20.4 m. The girder and floorbeam spacing was maintained due to the interaction of the movable span with the existing pier to remain. The wider traffic lanes on the new bridge result in a wider out-to-out dimension of the leaf. This required modifications to the bridge seat at the rest pier and the front wall of the bascule pier to accommodate the new span. The new span weighs approximately 600 metric tons and opens to an angle of 74°.

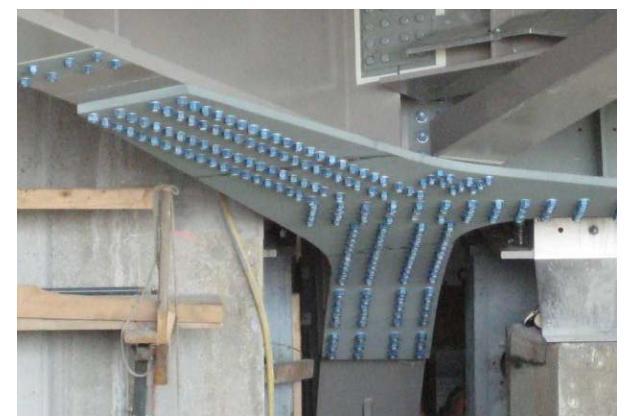
Figure 7-Interior Knee Joint Connection

This innovation design allowed the bridge to be specifically adapted to the crossing with a minimal use of material. In addition, simple shear connections are used throughout with the exception of the knee joint connections of the cross-girder, bascule girder (forward portion) and tail girder (rear portion).

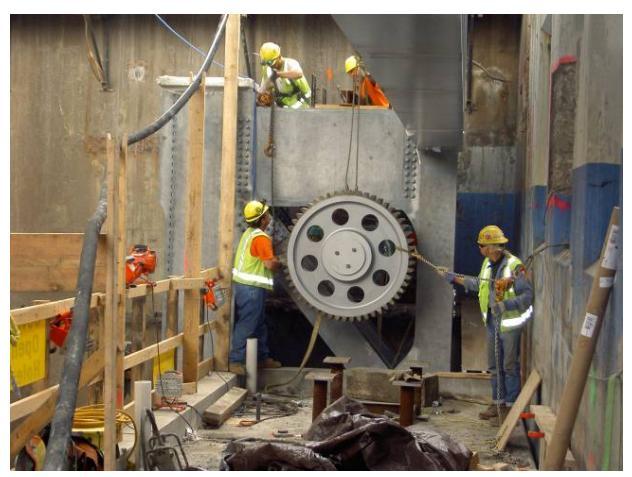
Figure 8-Trunnion Tower and Gearing

The trunnion bearings are supported on trunnion towers. The trunnion towers are basically a truss frame which transmits the dead and live loads down the counterweight pit floor and walls. The trunnion towers also support the main pinion bearings and one of the two bearings for each of the secondary gearing pinion shafts.

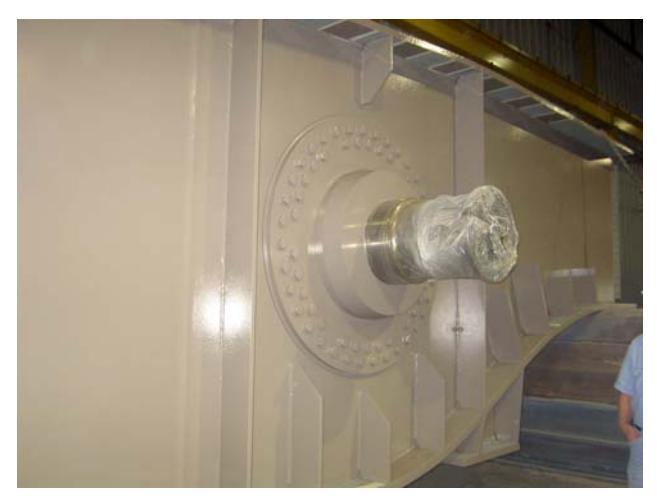
Figure 9-Trunnion and Girder Assembly

There are two trunnions that support each bascule span. A trunnion shaft is connected to each bascule girder using a hub and ring assembly. Each end of each shaft rests in a bearing, which allows the bridge to rotate about the trunnion axis. The bearings are bronze cylindrical sleeve type, which are grease lubricated. The trunnion shaft is essentially a simply supported beam of circular cross section.

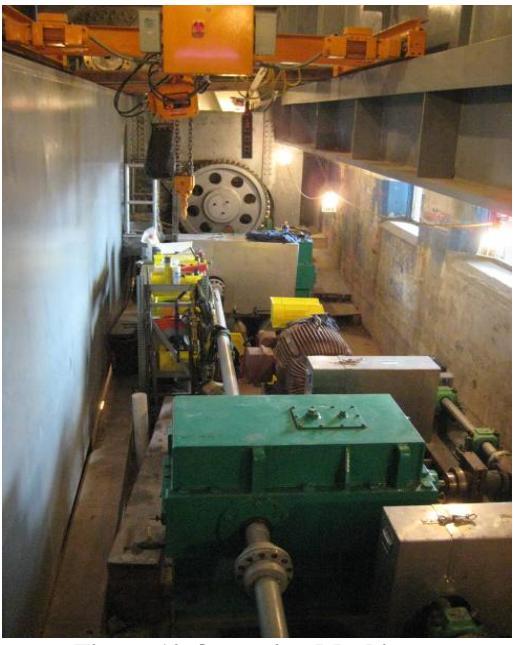
Figure 10-Operating Machinery

The span operating gear train for each bascule span is comprised of (2) sets of racks & pinions, (2) secondary sets of open gearing (2) secondary reducers and (1) primary differential. Power is generated by an electrical motor (1 of 2 is used at a time) which is coupled to the differential reducer. The torque of the primary reducer is equalized to two output shafts by internal differential gearing. The output of each shaft is than connected to the input shaft of a secondary reducer by a floating shaft. Each secondary reducer is coupled to a secondary pinion/gear set which in turn drives a pinion shaft. Each pinion drives a rack which is mounted to each of the bascule girders, such that the pitch diameter is concentric with the

trunnion shaft. The bridge is rotated by applying the required operating force to the rack. Braking force is applied by (2) motor brakes and (2) machinery brakes. The motor brakes are mounted on each input shaft to the primary reducer and there is a machinery brake mounted to each of the input shafts of the secondary reducers.

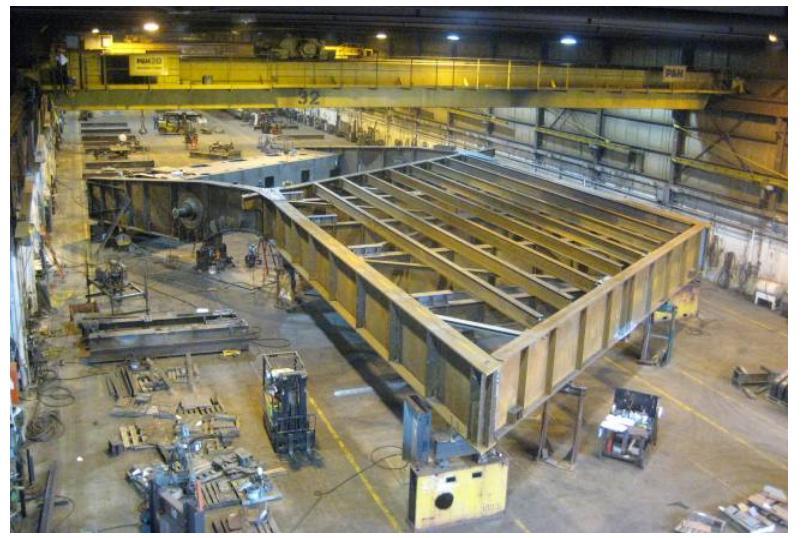
Figure 11-Shop Assembly of West Span

respective alignment while achieving the proper trunnion alignment. After this had been completed the bridge assembly continued with the shop connections of the bascule girders and floor beams. After confirming the alignment of the structural components and the trunnions were properly aligned the rear portion of the bridge was removed. The forward span assembly continued with the stringers and grating.

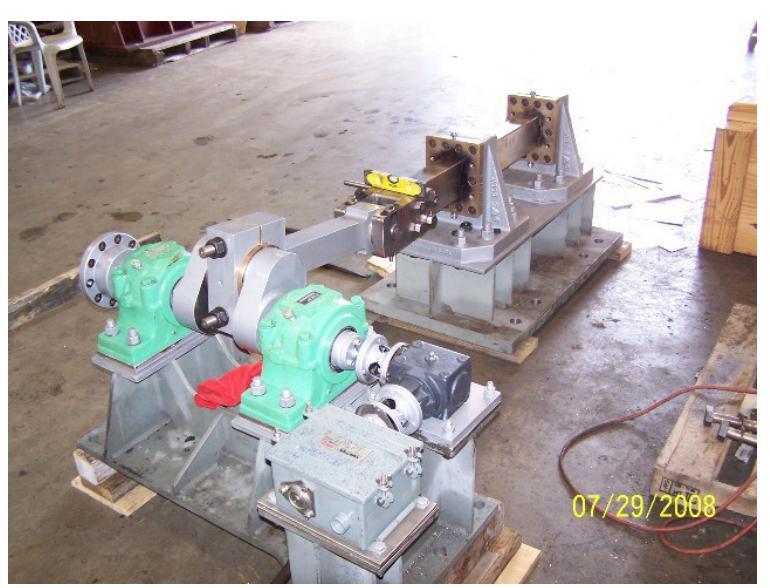
Figure 12-Lock Bar and Crank Assembly

guides and is inserted into a socket when driven. Each bar is operated by a crank and connecting rod mechanism. Both cranks for each leaf are driven by a central reducer and motor.

The span locks were fabricated and assembled in the shop as main assemblies for shipment to the field. The main assemblies included the lock bar & guides, crank shaft & bearings and reducer & motor. In the shop the function of the lock bar, crank and connecting rod was checked prior to shipment to the field.

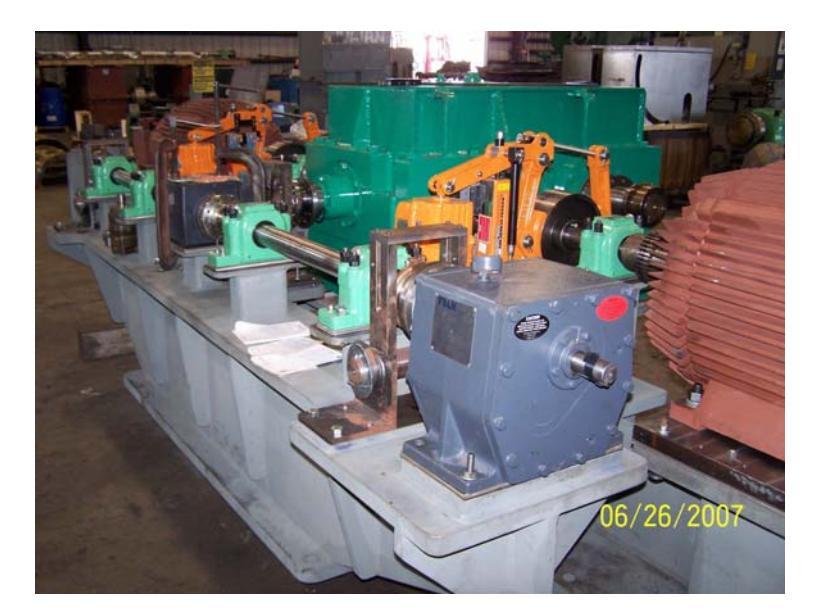
Figure 13-Primary Machinery Assembly

The operating machinery was fabricated as main assemblies for shipment to the field. The main

assemblies included primary reducer machinery, auxiliary machinery, secondary gear reducers, secondary pinions, main pinions with secondary gears. After these units were completed, functional tests were performed prior to shipment to the field for installation.

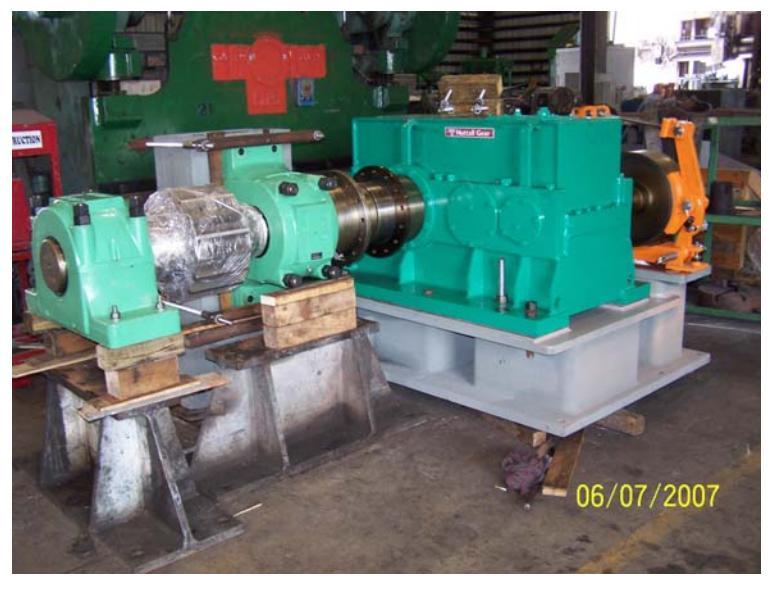
Figure 14-Secondary Machinery Assemblies

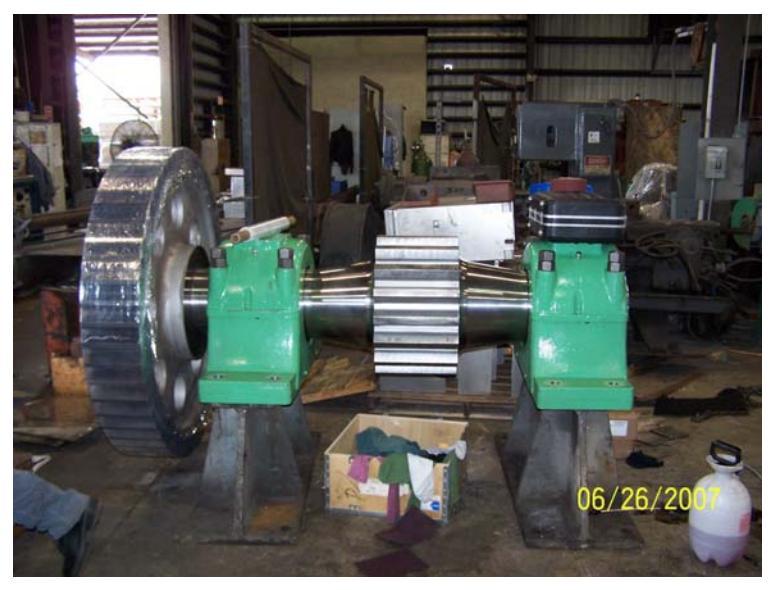
Figure 15-Main Pinion Assembly

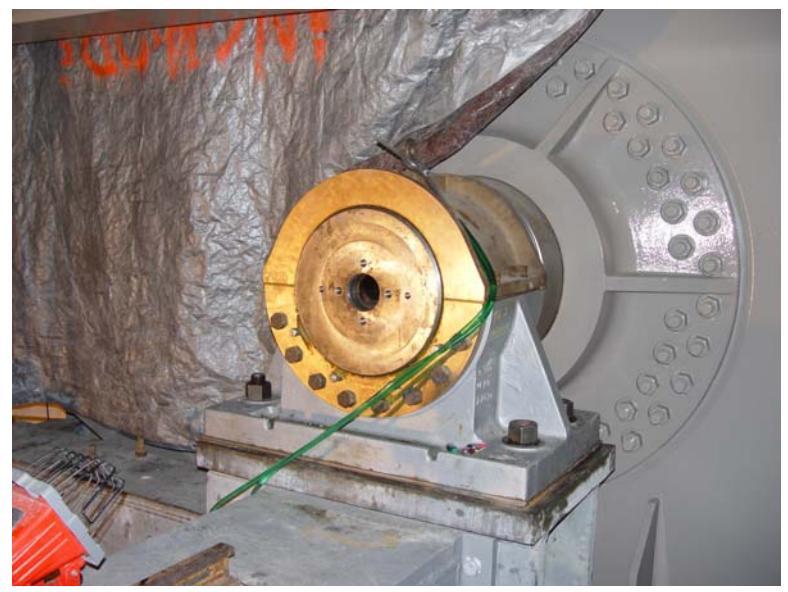
Figure 16-Trunnion and Bearing Assembly

The first mechanical task in the installation of the new bridges is to properly align the trunnions. This first started with aligning the new bearings on the new trunnion towers. After this was completed each of the tail girders were than installed. After the tail girders were in place the field assembly of the bascule spans commenced. A piano wire assembly was utilized through the center bore of the trunnion to establish and to continually monitor the condition of the alignment throughout construction of the bascule spans. In

addition the bearing fit was also inspected to confirm the bearings were properly aligned to their shaft journals.
