HEAVY MOVABLE STRUCTURES, INC. TWENTIETH BIENNIAL SYMPOSIUM

Hydraulic and Other Machinery Options to Replace Traditional Swing Bridge Machinery Travis Kimmins, P.E. Kevin Ciampi, P.E. H&H

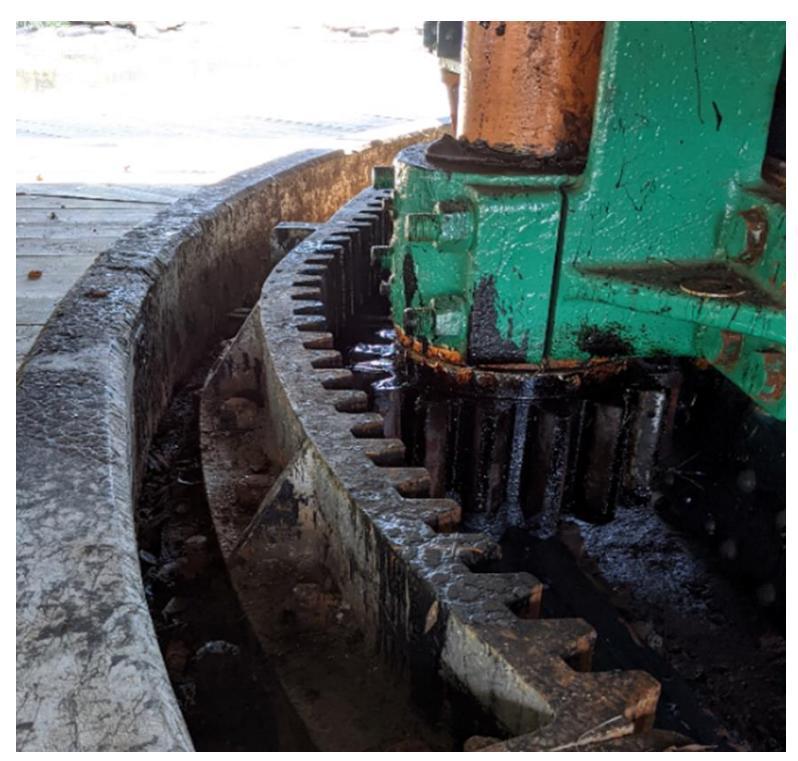
Photo 1: Deformation at the Rack due to a Barge Collision

span had considerable damage along with the pivot bearing and rack and pinion. While called an oil box, it is worth noting that the oil box and associated hardware is the first line of defense in the event of a vessel collision. For the Centerville Turnpike Bridge, after the pivot bearing oil box failed, the main pinion bottomed out on the rack, and the rack deformed approximately six inches.

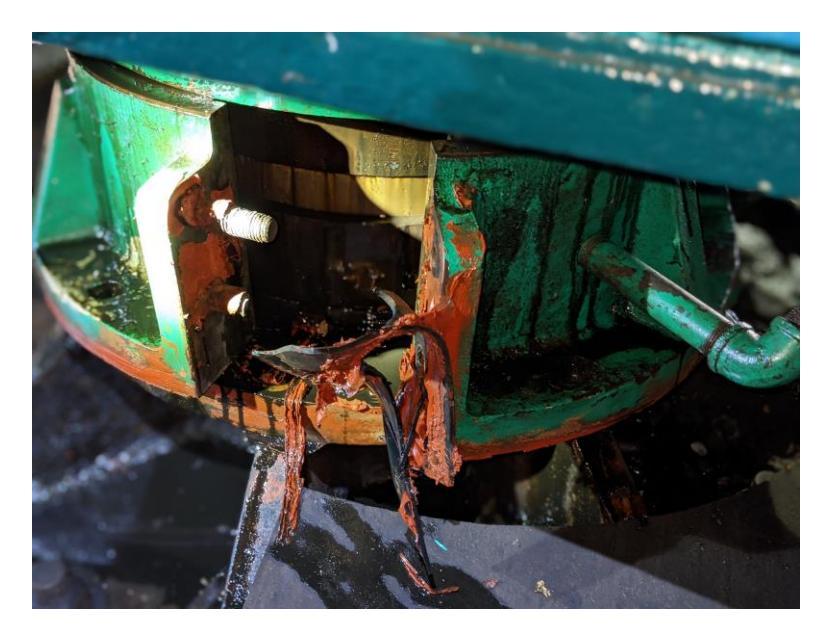
Photo 2: Oil Box Failure after the Barge Strike

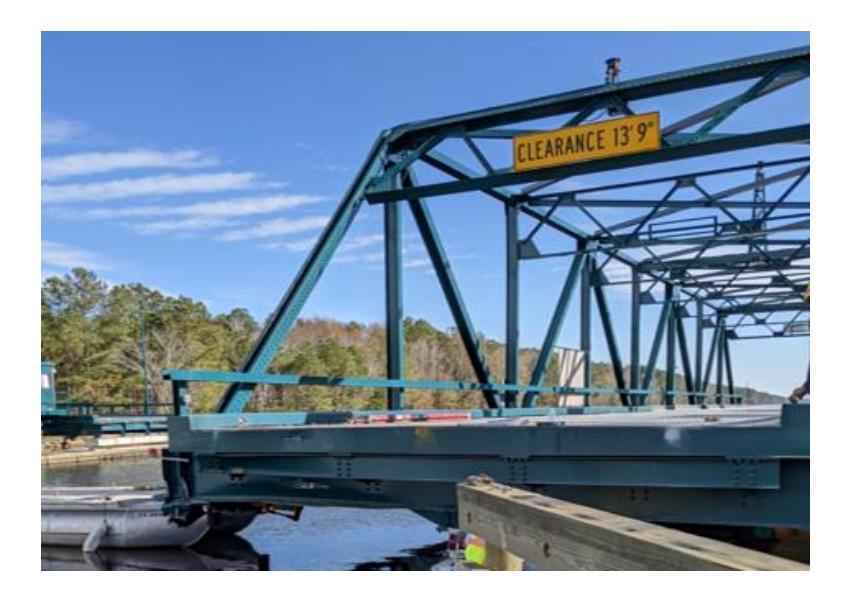
Photo 3: Location of the Initial Collision at the End Floorbeam

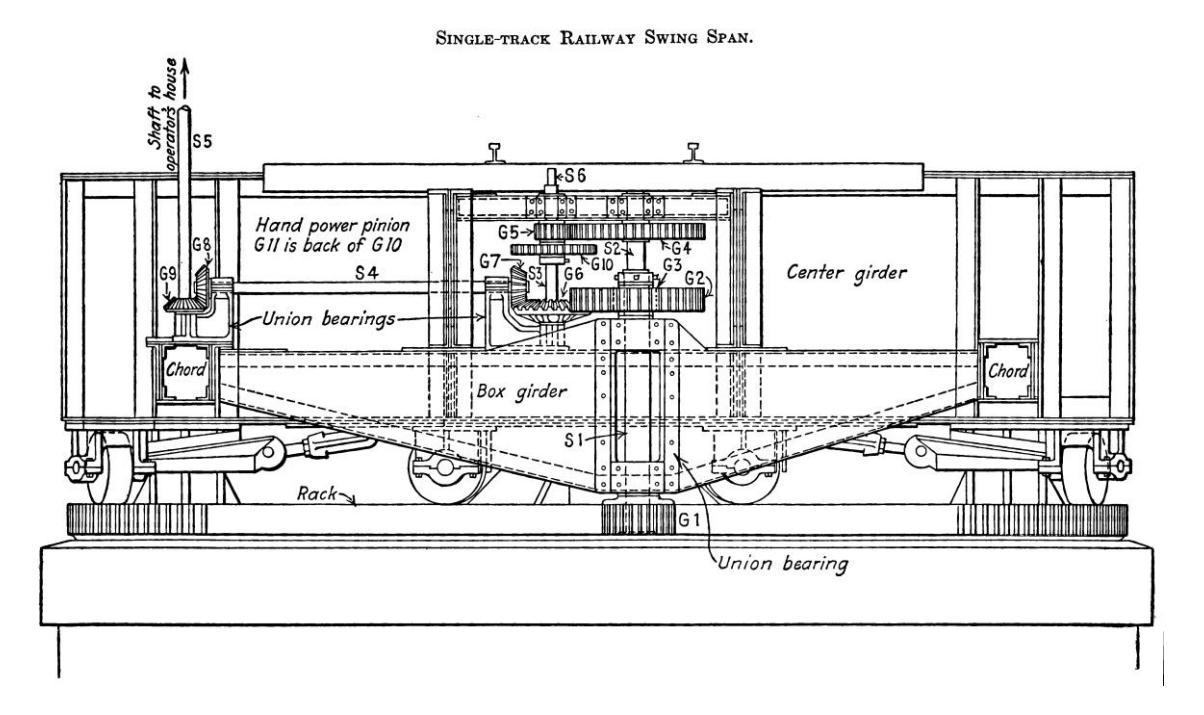
The drive machinery is typically located on the movable span, as shown below. Generally, access is poor, which can result in poor maintenance practices with increased wear and tear on the machinery. The figure is taken from Hovey (1927); however, oftentimes current machinery designs look similar, with the exception being that some of the open gearing is replaced with enclosed gear reducers and shafting to an above deck operators house is avoided.

Figure 1: Illustration of Traditional Swing Bridge Drive Machinery

One of the issues with traditional span drive machinery is the amount of backlash in the gearing. This backlash, coupled with the minimal friction loads and inability to maintain a positive force on the pinion when varying speeds or in certain wind conditions, can result in impact loading on the machinery due to span inertia. Due to these issues, many bridges are operated at a reduced speed. In addition, it is frequent to have bridges with 3/8" or more of backlash and a ratio of rack radius to end of bridge of 10:1 leading to an effective backlash at the seats of 3.75" or more from the main rack and pinion neglecting all other

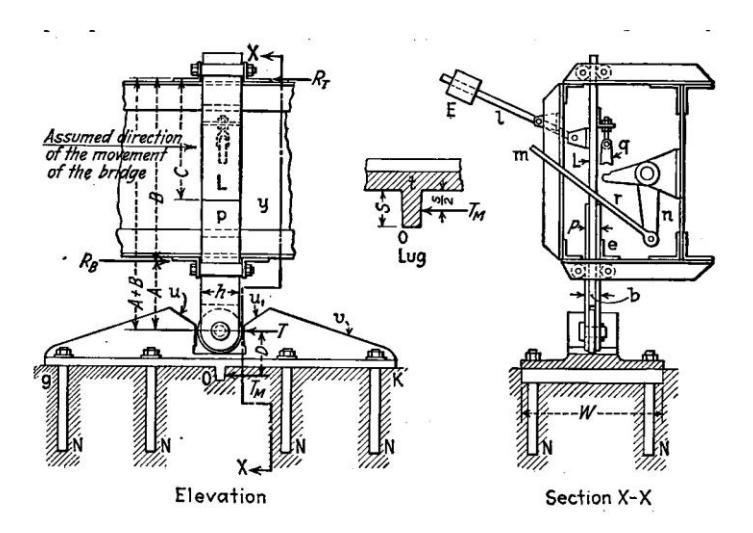
Figure 2: Illustration of Traditional Swing Bridge Latch Machinery

gearing in the drive train. This issue has historically been solved with latches which operate under gravity. They must be balanced and lubricated correctly so the inertia of the latch and its imbalance cause the bridge to be locked in place only at low speeds because the machinery cannot be relied on to align the end of the bridge accurately. These complex mechanisms are often misadjusted, damaged, or inoperable after being set to latch a bridge moving too quickly. Since swing spans require a full opening to be protected by the fender system, they are at a higher risk of being struck than bascules and vertical lift bridges which provide greater clearances to reduce boat strikes even when partially open.

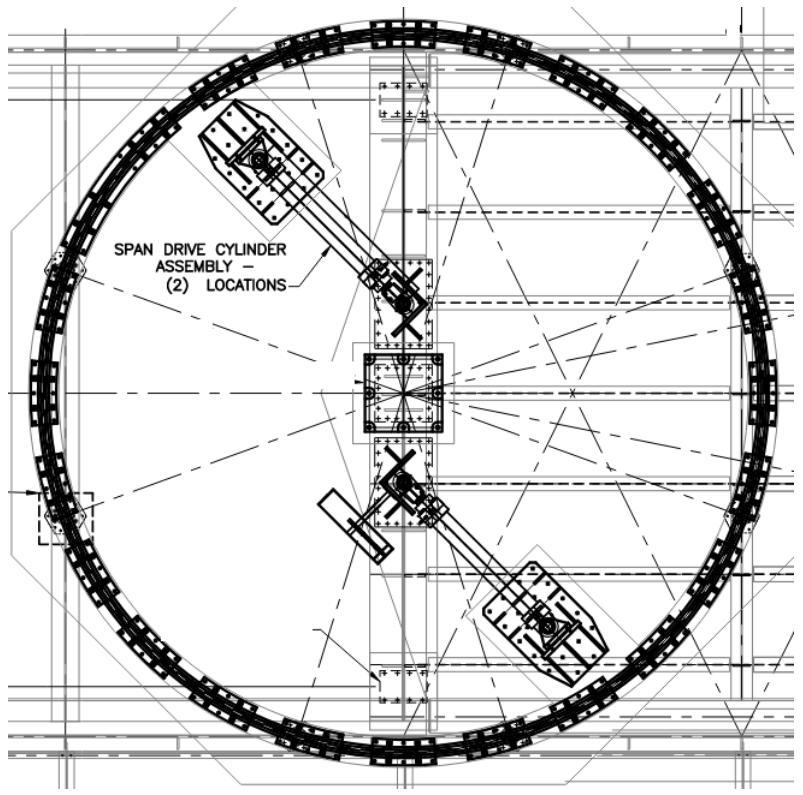
As an alternative to traditional machinery, opposing hydraulic cylinders provide a simple and cost effective means to operate the span, see Figure 3. Hydraulic cylinders can replace entire drive trains effectively providing a zero backlash operating system with equal or better redundancy, at a fraction of the cost. A push-pull configuration using two cylinders could be considered, but care must be taken to account for unbalanced forces as the pivot bearing would see the difference in force from the pressure being applied to the bore area of one cylinder and the annual area of the other cylinder. A push-pull configuration with four cylinders balances the forces and also provides redundancy in the event of a cylinder failure.

For the opposing cylinder arrangement shown below, different flow rates would generally be required in order to open and close the bridge at the same speed. This typically would be accomplished through pump controls. A fairly common approach is to use a pressure-compensated pump with a proportional control valve on the cylinder return line (metering out the flow). A better approach is to use an electronic displacement control on the pump. This allows you to control the flow without the need to run at an elevated pressure reducing the need for external cooling and providing greater flexibility to control the speed of the bridge. Another option used on other hydraulic bridges (e.g. East Michigan St. in Milwaukee) is a regeneration circuit, Ciampi & Kimmins (2022). In a regeneration circuit, pressure is applied to both the blind and rod sides of the cylinder when extending the cylinder. This circuit amplifies the pressure when extending the cylinder, while reducing the required flow rate, effectively making the bore end of the cylinder equal in area as the rod. By selecting the right cylinder ratio, the pressures and flow rates to extend and retract the cylinders are similar, which can simplify the hydraulic system, as well as the control system. Given that this system has none of the backlash concerns mentioned above, and the robustness of hydraulic cylinders, a bridge driven by hydraulic cylinders should be able to be operated at significantly faster speeds than with any other option.

Figure 3: Opposing Hydraulic Cylinder Arrangement for Swing Bridge Operation

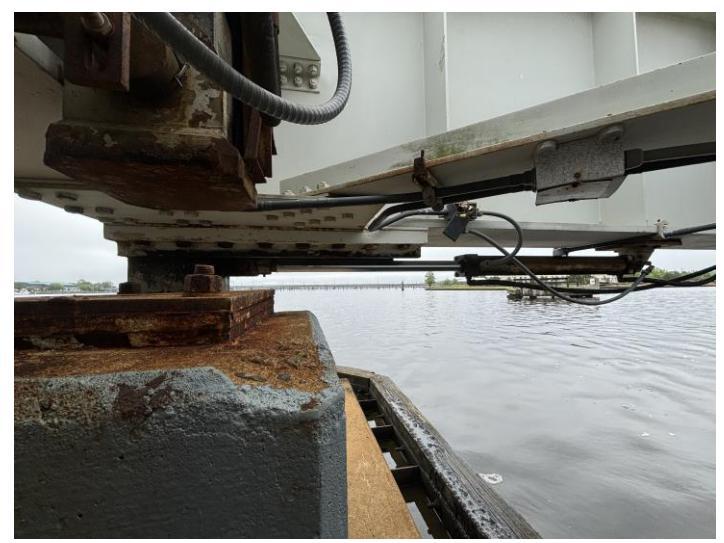
Photo 4: Hydraulic End Lifts and Sliding Live Load Shoe

wedges, a higher operating relief valve setting can be used, to overcome static friction and pull the wedges. Wedges used in this type of arrangement should use a shallow self-locking taper to prevent backdriving in addition to holding valves to provide redundancy. End wedges would be similarly controlled with the difference being that the operating relief for driving the wedge would be set higher as these wedges are intended to provide uplift. Given the larger taper required for end wedges, generally a crank is required. As an alternative, jacking cylinders with a sliding live load shoe provide a simple alternative to traditional end wedges with a proven track record on numerous bridges. This requires twice the hydraulic cylinders however since the live load bearings have no taper, back driving issues are eliminated, simplifying the machinery. This method of jacking the span and inserting live load shoes has also been used on mechanically operated bridges and is suitable with compact self-contained actuators. Note that the authors have seen several bridges which attempt to combine the live load shoe and jack into one power screw. This is not recommended, as it is not advisable to put live loads through machinery, necessitating frequent repair or replacement.

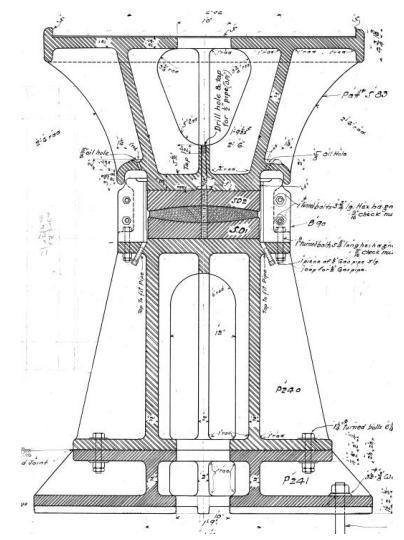
The issues with 3-disc pivot bearings are well known. Hovey (1926) stated "The middle disc of this type of center, being double-convex, is easily displaced and is very sensitive to changes of level of the center pier, and there is no tendency for it to move back into position after displacement. Bridge erectors are well aware of this fact and have nicknamed it a melon seed."

Figure 4: Three Disc Pivot Bearing

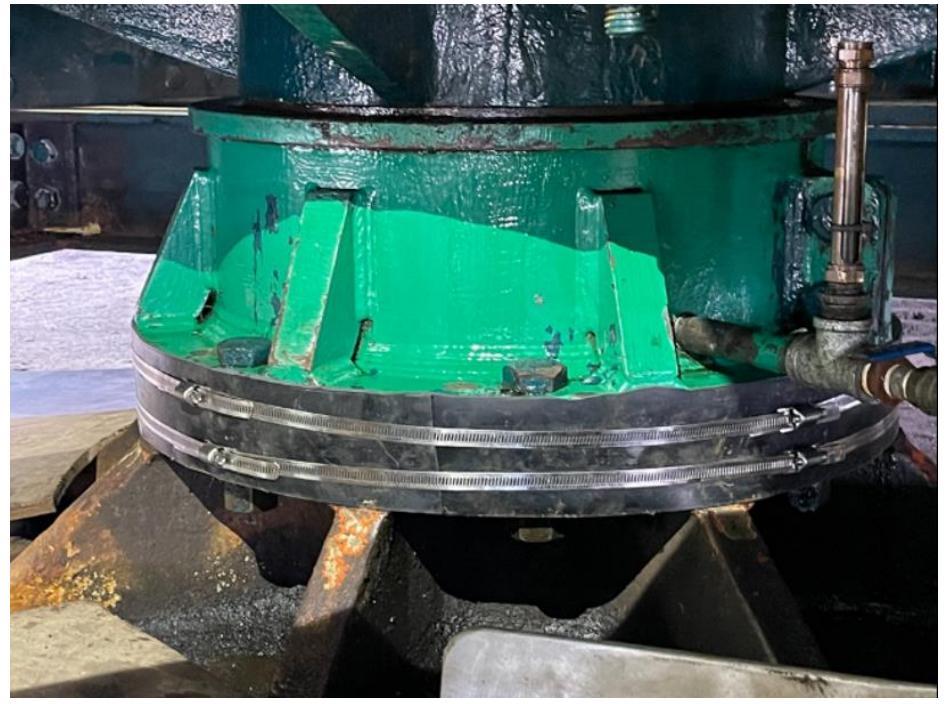
alternative to address leaking pivot bearings is to install a gasket on the exterior of the box as shown below. After the installation of this exterior gasket, the bridge owner went from having to add oil weekly, to going months without needing to add oil.

Photo 5: Exterior Gasket to Eliminate Leakage from a Failed Flange Gasket

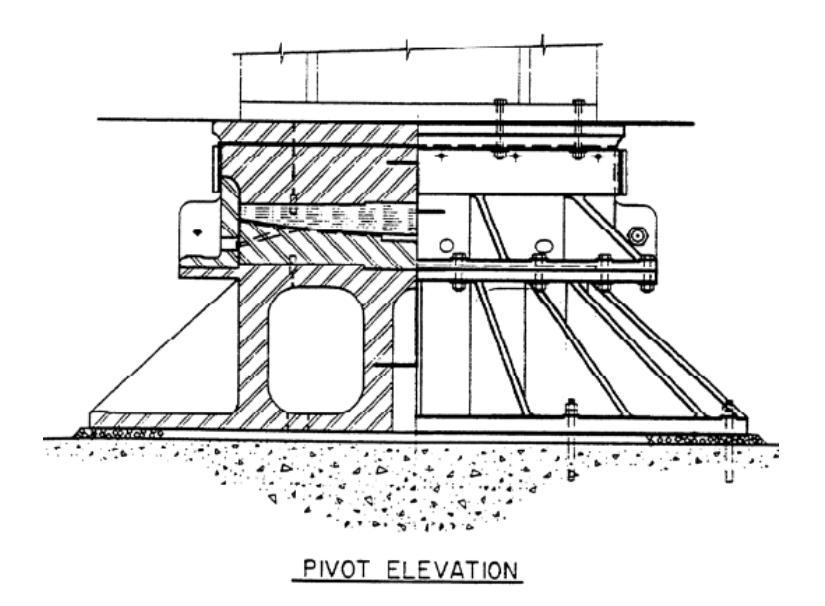
Figure 5: Two DiskBridge Pivot Bearing Illustration (Abrahams 1996)

While oil boxes are the most common option for a pivot bearing, consideration should be given to designing a greased pivot bearing. The George P. Coleman Bridge utilizes a 60" greased pivot bearing. While this addresses some of the leakage problems associated with oil boxes, care must be taken to provide grease flow towards a purging area as new grease is added. Generally speaking, grease is recommended in plain bearings at lower surface speeds, with boundary lubrication, where retaining lubrication is challenging. When oil is used, very high viscosity, slow speed worm gearbox oils have shown the best performance.

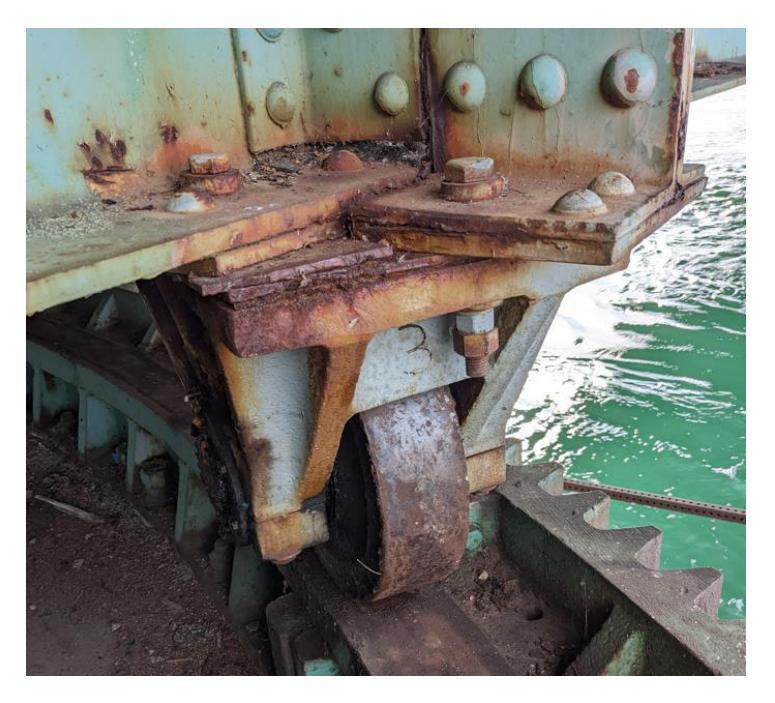
Balance wheels are intended to help stabilize the bridge when experiencing wind loads. However, traditional balance wheels can be prone to misalignment and wear; oftentimes either riding hard against the balance wheel track, or having excessive clearance and potentially allowing the span to tip excessively and contact the wedge seats or fender. Often there are insufficient bolts and pack rust is prevalent as shown in Photo 6. Consideration should be given to design balance wheel with threaded rods for ease of adjustment as shown in Photo 7.

Photo 6: Pack Rust and Corrosion for a Typical Balance Wheel

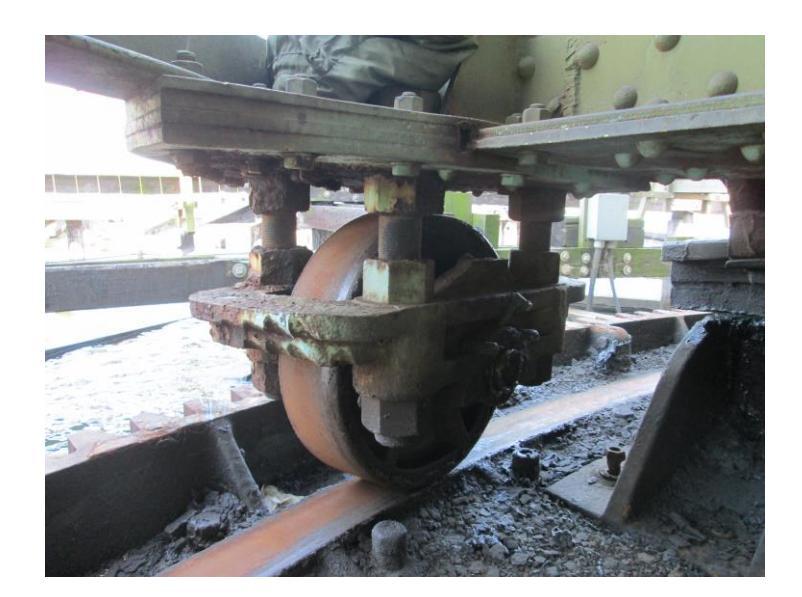
Photo 7: Threaded Rod Balance Wheel Design for Ease of Adjustment
