# HEAVY MOVABLE STRUCTURES, INC. TWENTIETH BIENNIAL SYMPOSIUM

Insight and Techniques into Mechanical Offsite Inspections for the Rumson Road Movable Bridge Replacement Project Joshua Kuehn, P.E. Maame Assasie-Gyimah, P.E. WSP

# Introduction to the Rumson Road Movable Bridge Replacement Project

# Bridge S-32 Over Shrewsbury (Rumson Road) Location

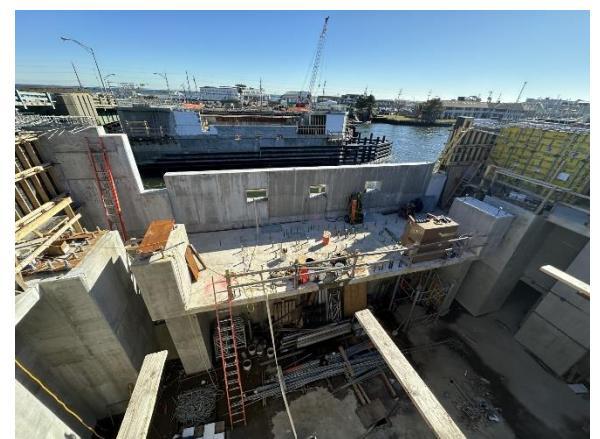
Photo No. 2: Rumson's Movable Bridge Pier under construction.

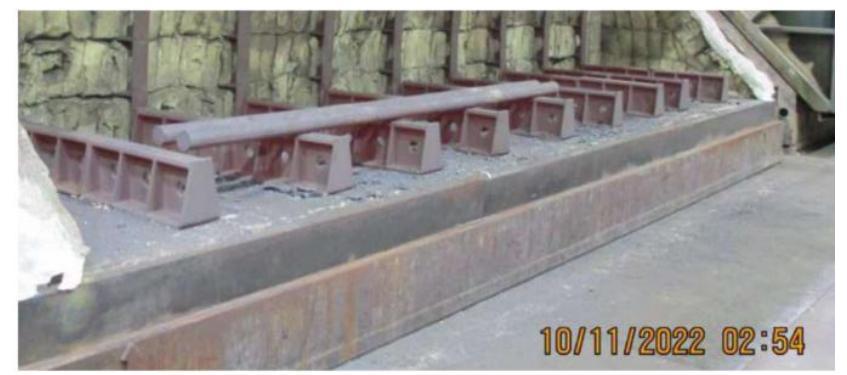
Inspection of the forging and machining processes of the dowel pins was conducted and its adherence to the approved Shop Technical Drawings, Special Provisions, and quality checks such as temperature consistency and Brinell hardness tests was verified. This inspection process was done in accordance with the ASTM A668 standard for forgings for carbon and alloy steel. Brinell hardness testing helps to evaluate the strength, ductility and other material properties of the dowel pins so that they serve the intended purpose of securing the trunnion hub during assembly.

Photo No. 3: Forged rods that were machined into the trunnion dowel pins in the furnace undergoing tempering.

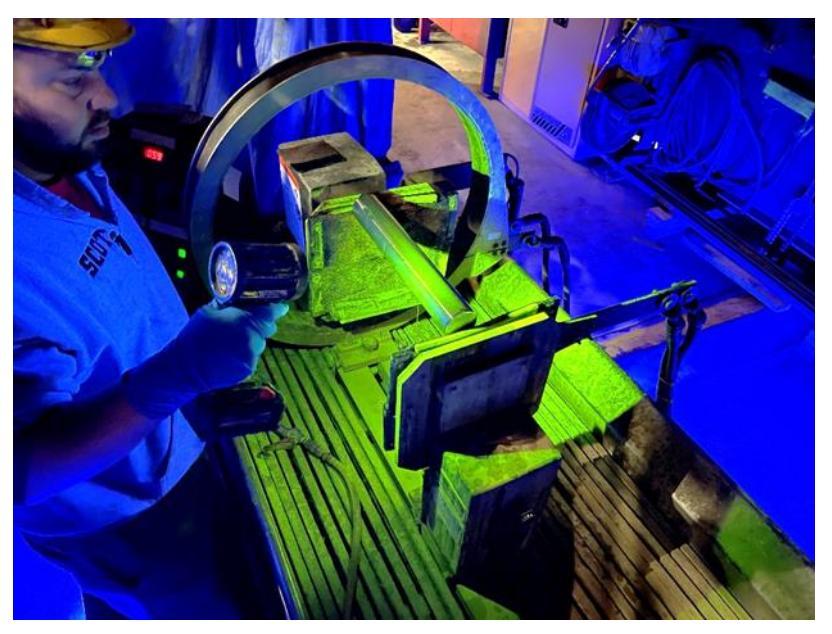
Additional inspections for the nondestructive testing on the twelve trunnion dowel pins were performed. The inspection included a magnetic particle and ultrasonic testing which adhered to the ASTM E709 and ASTM A388 respectively. Ultrasonic testing and magnetic particle testing identify internal cracks, porosities voids. and other discontinuities that were caused during the forging of the dowel pins.

Photo No. 4: Finished trunnion dowel pins undergoing magnetic particle testing.

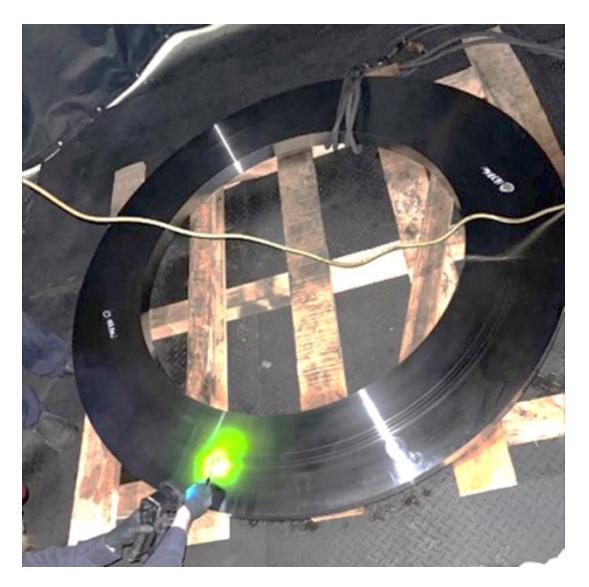
A comprehensive nondestructive examination was conducted and witnessed on four trunnion backing rings. The inspection's findings were derived from thorough visual assessments during the magnetic and ultrasonic testing phases. The Magnetic Particle Testing was performed in accordance with ASTM A275 and ASTM E709 which presented special requirements during the testing inspection. The above-mentioned non-destructive testing was intended to identify any internal discontinuities in the trunnion backing rings.

Photo No. 7: NDT Magnetic particle testing being performed on trunnion backing rings.

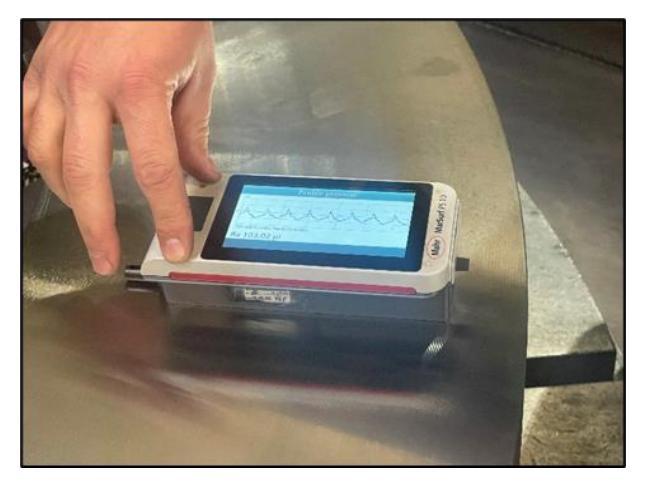
An inspection of the rough machining of the four (4) trunnion backing rings was conducted. The rough machining consisted of material removal, surface finish and Brinell hardness checks of all the surfaces of the ring. The surface finish and Brinell hardness requirements were outlined in the Technical Special Provisions and the approved Shop Drawings submitted by the mechanical fabricator for the project. Surface finish tests help to ensure that the surface between the backing rings and the trunnion is smooth, even and consistent. Brinell hardness tests were conducted to confirm the strength of the backing rings to serve its purpose in the trunnion assembly.

Photo No. 5: Trunnion backing rings being tested for surface finish.

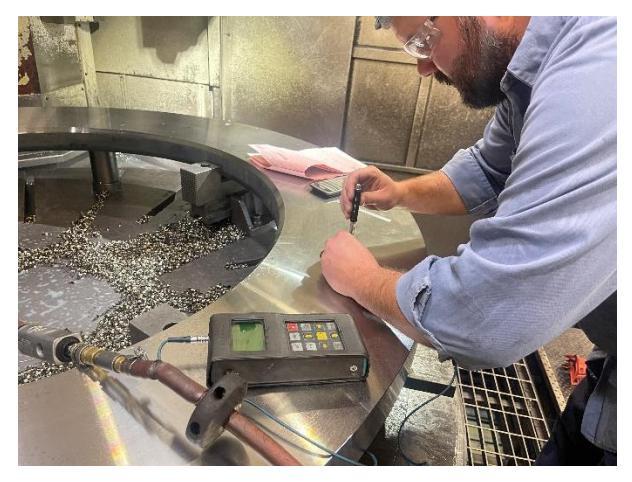
Photo No. 6: Trunnion backing rings undergoing hardness testing.

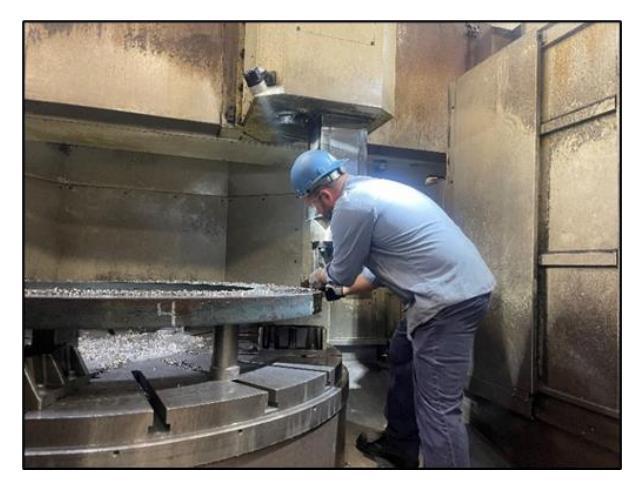
Photo No. 8: Trunnion backing rings undergoing machining.

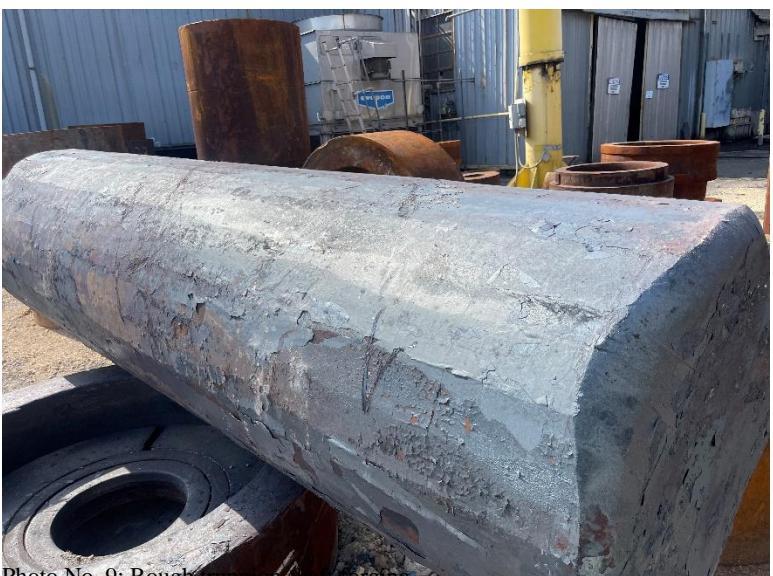
Photo No. 9: Roug

Inspection of the raw material was performed. The rough cut of the raw steel for the trunnion shaft material was inspected at the forging shop and was heat treated in preparation for the forging process.

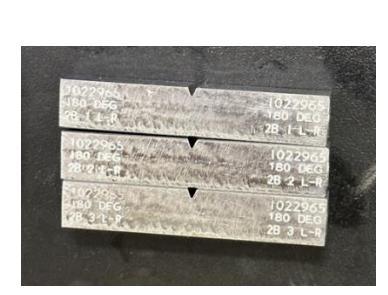
The material testing for the trunnion shafts which included tensile, charpy, and Brinell hardness tests. Material tests help to determine the ductility, strength and wear resistance of the trunnion shaft.

Photo No. 10: Samples of trunnion shaft material machined down to charpy test samples.

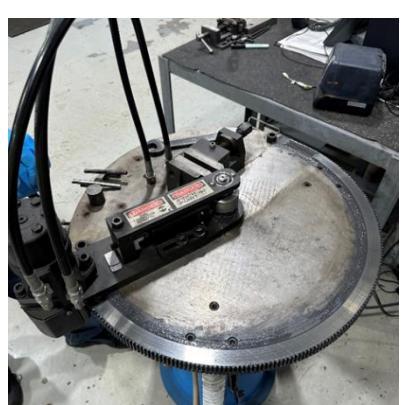
A bend test was conducted on trunnion shaft material for noticeable splitting of the metal or failure of the material.

Photo No. 11: Sample of trunnion shaft material undergoing a bend test.

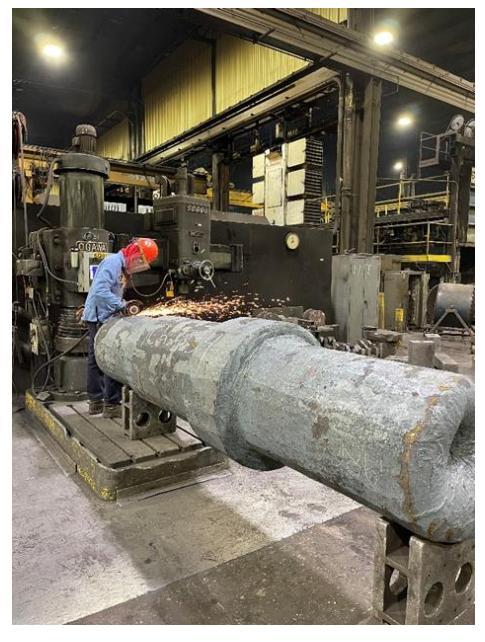
Photo No. 12: Trunnion shaft undergoing Brinelle Hardness Testing.

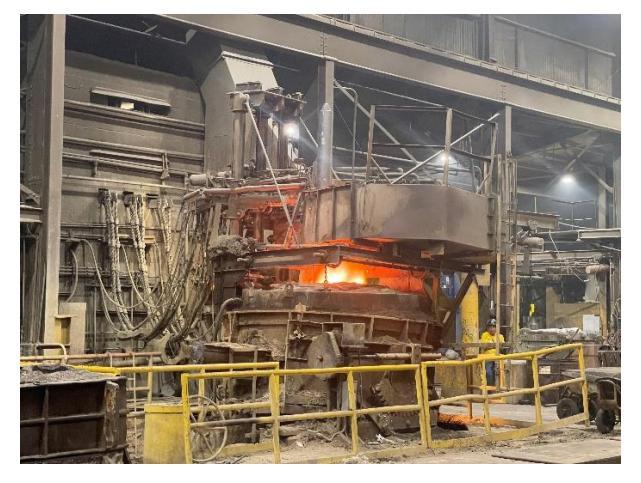
Grinding, arching and blasting of the castings was done to ensure that the castings have an even surface in preparation for machining. Heat treatments of the castings, which include normalizing and quenching was performed to improve the strength and durability of the castings. This was done in between the various stages of the entire casting process. Weld mapping and weld repairs were performed to correct the visible significant surface defects caused by the casting process. These defects are usually caused by poor riser/gate designs, incorrect sand bonding agents used and high melting/pouring temperature. The final stage of the casting process is the non-destructive testing. Magnetic particle and ultrasonic testing help to identify internal defects in the casting components. The castings were accepted or rejected based on the results of the non-destructive testing.

Photo No. 13: Furnace heating casting materials.

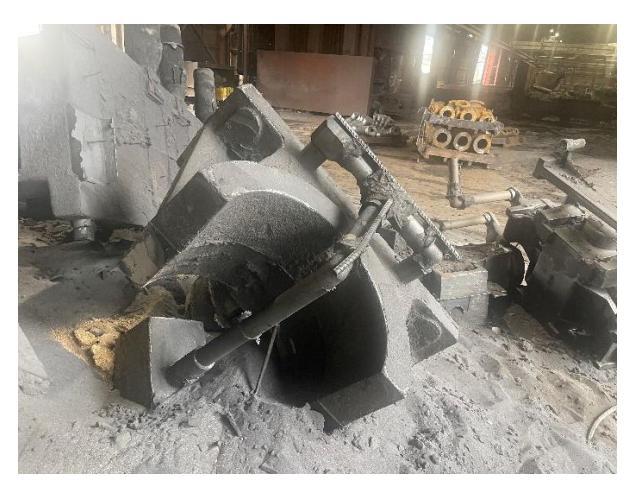
Witnessing and inspection of the casting process for the four trunnion hubs and eight trunnion bearing bases were conducted at the casting foundry. Before starting, Project Special Provisions, Shop Drawings, and ASTM standards were reviewed. The stages of the casting process included mold making, pouring, shakeout, blasting, grinding, non-destructive testing, weld mapping, weld repairs, and heat treatment. The first step involved creating sand molds from plastic patterns shaped like the trunnion hub or bearing base. Next, steel was melted in a furnace and poured into the molds. After cooling for a couple of days, the castings were removed from the sand molds and smoothed.

Photo No. 14: Trunnion bearing base casting shaken out of the mold.

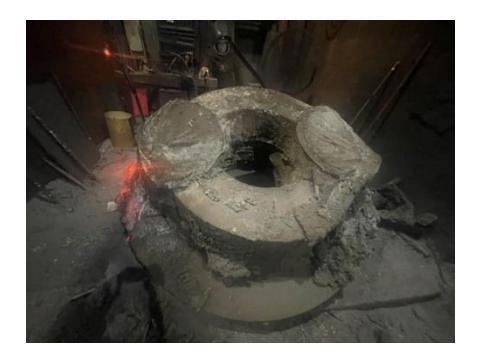
Photo No. 15: Casting undergoing arching and grinding to remove excess casting material.

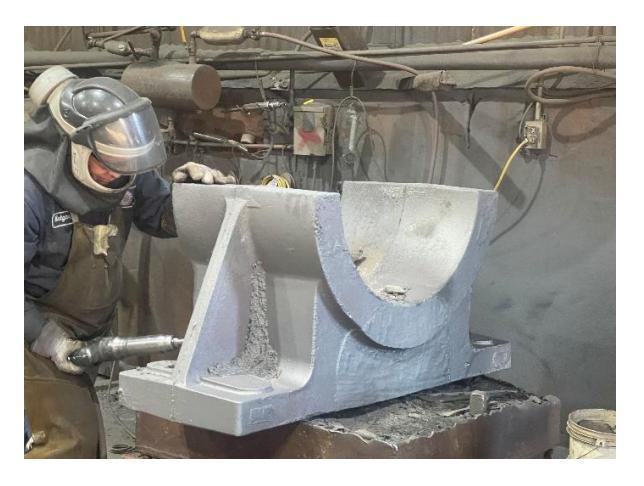
Photo No. 16: Trunnion bearing base casting refinement.

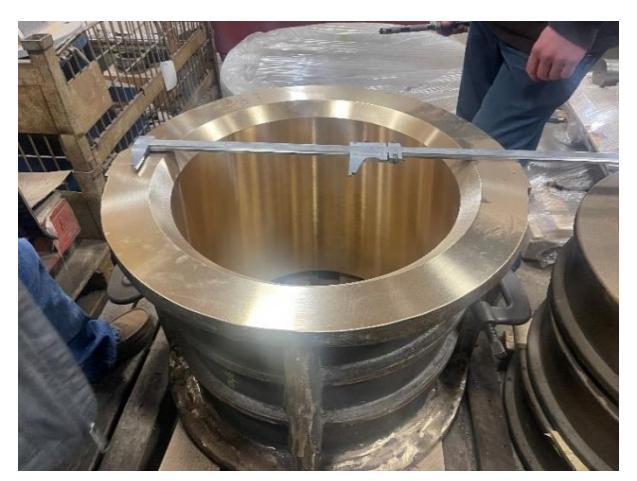
The bronze castings machining was inspected and the compression testing was witnessed for the trunnion bearing bushings and bearing caps. Compression testing was required by the Project Special Provisions on bronze castings and was witnessed per ASTM B22 requirements for the specified bronze material. Compression tests on bronze castings help to determine the properties of the bronze material under pressure.

Photo No. 17: Trunnion bushings visual and dimensional inspection.

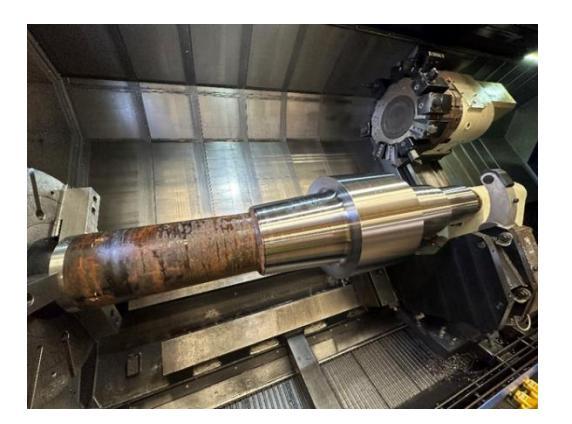
Inspection and witnessing to oversee the process for the initial setup and machining of the main pinion shaft and gearing were performed. This set up was done prior to the cutting of the gear teeth which was performed at another facility after the forgings were completed and machined.

Photo No. 19: Pinion shafts being machined down to size.

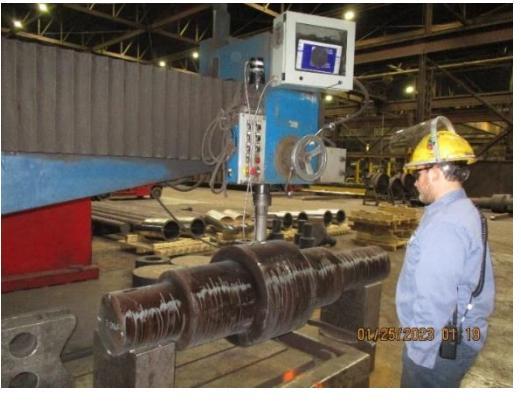
The Non-Destructive Testing (NDT), heat treatment and Brinell hardness testing of pinion shaft/gear segment forgings was witnessed. The NDT comprised of ultrasonic and magnetic particle testing. The Ultrasonic Testing was performed in accordance with ASTM A388. The magnetic particle testing was also executed in accordance with ASTM A275 and ASTM E709. Magnetic particle and ultrasonic testing help to identify internal discontinuities that were caused during the forging process.

Photo No. 18: Pinion shaft undergoing Brinelle Hardness testing.

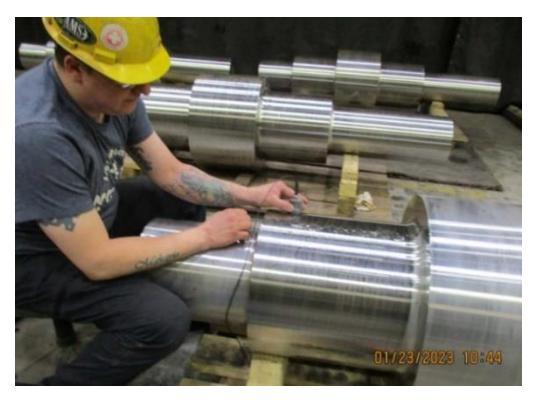
Photo No. 20: Ultrasonic testing of pinion shafts in process.

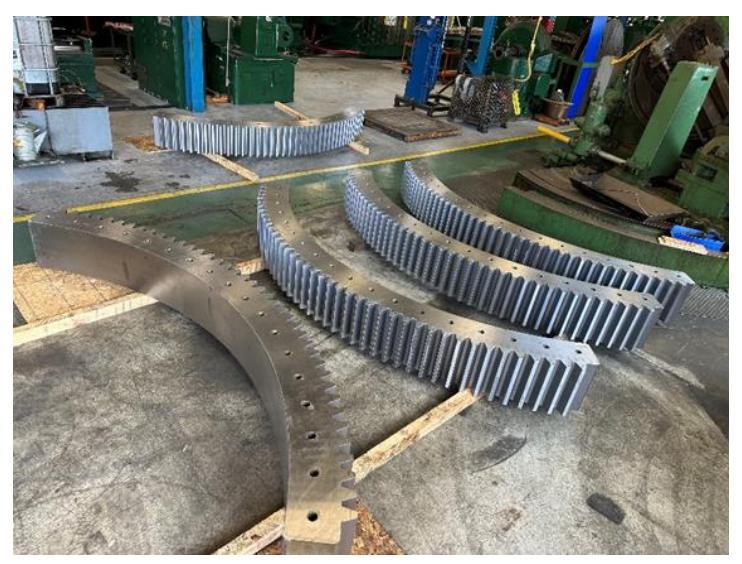
A detailed visual inspection of rack gear teeth and rack gear teeth measurement verification was conducted.

Photo No. 21: Visual and dimensional check performed on finished rack segments.

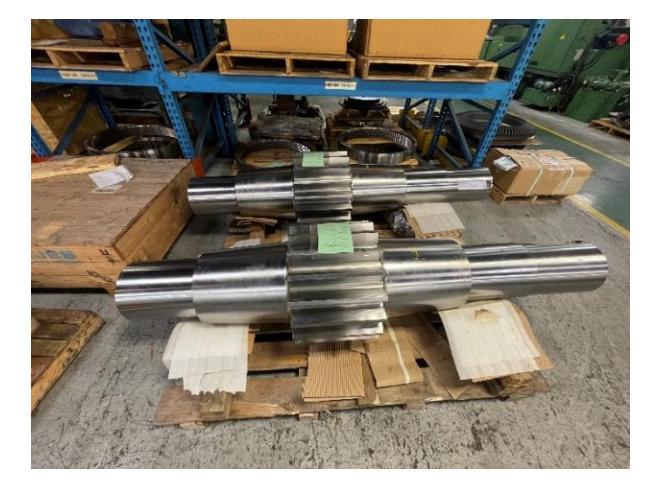
The five (5) pinion gears were scheduled for gear tooth measurement verification and inspection. There was a total of five (5) pinions each with eighteen (18) machined gear teeth. Span tooth thicknesses, gear tooth surface finish and pinion bearing diameters were verified and confirmed with calibrated micrometers. The keyway sizes on the pinions were verified against the approved Shop Drawings. Pinion gear teeth were cleaned and inspected for defects and other wear marks and no defects were noted.

Photo No. 22: Visual and dimensional checks performed on machined pinion shafts.

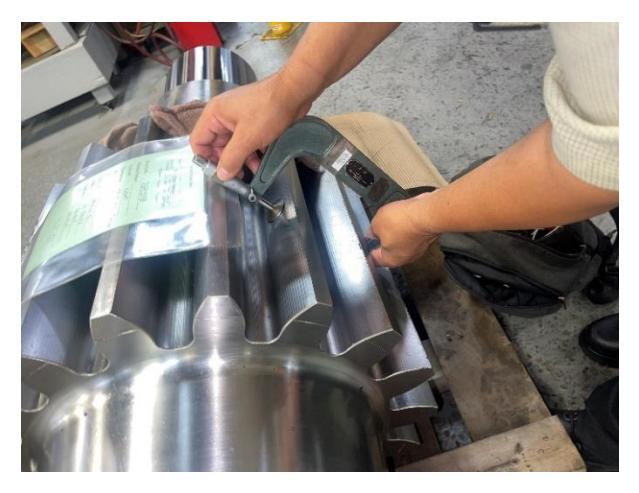
Photo No. 23: Dimensional verifications in progress on the integral pinion gear teeth.

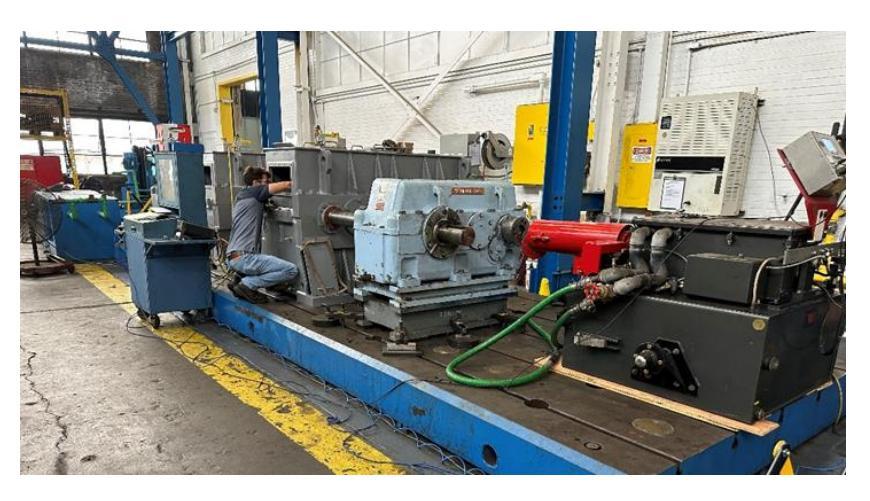
Photo No. 24: Primary reducer testing set up on testing platform for runtime tests.

The witnessing of the reducer testing for the two primary reducers was conducted over five days per the procedure, approved by the Engineer of Record (EOR). Similar to the reversing unit, the primary reducer testing consisted of a no-load and load test under specific rpm, hp and torque requirements specified in the Special Provisions and the testing procedure submitted by the enclosed reducer fabricator. The inspectors witnessed and recorded the measurements of reducer bearing cap temperatures, ambient temperatures and noise levels. A visual inspection of the gear tooth surface, and contact was conducted. The testing was also inspected for excessive noises and vibrations during the testing process.

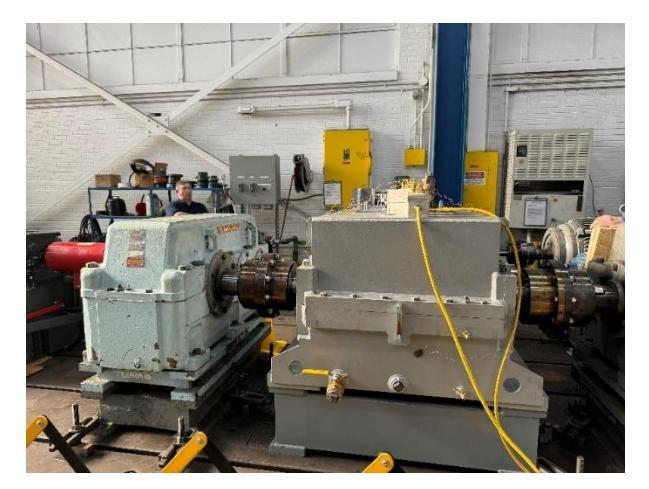
Photo No. 25: Secondary reducer setup for runtime test under load.

Each reducer testing for the two secondary reducers was performed over two days per the procedure, approved by the Engineer of Record (EOR). The procedure for the secondary reducers was similar to that of the primary reducer, which consisted of the no-load and load tests with different torque and rpm requirements.

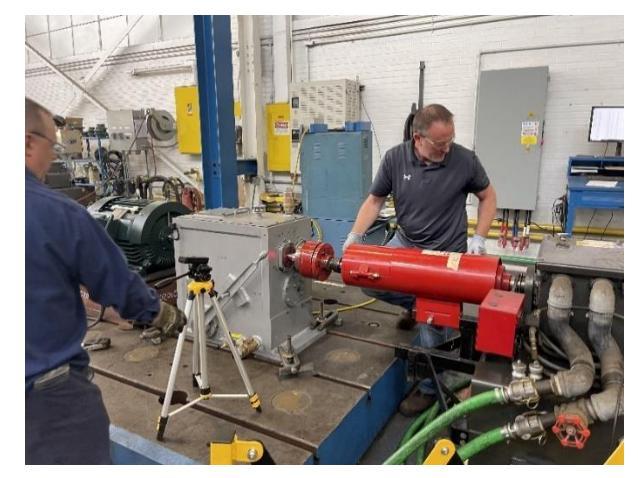
The reversing unit testing consisted of a no-load and load test under specific revolutions per minute (rpm), horsepower (hp) and torque requirements specified in the Special Provisions and the testing procedure submitted by the enclosed reducer fabricator. The inspectors witnessed and

recorded measurements of reducer bearing cap temperatures, ambient temperatures and noise levels. Also, visual inspections of the gear tooth surface, and contact were conducted. The testing was also observed for excessive noises and vibrations during the testing process.

Photo No. 26: Reversing reducer undergoing runtime testing under load.

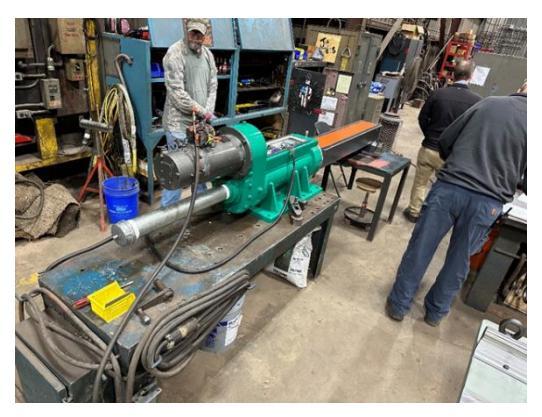
Bronze castings measurements for the final machined span lock guide and receiver shoes were verified per the Shop Drawings and visually inspected. The dimension checks help to identify any deviations in dimensions from the Contract Plans and Shop Drawings before the span lock guide and receiver shoes are shipped out to the field. Span lock actuator, limit switches and brakes functional testing was performed per the approved procedure. Systems were actuated and voltages verified to meet Contract Documents. Functional testing is performed to verify that the AASHTO designed span lock actuator features work as intended to.

Photo No. 27: Span lock functional check performed on actuator and lock bar components.

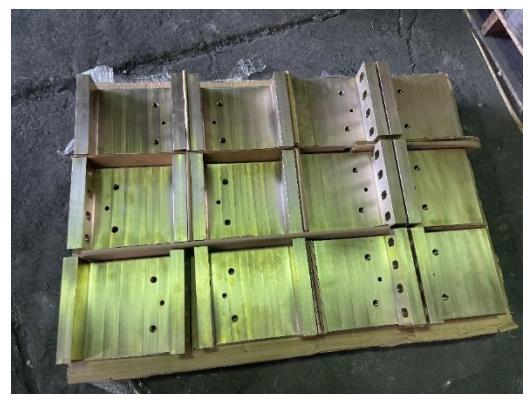
Photo No. 28: Visual and dimensional checks performed on lock bar shoes after final machining.
