## East Half Replacement – Hood Canal Bridge

**Michael J. Abrahams**  
**Scott Snelling**  
**Parsons Brinckerhoff Quade & Douglas, Inc.**

**TENTH BIENNIAL SYMPOSIUM**

# East Half Replacement of the Hood Canal Bridge

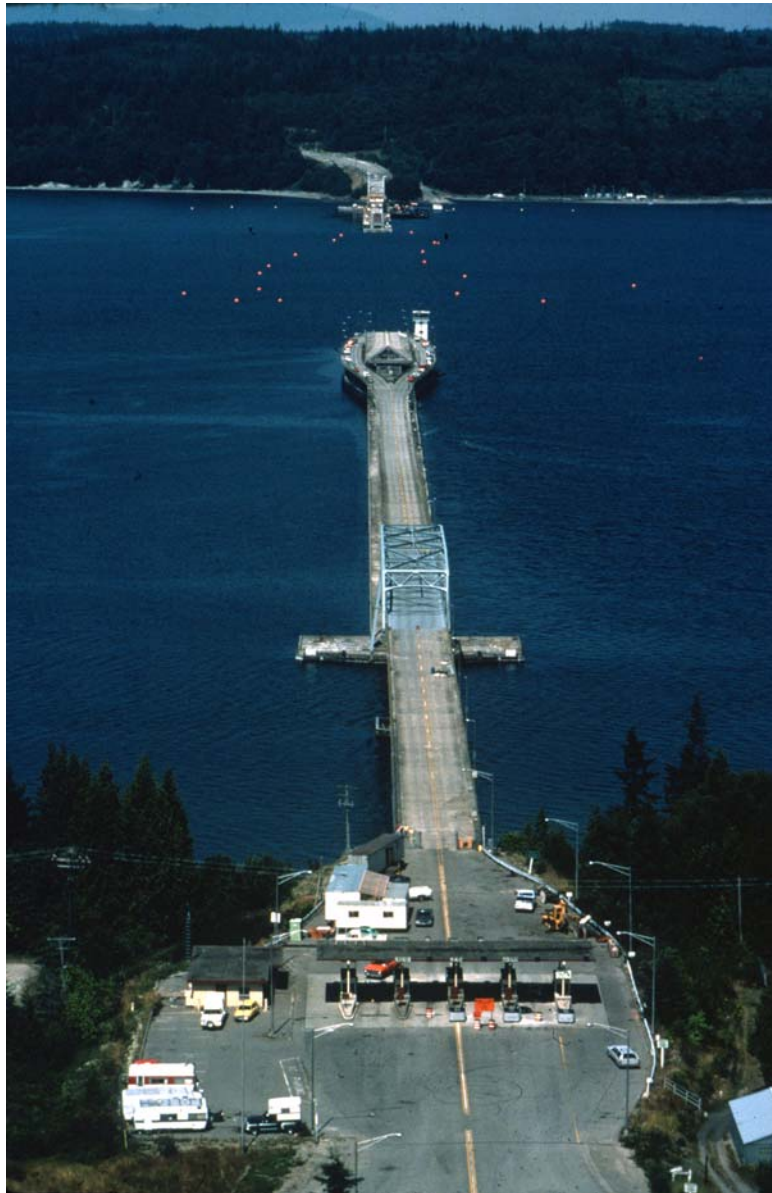
Figure 1 – Aerial Photo Showing Existing East Half (1958 Design) and Sunken West Half.

In February 13, 1979, a 100 year storm destroyed the western half of the Hood Canal Bridge-the principal highway link from Seattle to the Olympic Peninsula, see Figures 1 & 2. The storm wind gusts were reported to be 120 miles per hour with sustained winds of 85 miles per hour. The loss of this critical bridge link resulted in a 100-mile detour and activation of limited and costly emergency ferry service. The owner of the bridge, the Washington State Department of Transportation, determined that the structure should be replaced as a floating bridge but that the replacement would incorporate the considerable advances in the analysis of floating structures. The West Half replacement was completed in a two stage process in

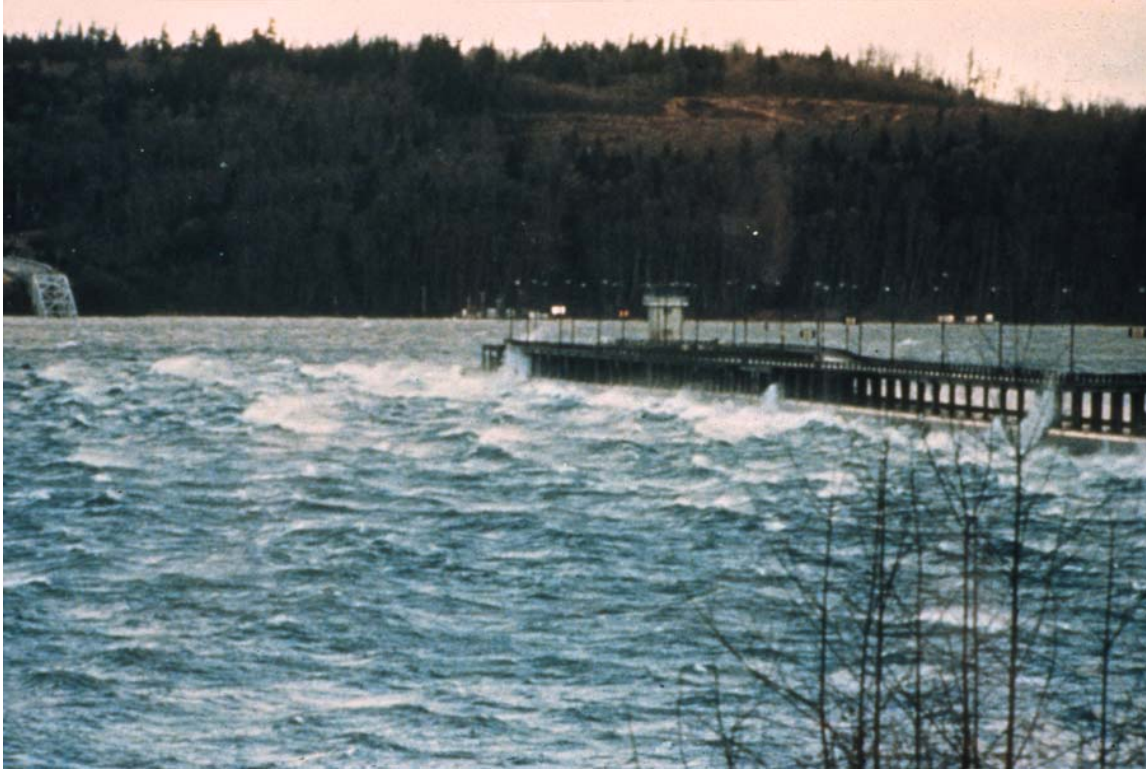
Figure 2 – East Half Sunk During 100 Year Storm

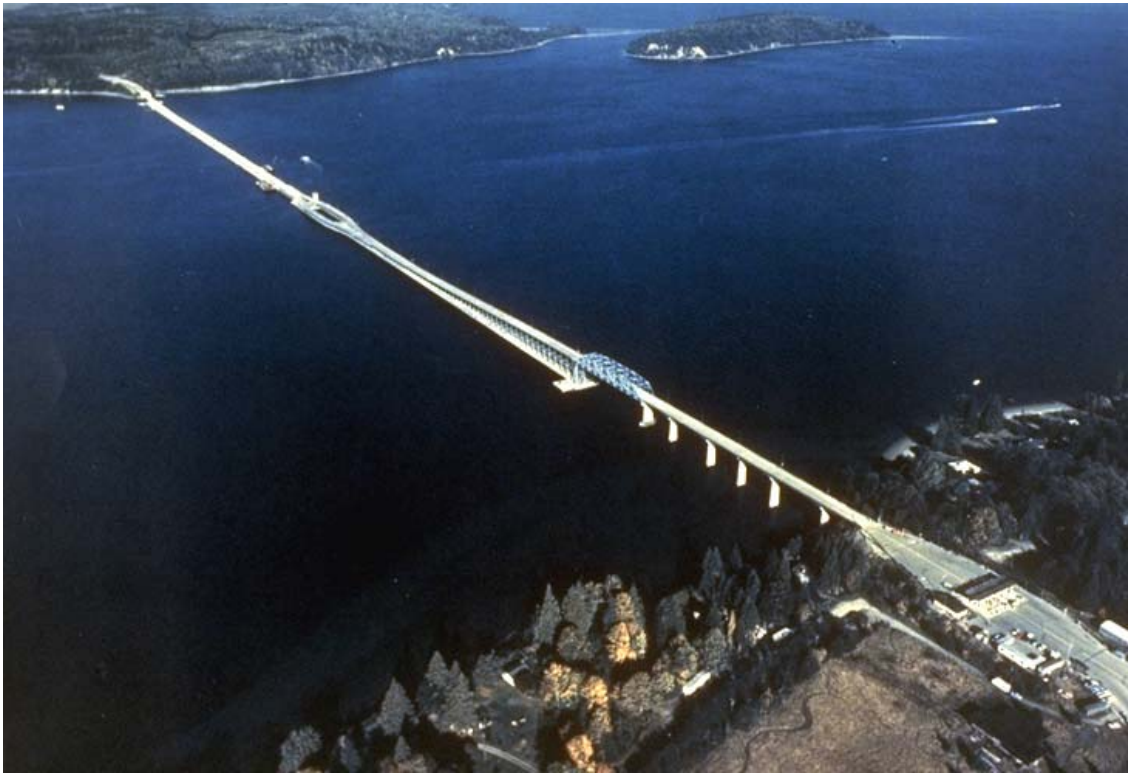
Figure 3 – Aerial Photo Showing Existing East Half (Near) and New West Half During Stage 1

To speed the restoration of highway service across the canal, the Department obtained Coast Guard approval to restrict the navigation channel during Stage I construction to the 300-foot width provided by the remaining half of the original 600-foot-wide twin draw spans, see Figure 3. In Stage II, a new draw span (on the West Half) replaced a portion of the Stage I construction, restoring the navigation opening to its full width. Stage III, the East Half replacement design was also completed at that time, see Figure 4. Based on a review of available wind speed records, the replacement bridge was designed to withstand sustained waves generated by 83-mph winds and wind pressure from 110-mph gusts. The canal is a deep natural waterway-up to 340 feet in spots-with strong currents and tidal variation of over 16 feet. Adding to design complexity, the bridge was designed for a seismic event and all construction materials were required to withstand a marine environment.

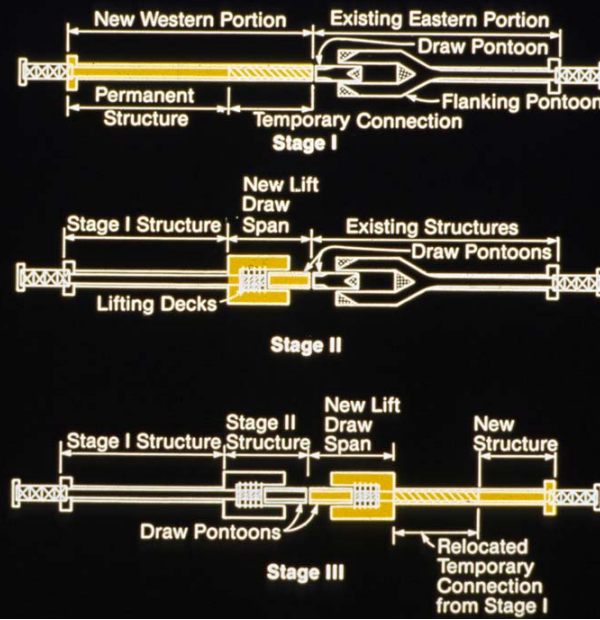
## Construction Staging Plan

Figure 4 – Construction Staging Plan

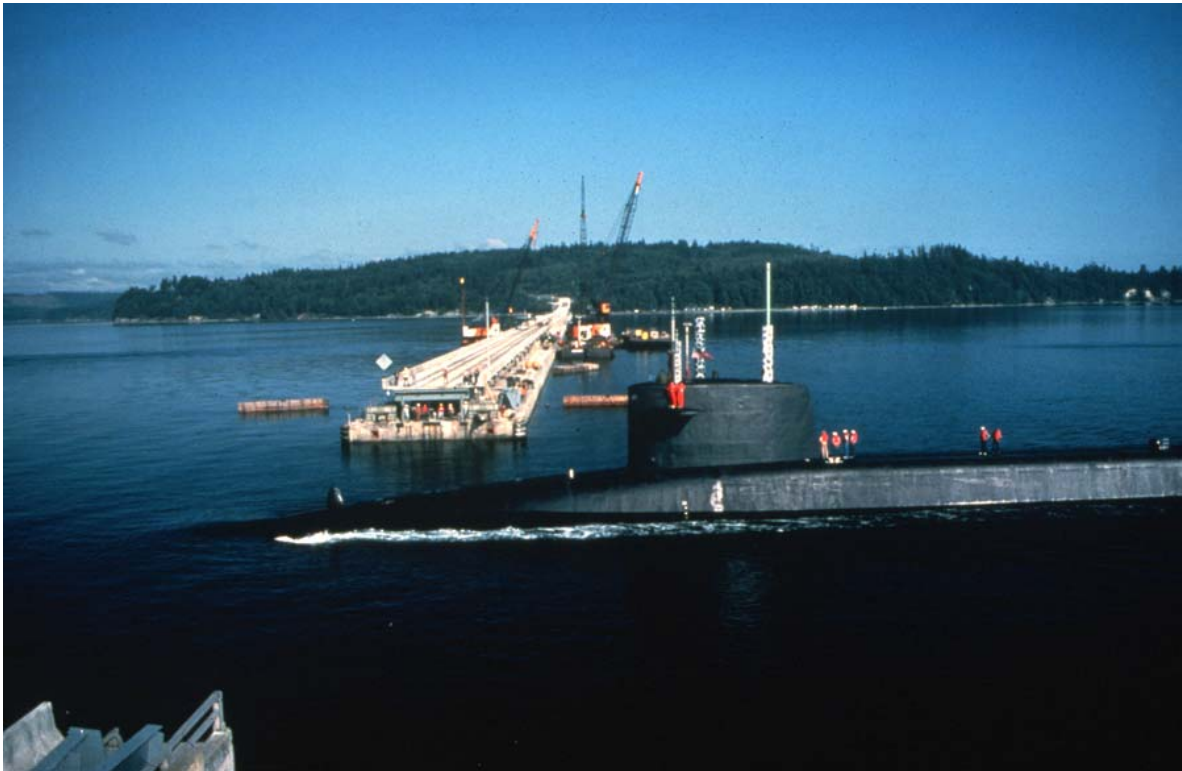
Figure 5 – Submarine Passing Through Open Bridge During Stage I

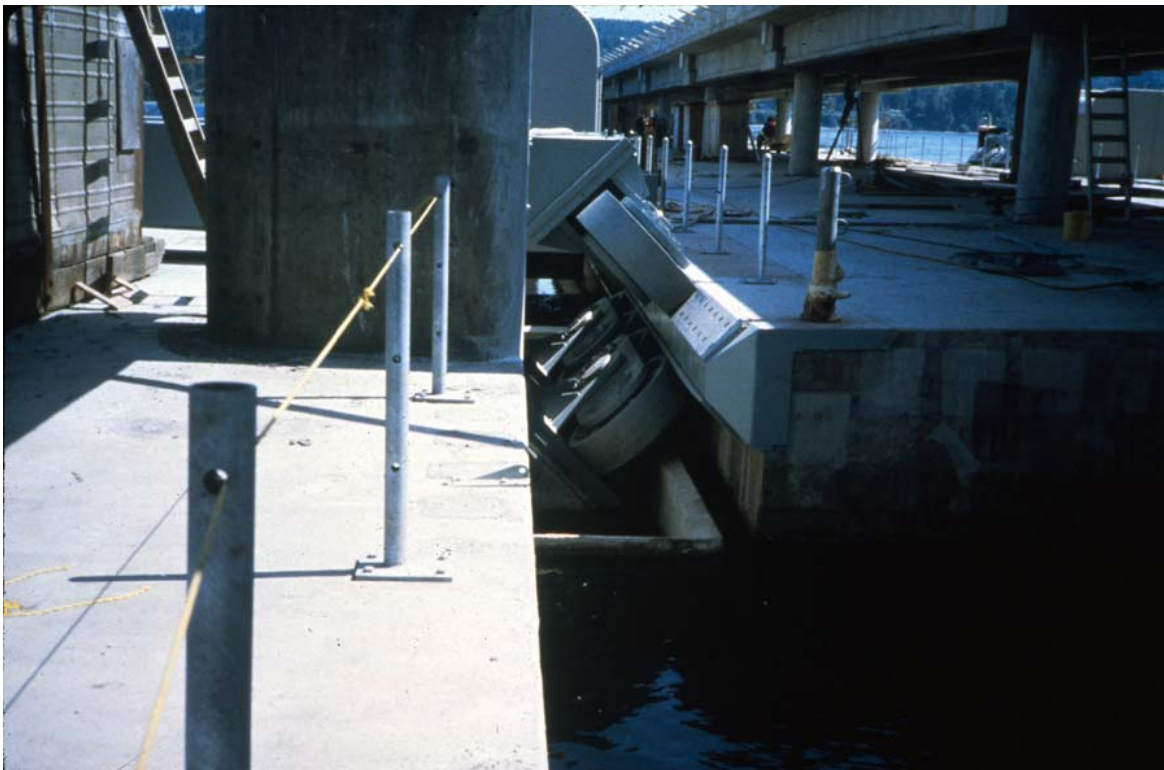
Figure 6 – 1982 Guide Rollers. Standing on Flanking Pontoon Looking Longitudinally

The final 1982 configuration incorporates sets of two 4-foot-diameter rollers are joined by an equalizer frame, see Figure 6. As shown in Figure 7, the guide rollers are oriented at 45 degrees to a horizontal plane. This arrangement permits the guide rollers to be mounted in a way that does not penetrate the pontoon walls and, at the same time, allows the rollers to be out of the water to facilitate adjustment or replacement.

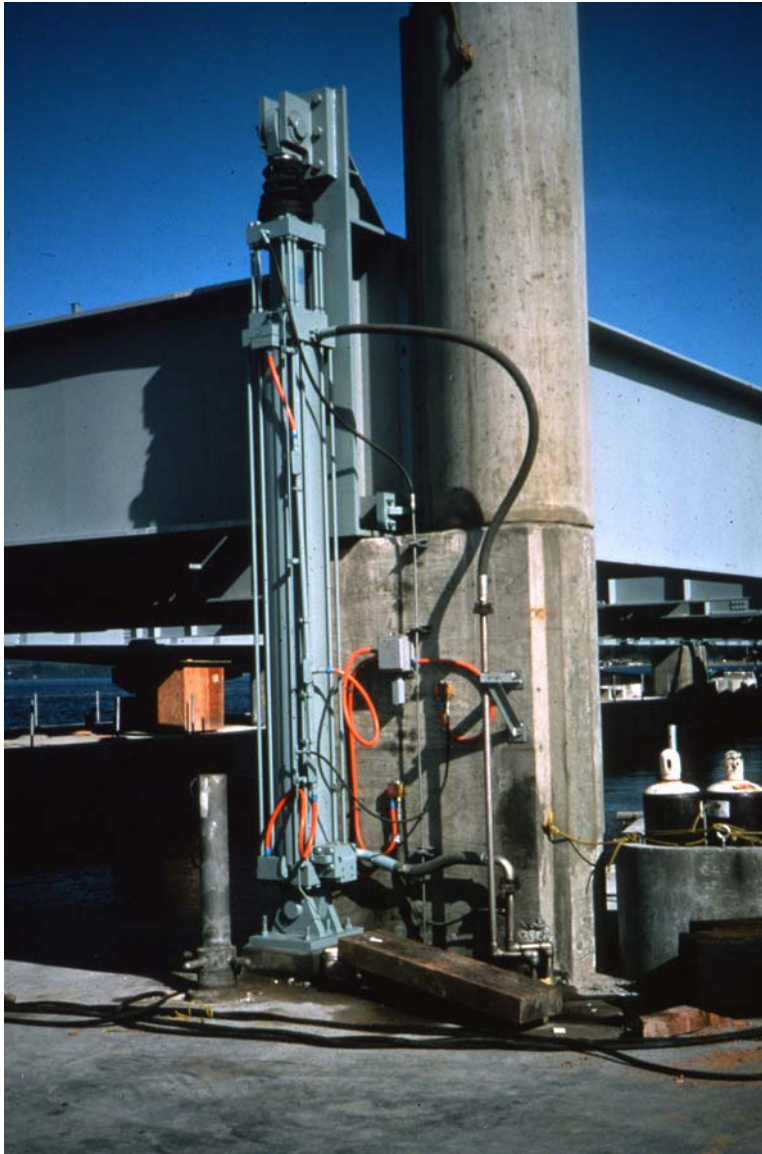
Figure 6 – 1982 Hydraulic Cylinder for Lift Decks.  
Replaced in 1998 Hydraulic Rehab

Each set of lift deck machinery consists of one Hydraulic Power Unit (hpu) and four hydraulic cylinders, one lifting each corner of the deck, see Figure 8. The hpu's contain a flow divider that is used to equally proportion the fluid to the cylinders. The three hpu's for each half of the bridge are contained in a single pontoon cell. Stainless steel hydraulic piping runs from the hpu's through the pontoon cells to each cylinder and back. The cylinders are 12 inches in diameter with a 9-foot-long stroke. The lift spans operate sequentially, after one starts to move the next unit follows. The entire operation is controlled from the control house.

The 1982 (Unit II) design used 75hp@1200 rpm motors and 120gpm (~400cc) pumps. Each deck took about 75 seconds to rise. Each cylinder was equipped with a "Bear Loc" to hold the cylinder rod in case of a loss of fluid pressure. The "Bear Loc" is a patented device which utilizes a hydraulically expanded sleeve around the piston rod. In order to control the lowering of the span, a counterbalance valve in the hpu was used.

In 1998 a hydraulic rehabilitation was performed. The work involved replacing the cylinders, the pumps, and the directional control valve. The "Bear Loc" on the original cylinders proved to be difficult to maintain. Therefore, the replacement cylinders used a cylinder mounted load holding valve instead. The original fixed displacement pumps were replaced with more sophisticated 500cc (~150gpm) variable displacement axial piston pumps with pressure compensating control. The hydraulic rehabilitation proved troublesome because the new pumps were poorly suited to the low pressure and flowrate associated with the 30-foot-wide roadway and 75 hp motor, resulting in a low pump efficiency of 73%. Subsequent to the rehabilitation the lifting times dropped to 90 seconds and the motors continue to have problems with overloading the circuits and tripping out. The new directional control valve caused additional troubles, as it requires the pumps to start against the system relief valve until enough pilot pressure is built up to operate the valve. Further problems were encountered with the cylinders that were supplied in the metric size of 320mm (12.598") diameter, instead of 12". The larger size contributed to the slower lift times and reduced pump efficiency. On half of the locations, the cylinder manifold also interfered with the adjacent concrete guide columns, requiring the columns to be chipped out
